Franklin Square Park

Level 3 Advanced Assessments Report

Tree Risk Assessment Report

Franklin Square Park
130 E West Street
Southport, NC 28461
February 2, 2024

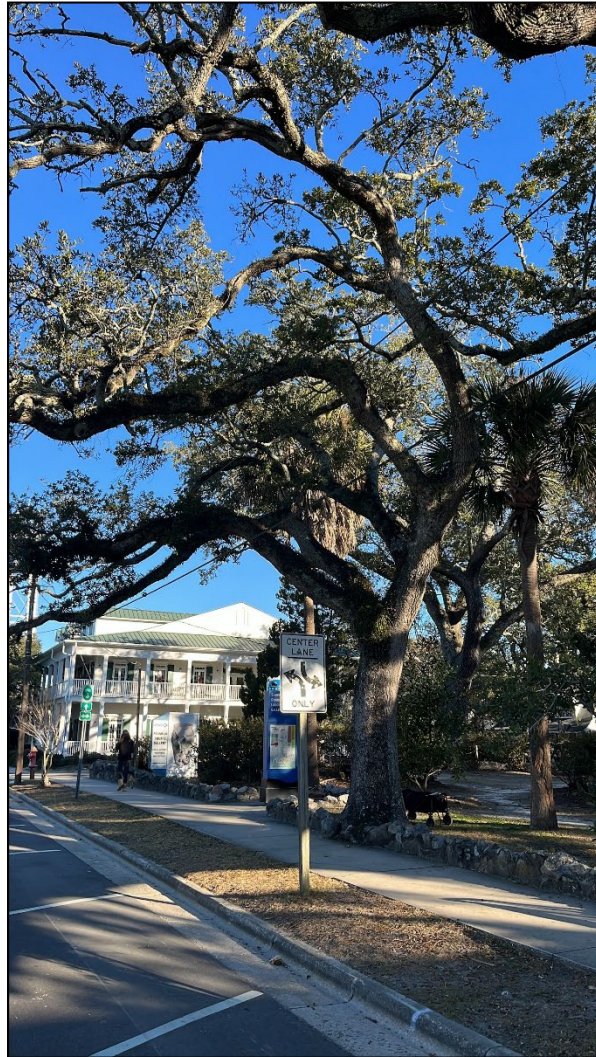
Photo 1: Looking north at live oak #1 showing the uneven crown hanging over on street parking, a sidewalk, and overhead lines.

Live oak #1 was in fair condition with dead branches in the crown, an unbalanced crown, co-dominant stems, and a cavity in the root collar.

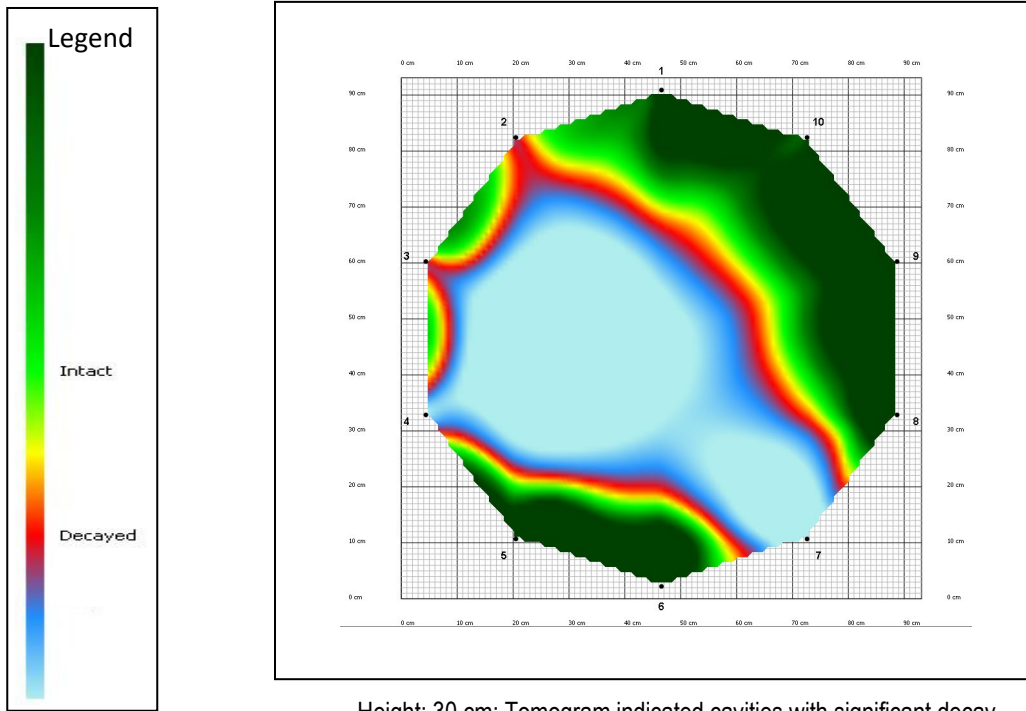
ArborSonic 3D™ Tomogram Live Oak #1 - 30 cm

Height: 30 cm; Tomogram indicated cavities with significant decay.

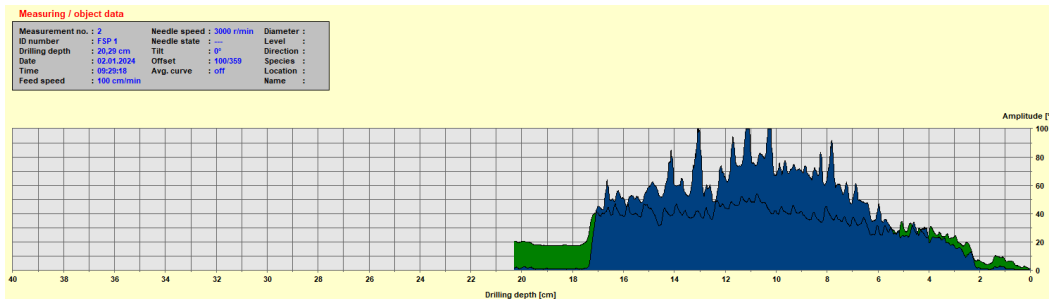
IML Resi-PD 400 Resistance Drill Readings: Live Oak #1 - 30cm

Drilling at 30 cm above grade, the sensor #2 position indicated 17 cm (6.7 inches) of sound wood.

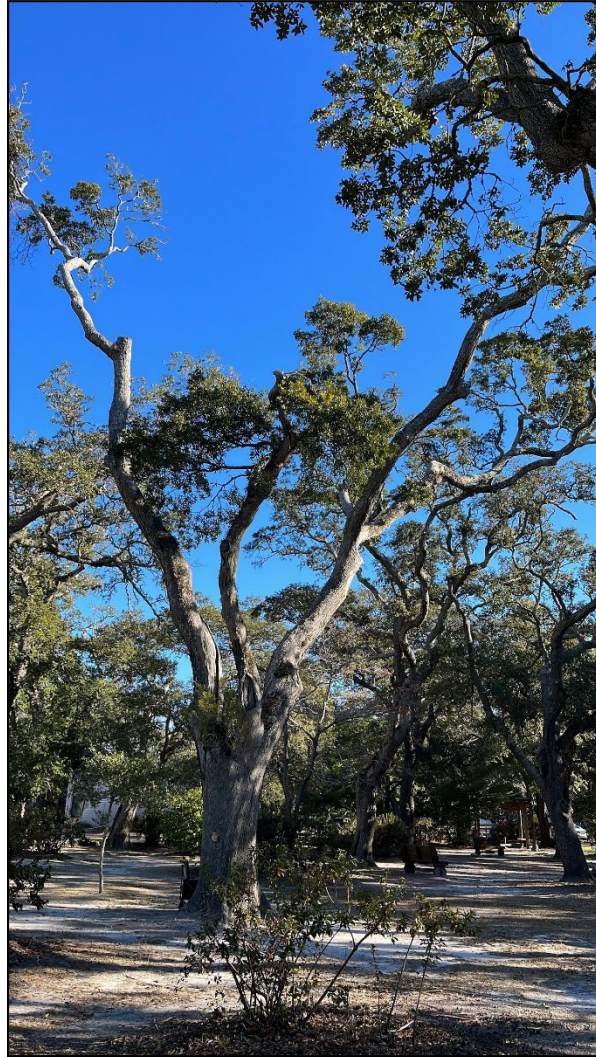
Photo 2: Looking northeast at live oak #3 showing the lions tail pruning and the co-dominant stems.

Live oak #3 was in poor condition with dead branches throughout the crown, co-dominant stems, lions tail pruning, a stem cavity, and decay in the stem.

I recommend removing live oaks #3, #24, and #25 entirely to remove the risk of root, root collar, trunk, crown, and branch failure. Grind the resulting stumps and back fill the holes. There will be no residual risk for these four trunks, crowns, or branches, but there may be a tripping hazard with the remaining roots, stump, or grindings that you will need to address for all four trees.

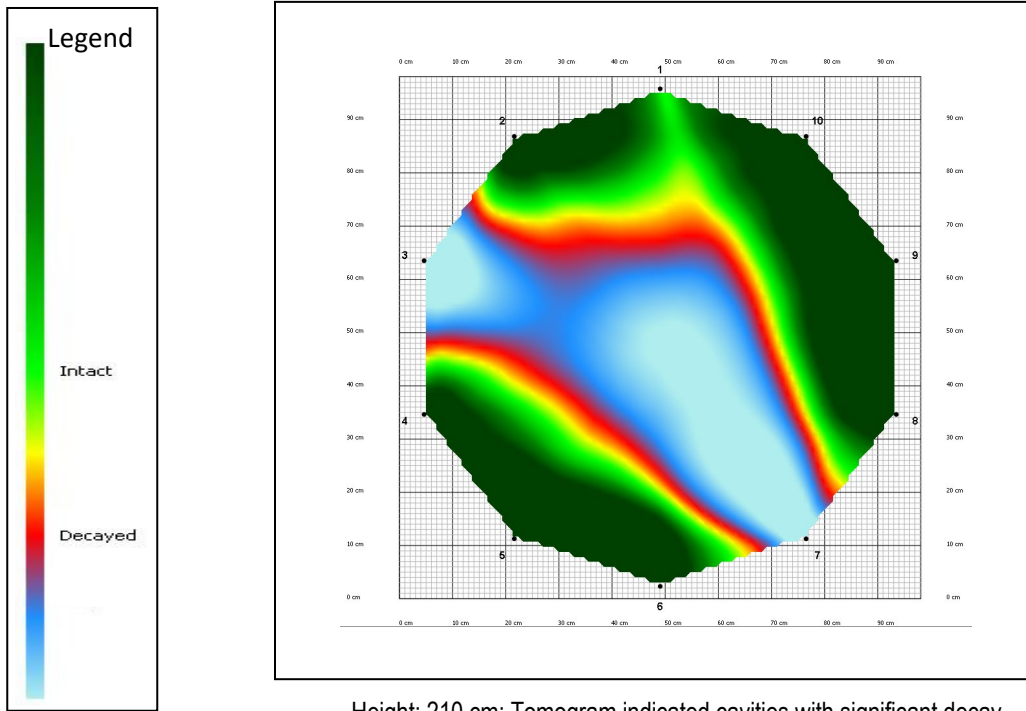
ArborSonic 3D™ Tomogram Live Oak #3 - 210 cm

Height: 210 cm; Tomogram indicated cavities with significant decay.

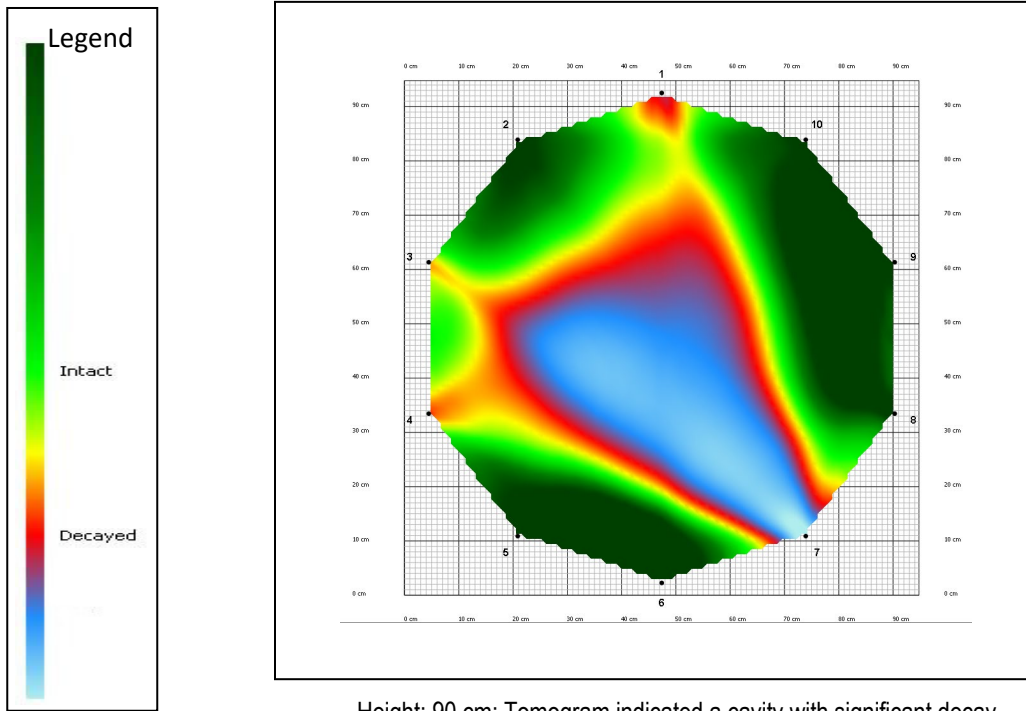
ArborSonic 3D™ Tomogram Live Oak #3 - 90 cm

Height: 90 cm; Tomogram indicated a cavity with significant decay.

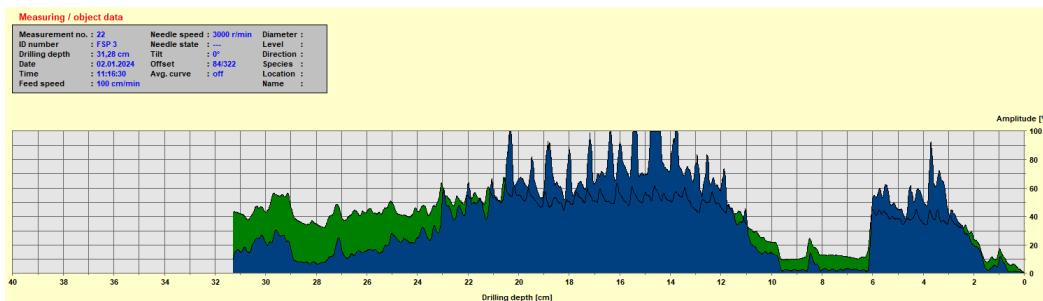
IML Resi-PD 400 Resistance Drill Readings: Live Oak #3 - 90cm

Drilling at 90 cm above grade, the sensor #4 position indicated 18 cm (7 inches) of sound wood.

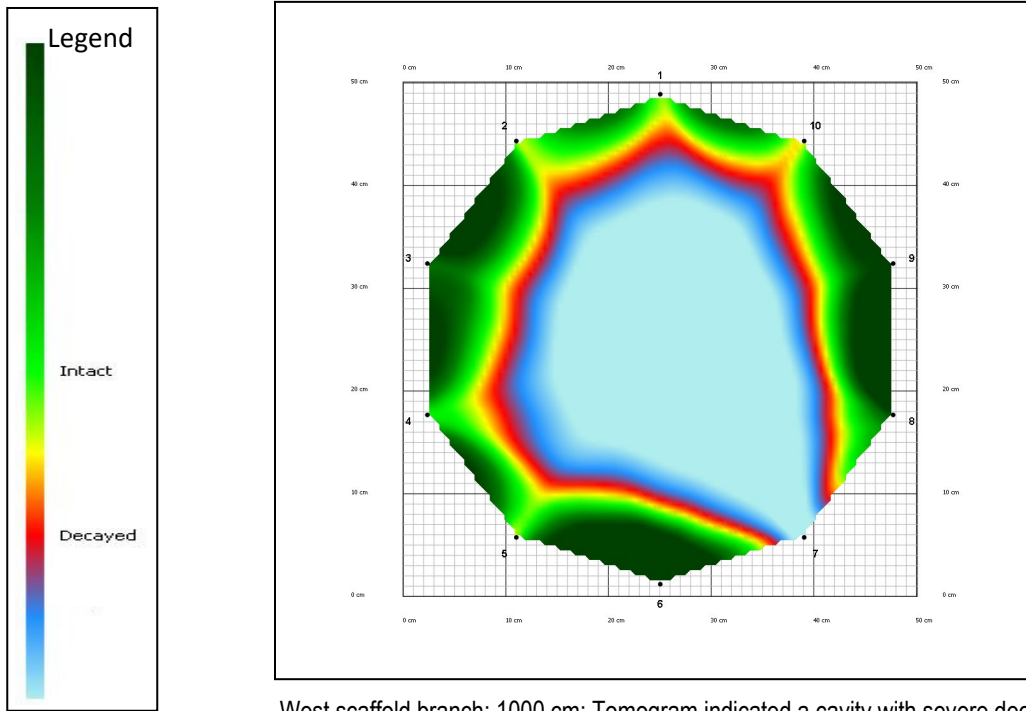
ArborSonic 3D™ Tomogram Live Oak #5- W Scaffold Branch - 1000 cm

West scaffold branch: 1000 cm; Tomogram indicated a cavity with severe decay.

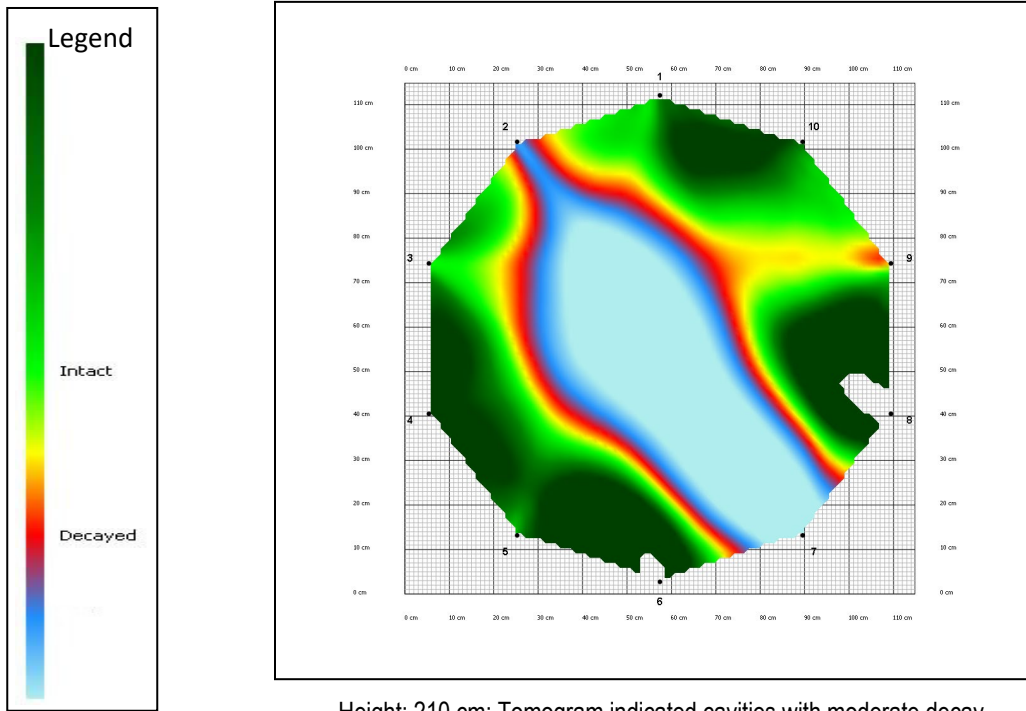
ArborSonic 3D™ Tomogram Live Oak #5- 210 cm

Height: 210 cm; Tomogram indicated cavities with moderate decay.

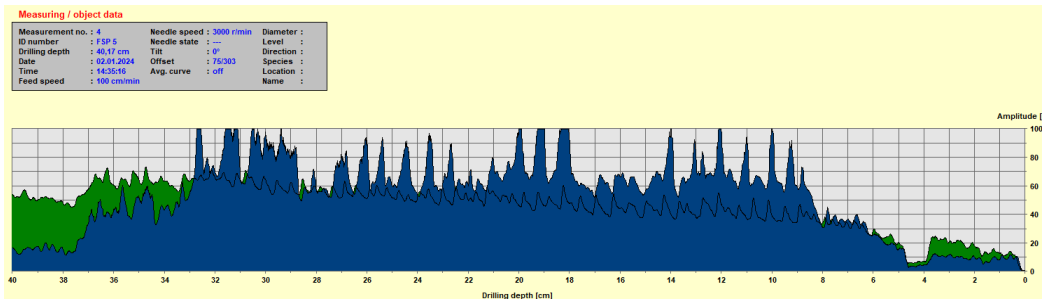
IML Resi-PD 400 Resistance Drill Readings: Live Oak #5- 210cm

Drilling at 210 cm above grade, the sensor #2 position indicated 33 cm (13 inches) of sound wood.

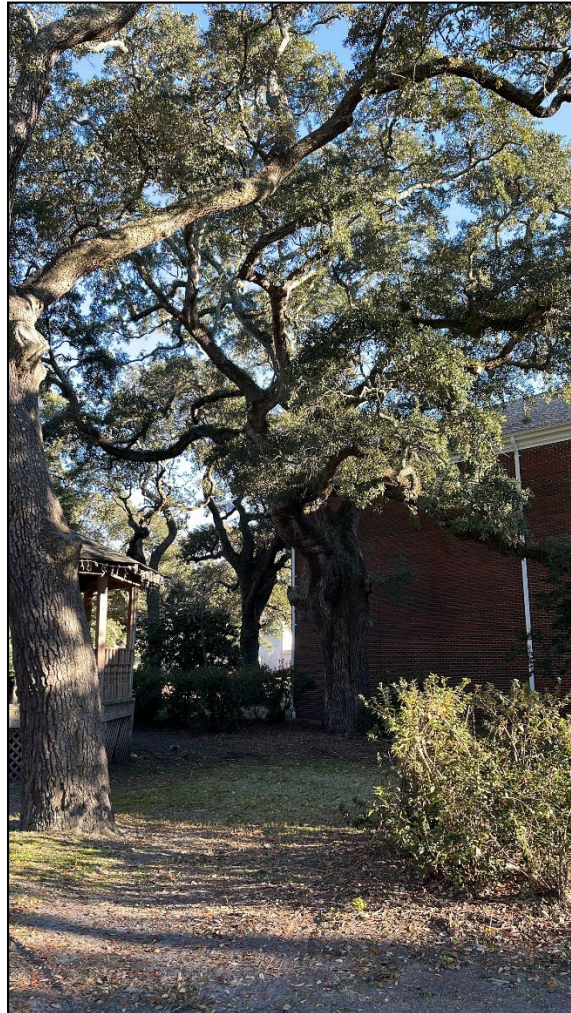
Photo 4: Looking east at live oak #8 showing the close proximity to the building.

Live oak #8 was in fair condition with dead branches throughout the crown, an uneven crown, co-dominant stems, and a stem cavity.

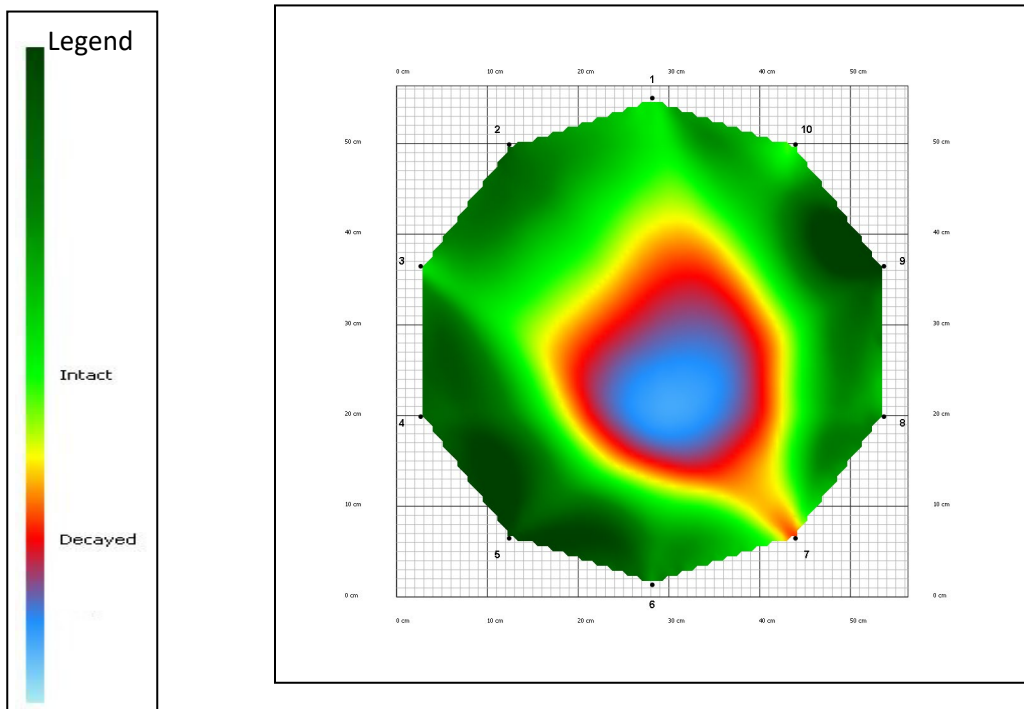
ArborSonic 3D™ Tomogram Live Oak #8 - 500 cm

Height: 100 cm; Tomogram indicated minor decay.

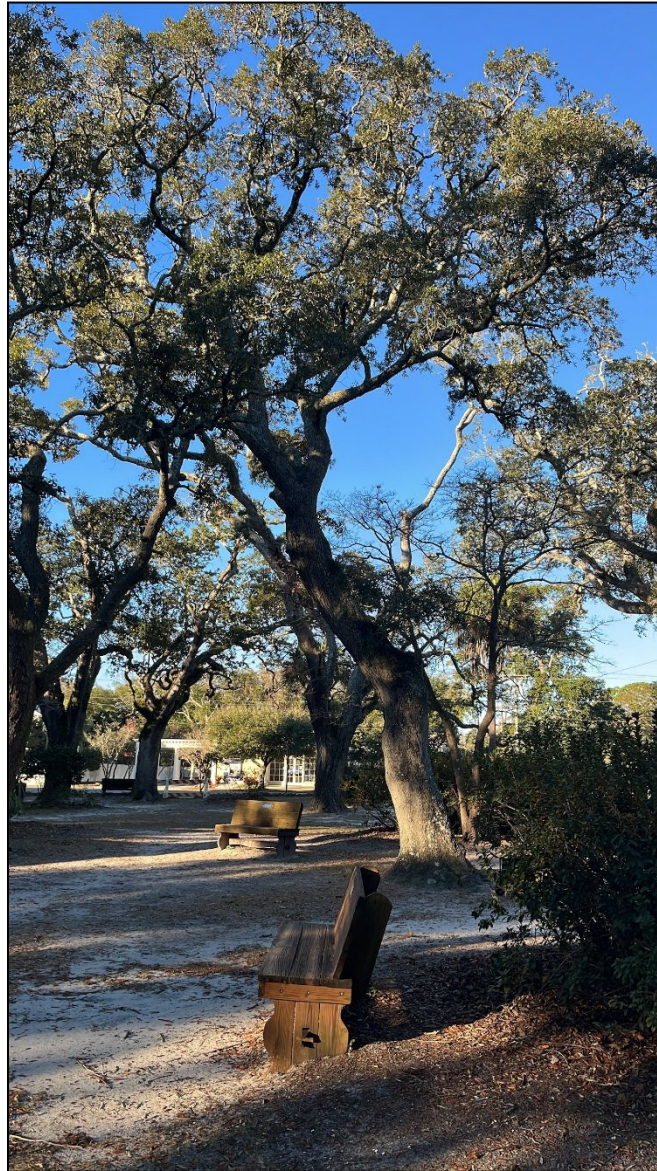
Photo 5: Looking west at live oak #10 showing the over-extended branch at the right.

Live oak #10 was in fair condition with dead branches, an unbalanced crown, a cavity in the north side of the stem, and a cavity in the west side of the lower stem.

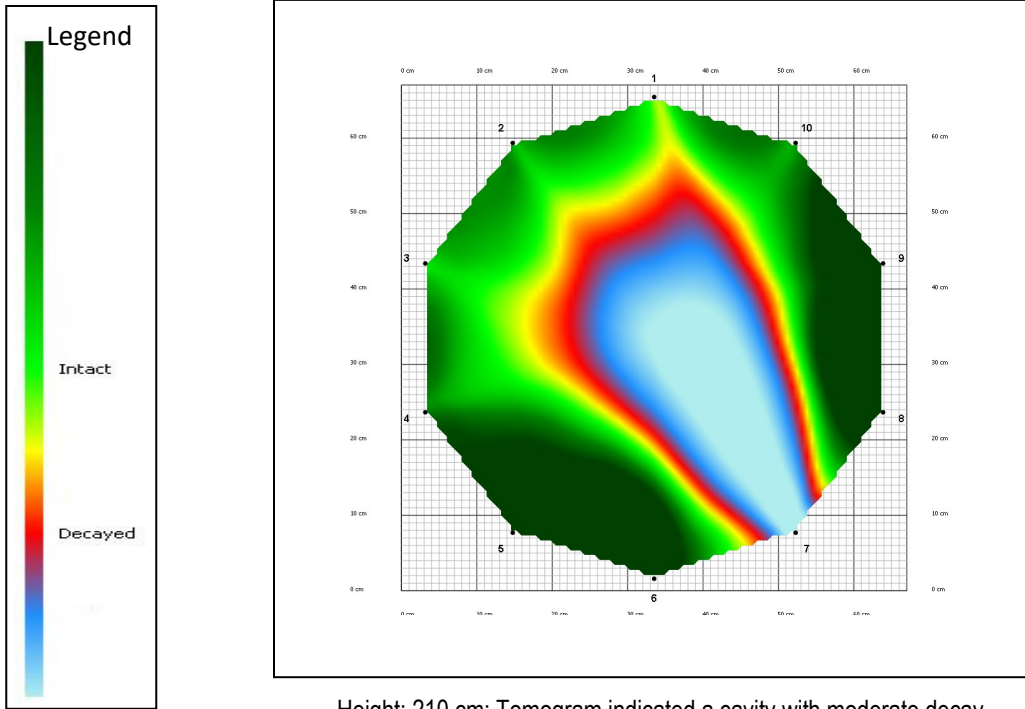
ArborSonic 3D™ Tomogram Live Oak #10- 135 cm

Height: 210 cm; Tomogram indicated a cavity with moderate decay.

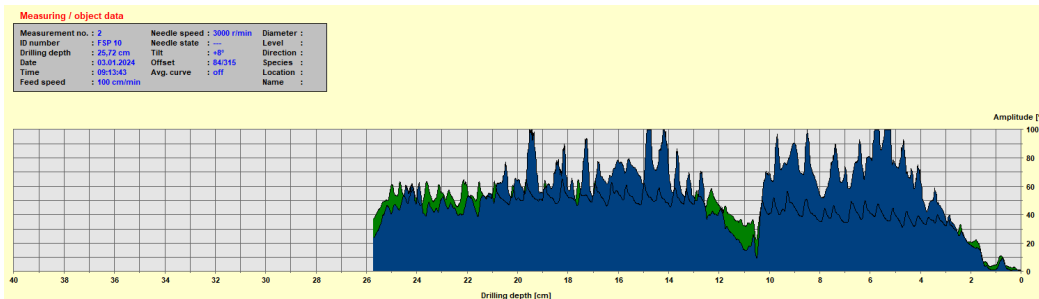
IML Resi-PD 400 Resistance Drill Readings: Live Oak #10 – 135 cm

Drilling at 135 cm above grade, the sensor #7 position indicated 33 cm (13 inches) of sound wood.

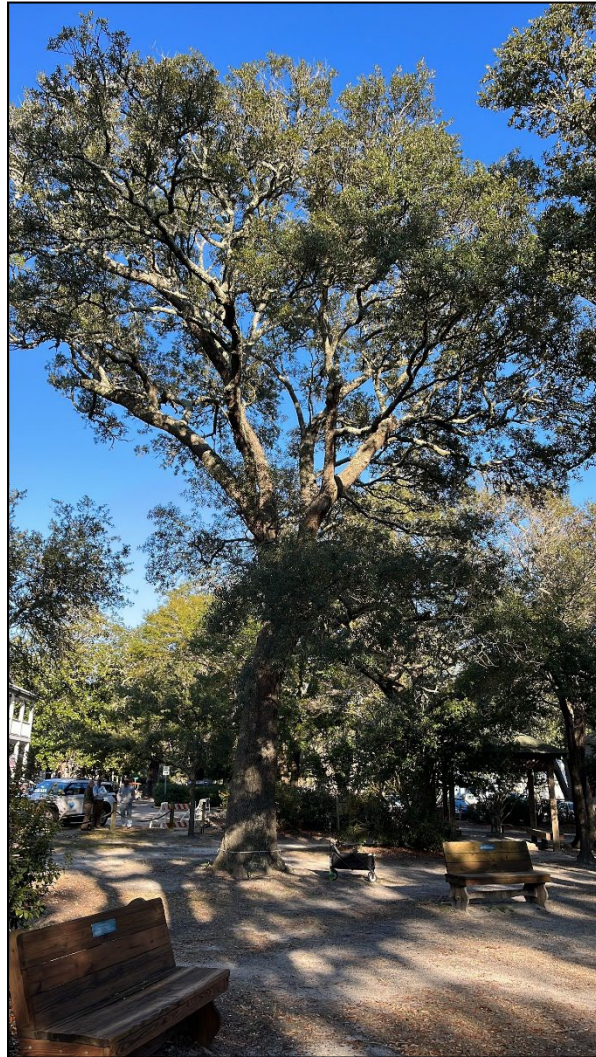
Photo 6: Looking north at live oak #14 showing the co-dominant stems.

Live oak #14 was in fair condition with dead branches throughout the crown, co-dominant stems, and shallow cavities in the lower trunk.

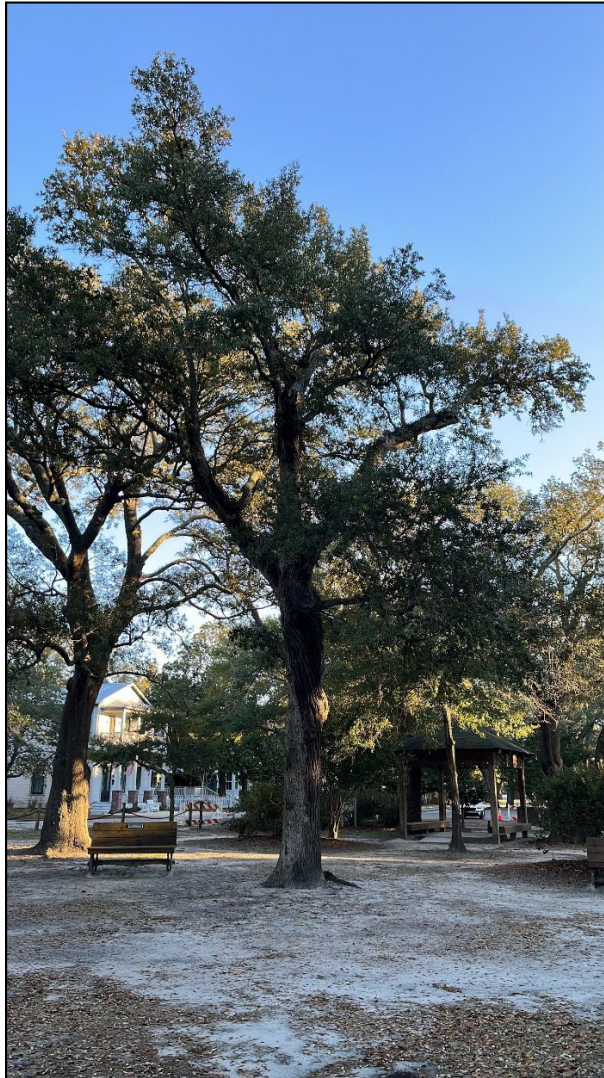
Photo 7: Looking northwest at live oak #15 showing the co-dominant stems.

Live oak #15 was in fair condition with dead branches throughout the crown, co-dominant stems, a cavity in the trunk, and a girdling root.

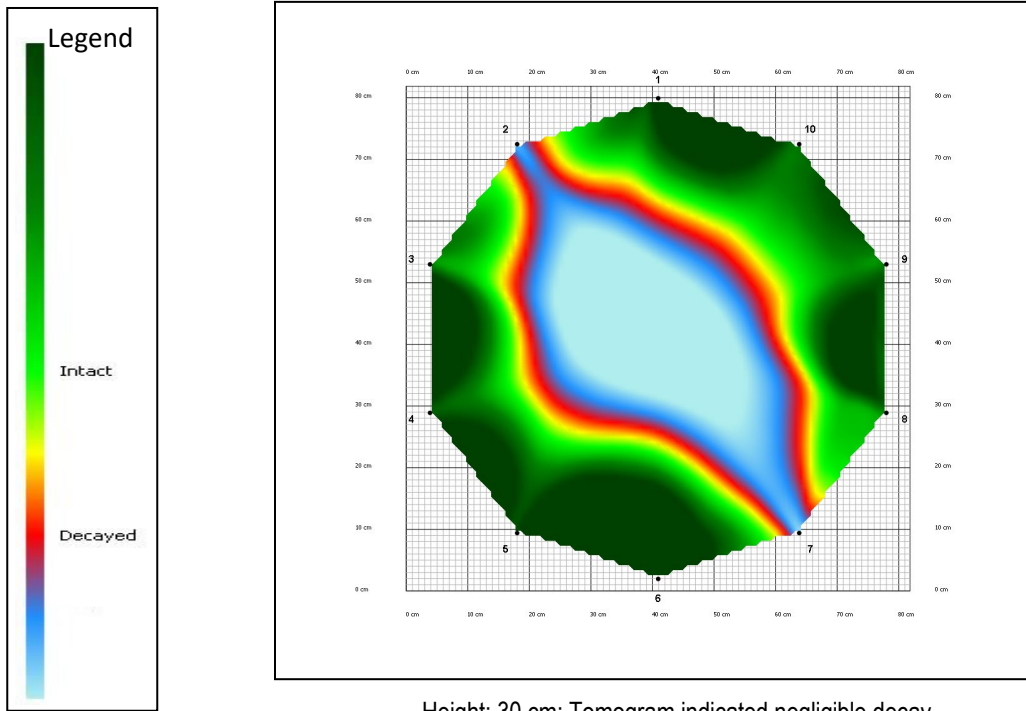
ArborSonic 3D™ Tomogram Live Oak #15- 30 cm

Height: 30 cm; Tomogram indicated negligible decay.

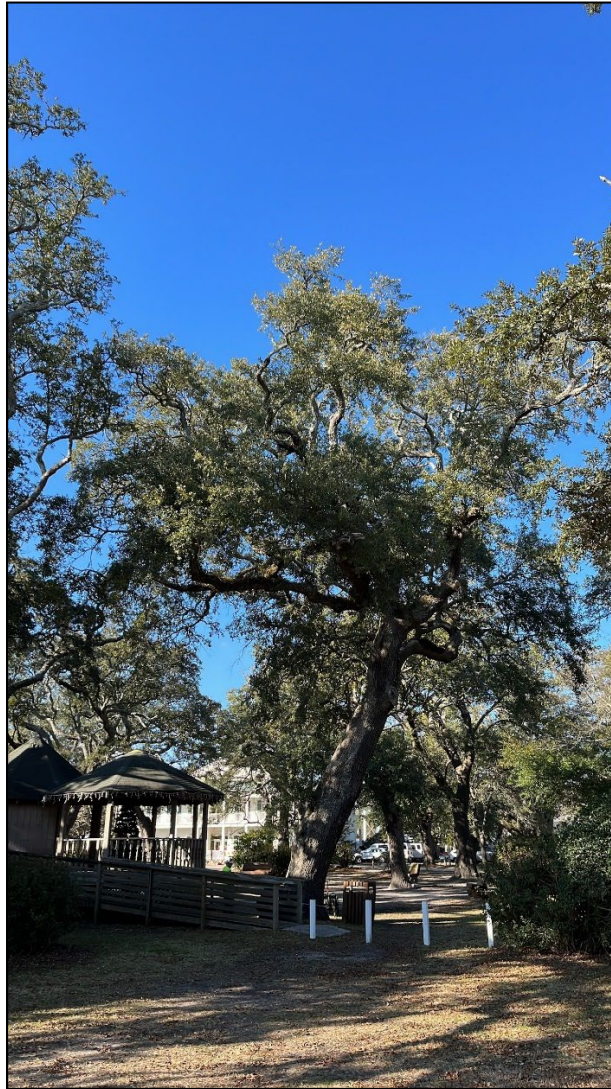
Photo 8: Looking west at live oak #16 showing the leaning trunk and proximity to the stage.

Live oak #16 was in fair condition with dead branches throughout the crown, an uneven crown, co-dominant stems, a trunk lean, a cavity in the trunk, and decay in the lower stem.

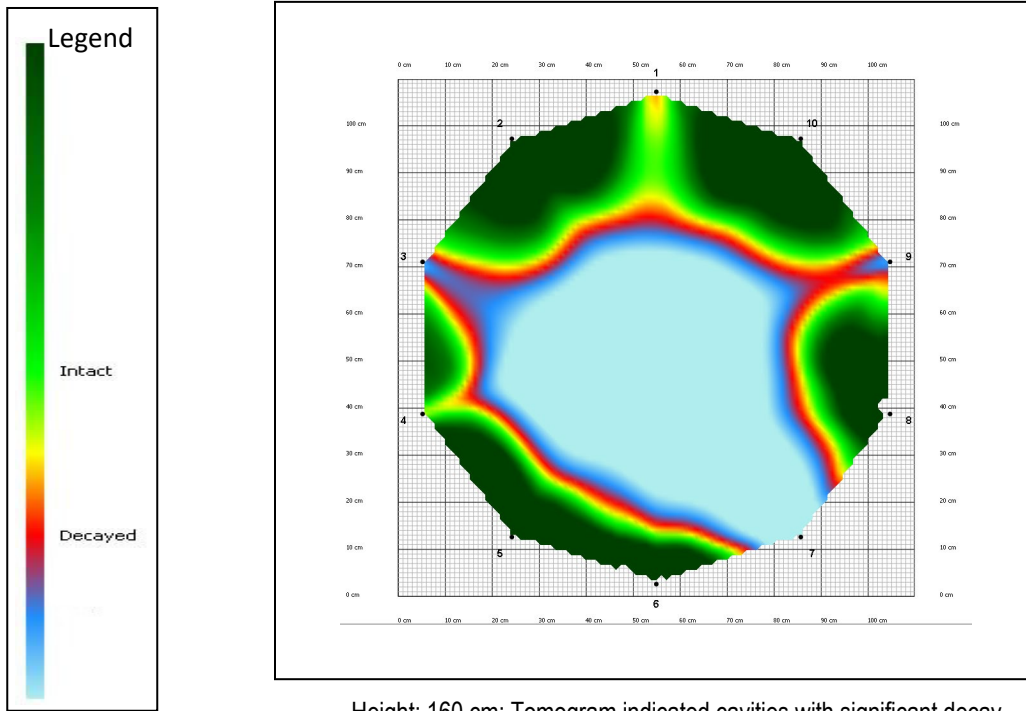
ArborSonic 3D™ Tomogram Live Oak #16- 160 cm

Height: 160 cm; Tomogram indicated cavities with significant decay.

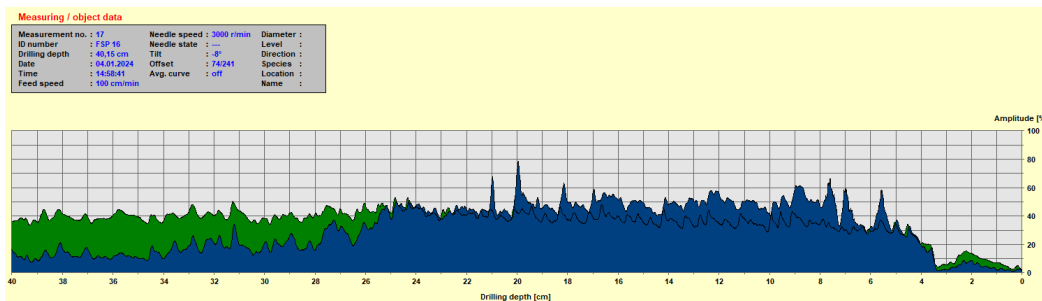
IML Resi-PD 400 Resistance Drill Readings: Live Oak #16- 160cm

Drilling at 160 cm above grade, the sensor #3 position indicated 25 cm (9.8 inches) of sound wood.

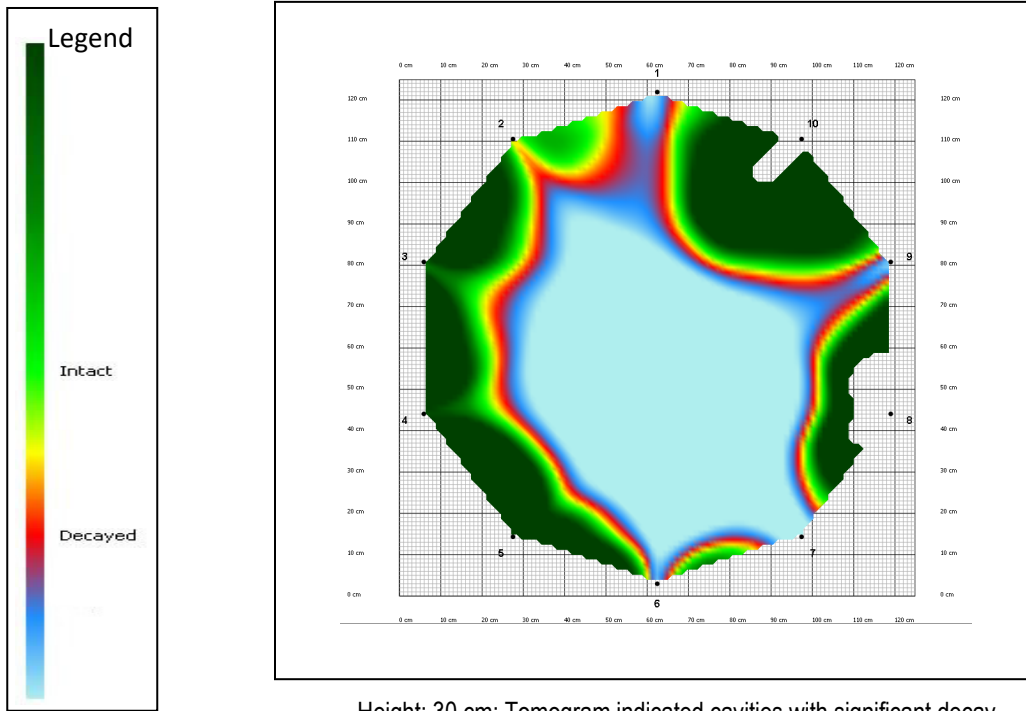
ArborSonic 3D™ Tomogram Live Oak #16- 30 cm

Height: 30 cm; Tomogram indicated cavities with significant decay.

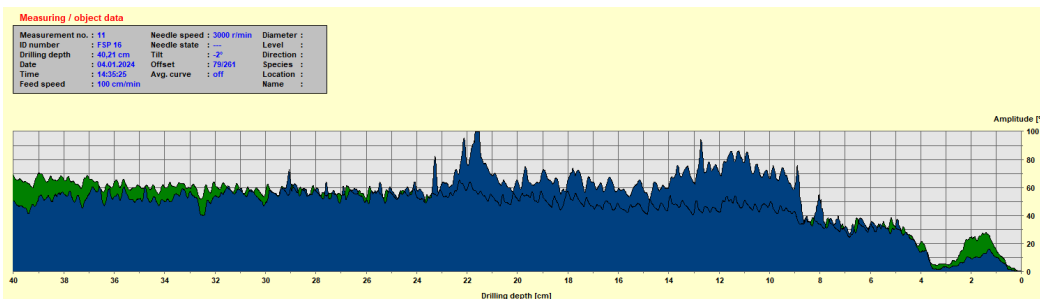
IML Resi-PD 400 Resistance Drill Readings: Live Oak #16- 30cm

Drilling at 30 cm above grade, the sensor #1 position indicated 31 cm (12.2 inches) of sound wood.

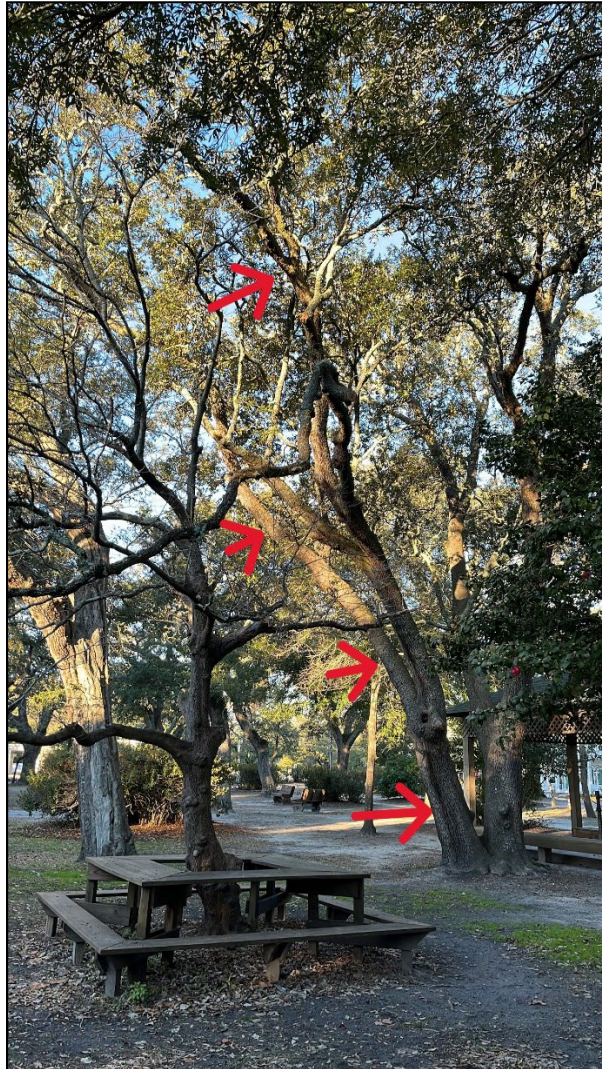
Photo 9: Looking west at live oak #18 showing the uneven crown.

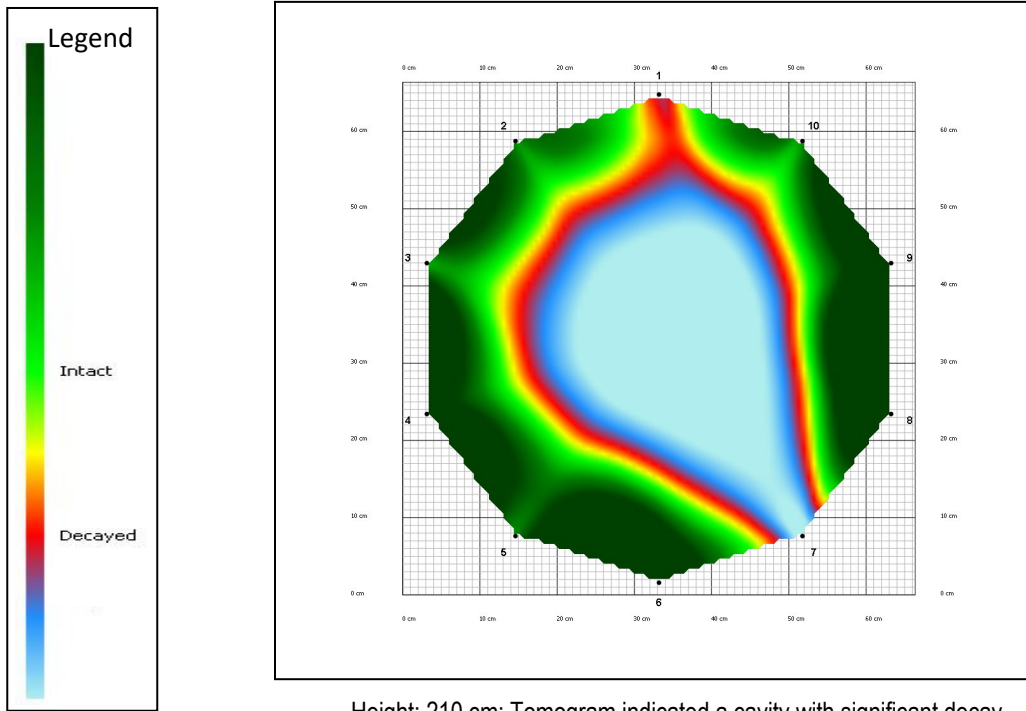
ArborSonic 3D™ Tomogram Live Oak #18- 210 cm

Height: 210 cm; Tomogram indicated a cavity with significant decay.

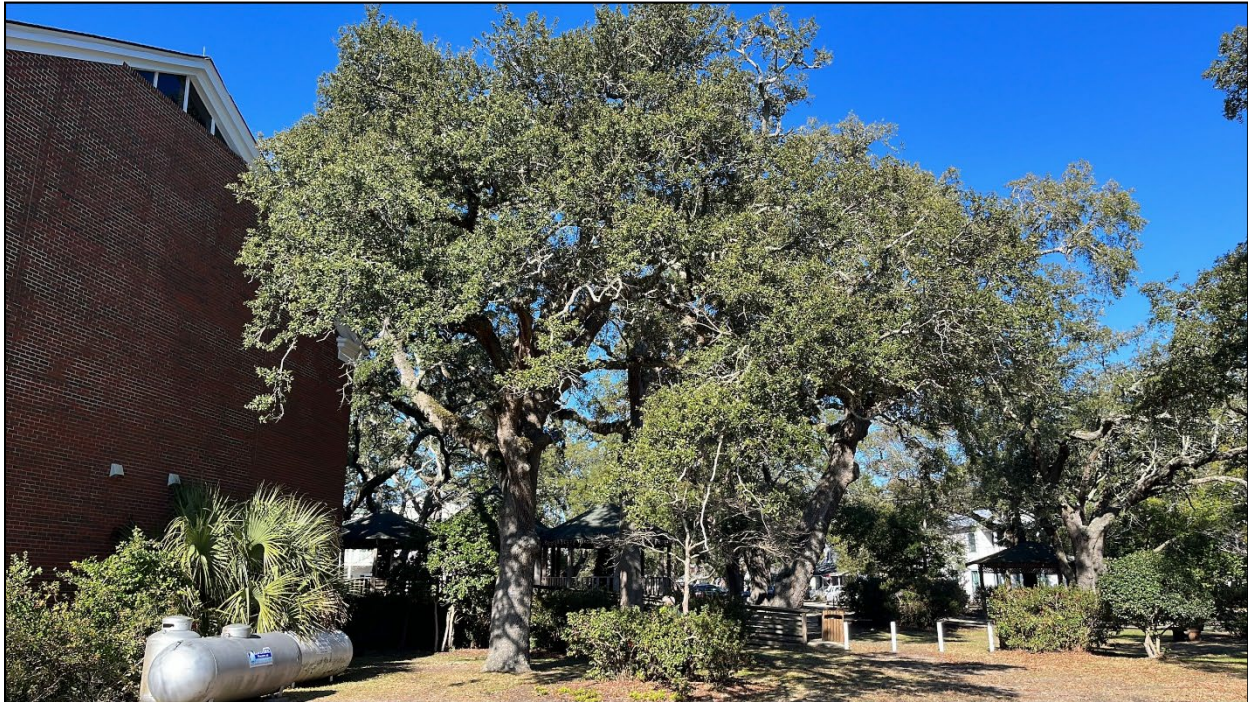
Photo 10: Looking north at live oak #22 showing the uneven crown and proximity to the building.

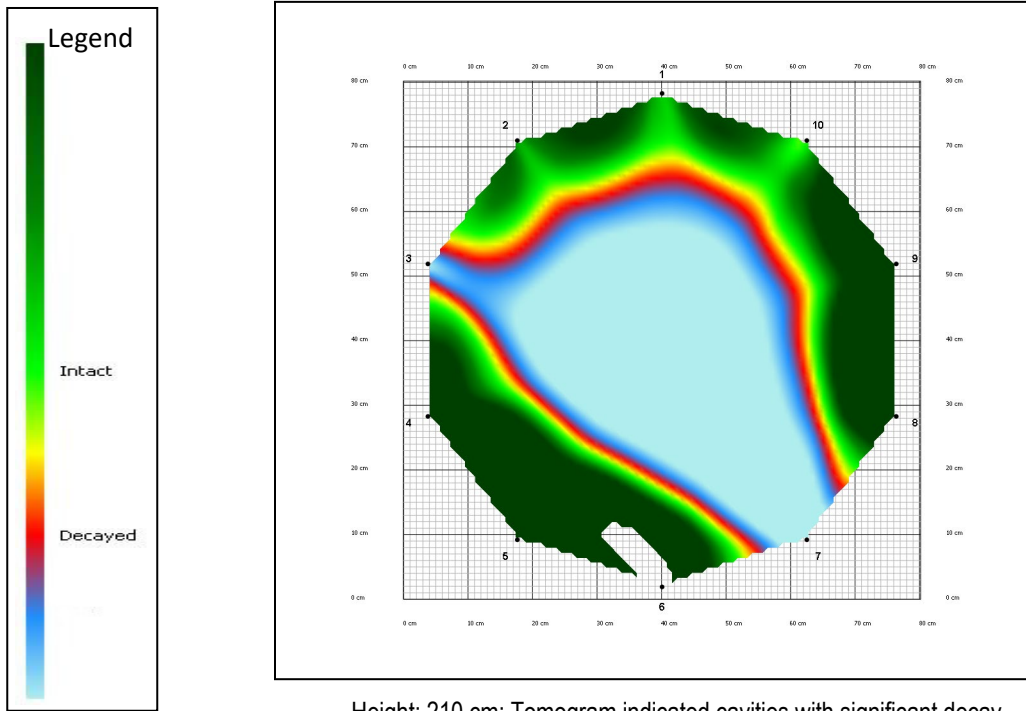
ArborSonic 3D™ Tomogram Live Oak #22 - 210 cm

Height: 210 cm; Tomogram indicated cavities with significant decay.

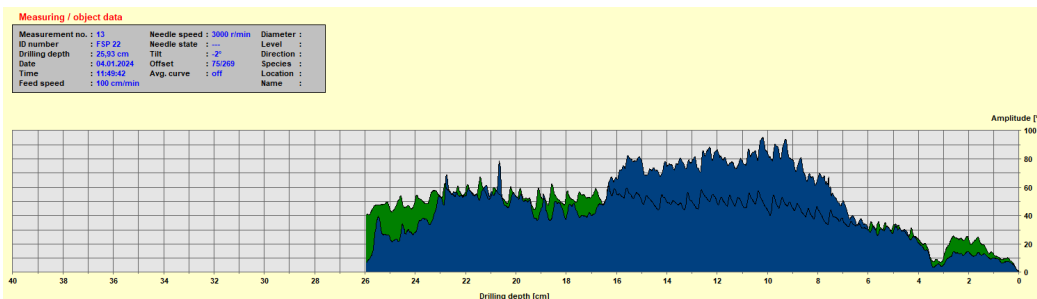
IML Resi-PD 400 Resistance Drill Readings: Live Oak #22 – 210 cm

Drilling at 210 cm above grade, the sensor #3 position indicated 20 cm (7.9 inches) of sound wood.

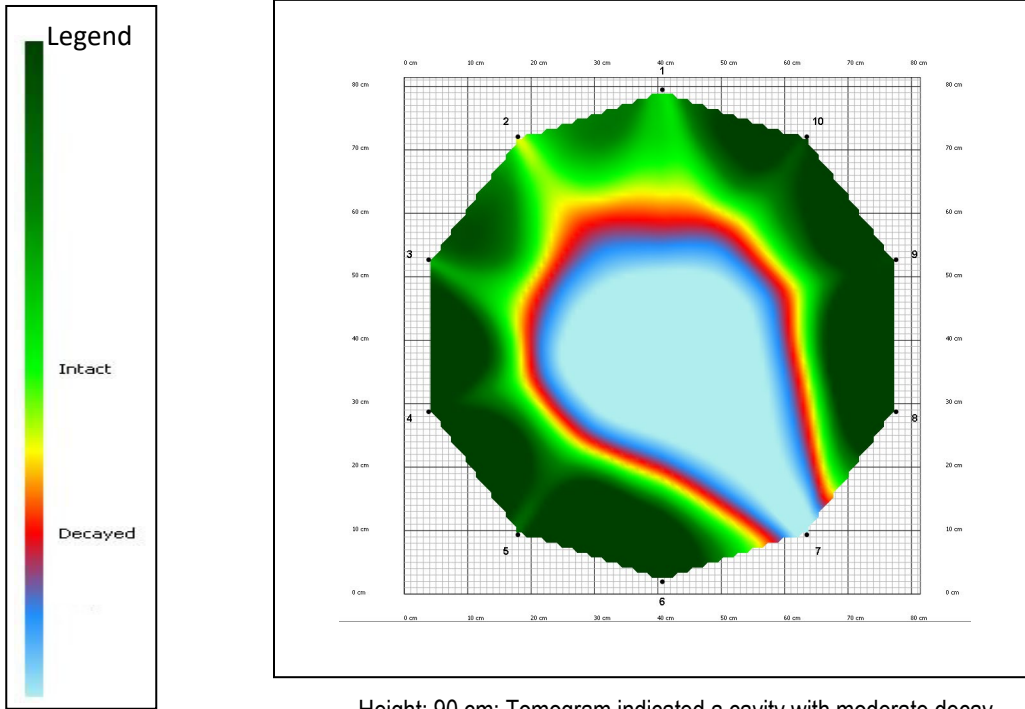
ArborSonic 3D™ Tomogram Live Oak #22 - 90 cm

Height: 90 cm; Tomogram indicated a cavity with moderate decay.

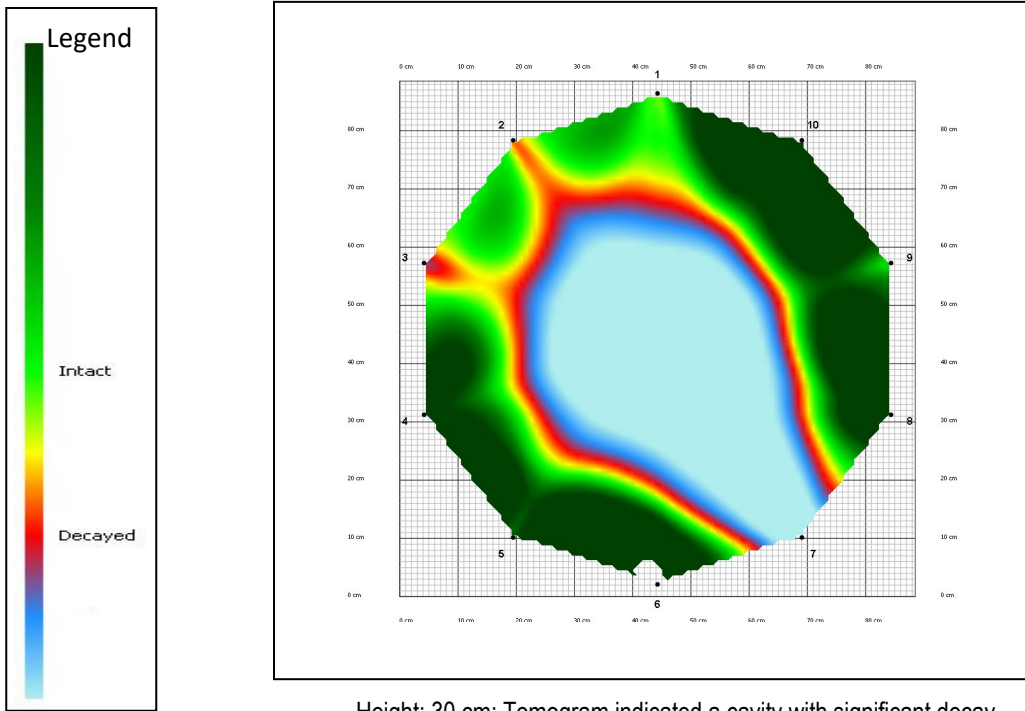
ArborSonic 3D™ Tomogram Live Oak #22 - 30 cm

Height: 30 cm; Tomogram indicated a cavity with significant decay.

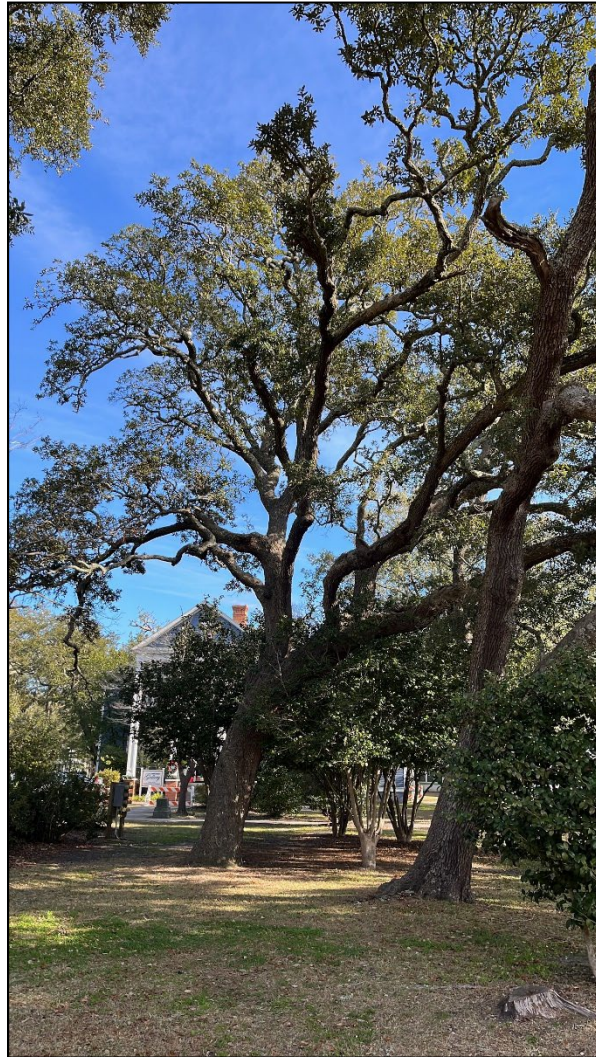
Photo 11: Looking north at live oak #24 showing the uneven crown.

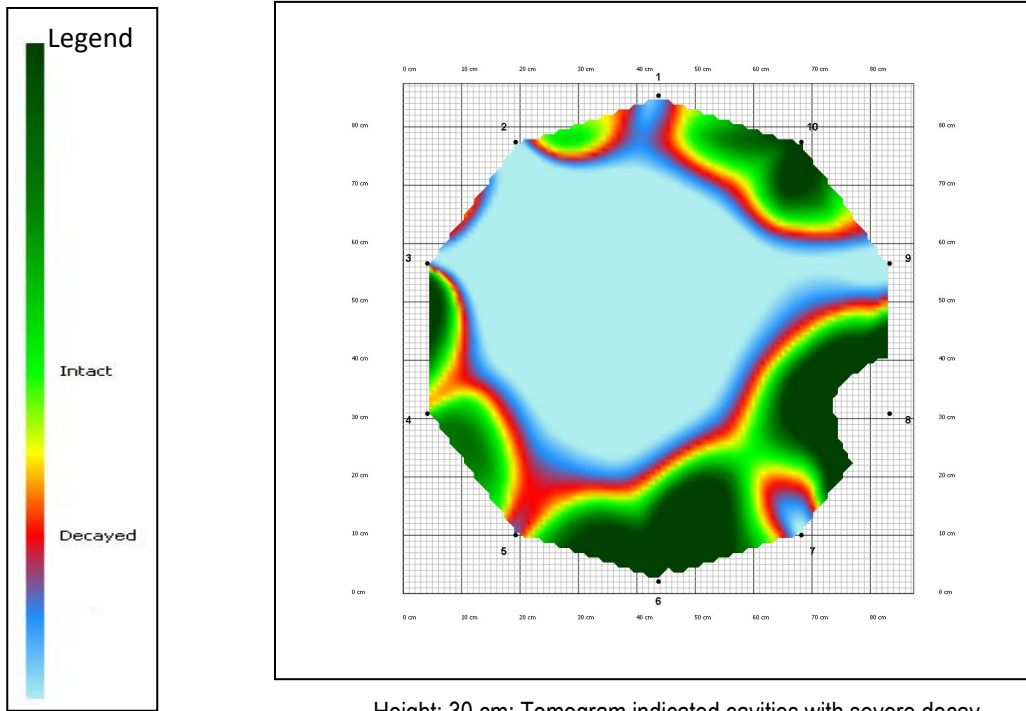
ArborSonic 3D™ Tomogram Live Oak #24 - 280 cm

Height: 30 cm; Tomogram indicated cavities with severe decay.

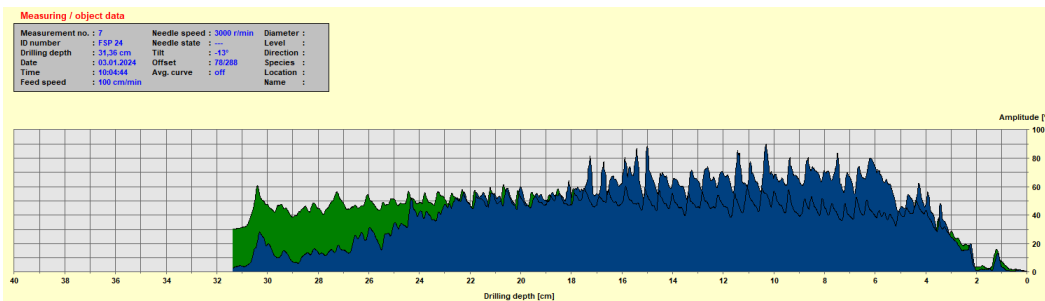
IML Resi-PD 400 Resistance Drill Readings: Live Oak #24 - 280cm

Drilling at 280 cm above grade, the sensor #2 position indicated 24 cm (9.4 inches) of sound wood.

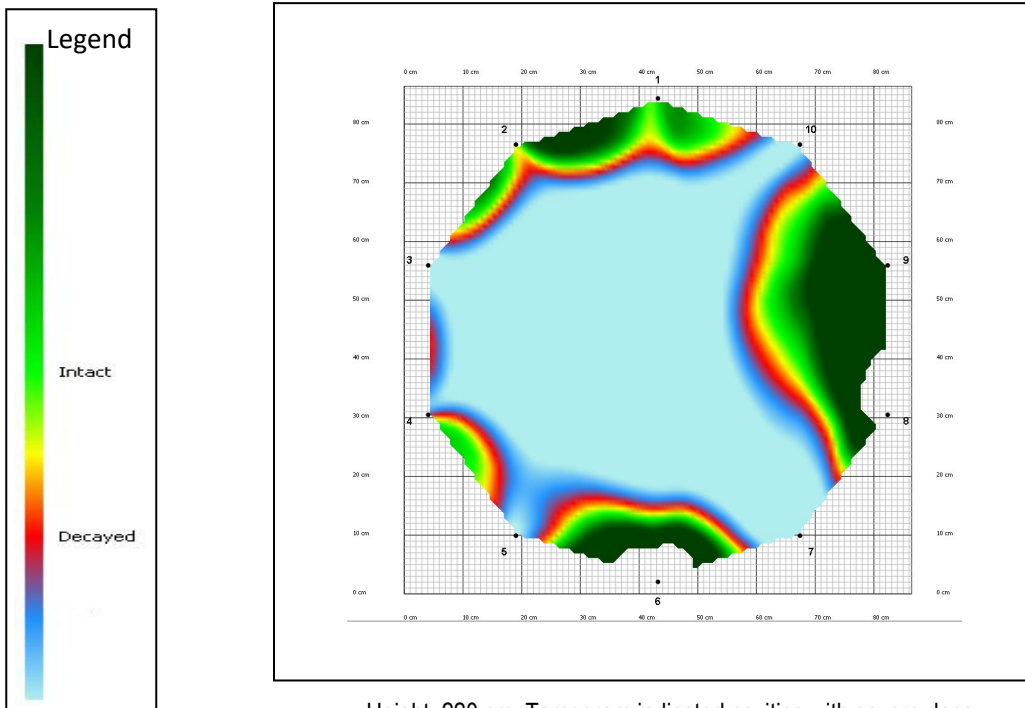
ArborSonic 3D™ Tomogram Live Oak #24 - 220 cm

Height: 220 cm; Tomogram indicated cavities with severe decay.

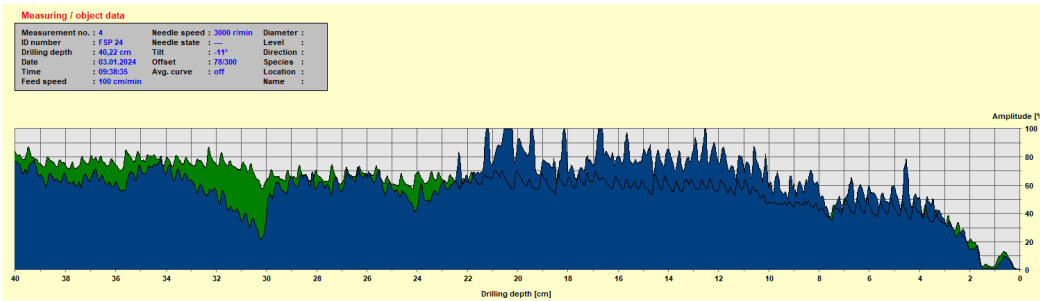
IML Resi-PD 400 Resistance Drill Readings: Live Oak #24 - 220cm

Drilling at 220 cm above grade, the sensor #2 position indicated 30 cm (11.8 inches) of sound wood.
