Franklin Square Park

Level 3 Advanced Assessments Report

Tree Risk Assessment Report

Franklin Square Park
130 E West Street
Southport, NC 28461
February 2, 2024

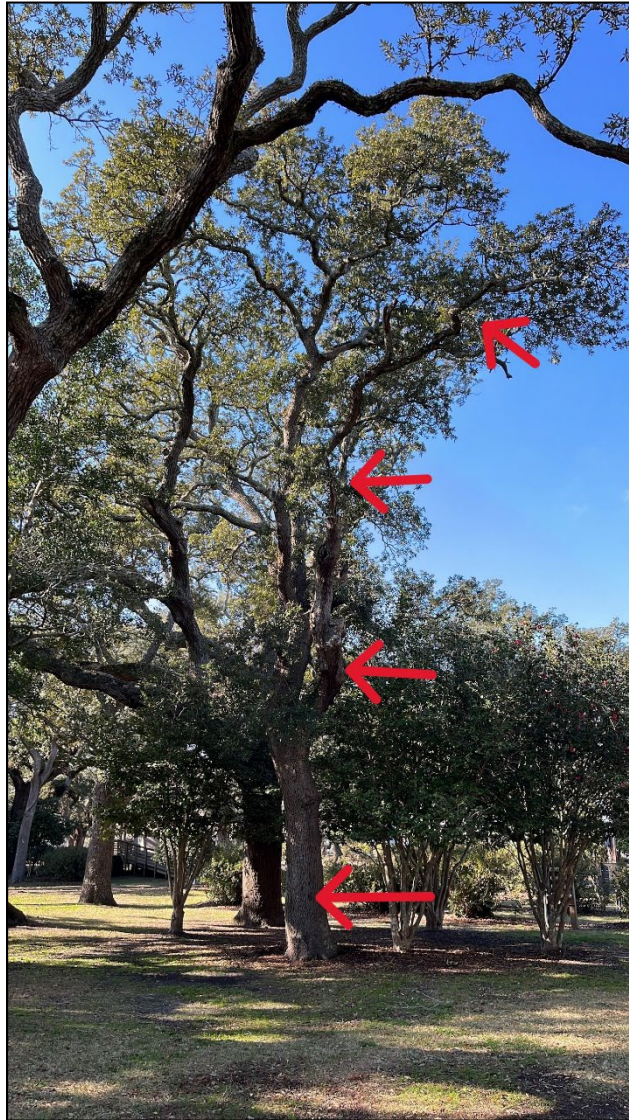
Photo 12: Looking west at live oak #25 showing the uneven crown.

I recommend removing live oaks #3, #24, and #25 entirely to remove the risk of root, root collar, trunk, crown, and branch failure. Grind the resulting stumps and back fill the holes. There will be no residual risk for these four trunks, crowns, or branches, but there may be a tripping hazard with the remaining roots, stump, or grindings that you will need to address for all four trees.

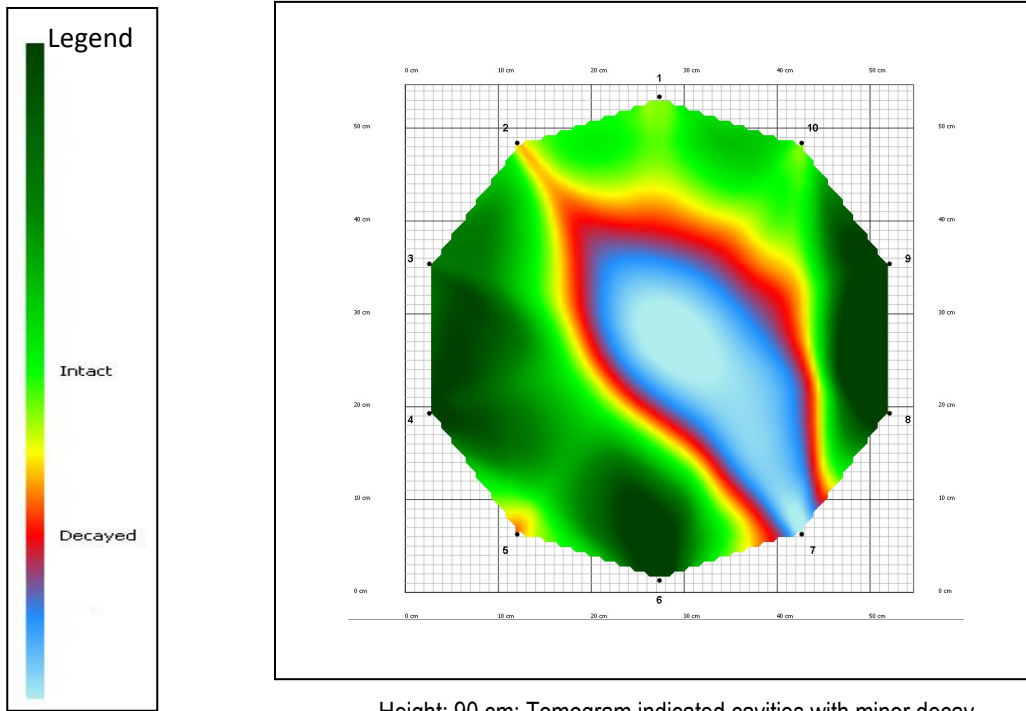
ArborSonic 3D™ Tomogram Live Oak #25 - 90 cm

Height: 90 cm; Tomogram indicated cavities with minor decay.

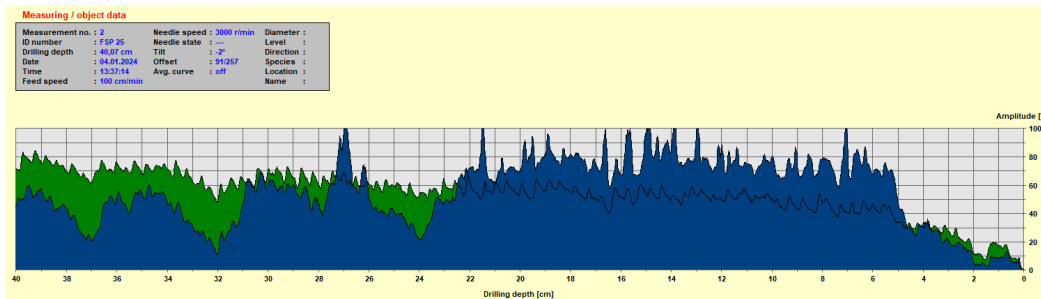
IML Resi-PD 400 Resistance Drill Readings: Live Oak #25 - 90cm

Drilling at 90 cm above grade, the sensor #7 position indicated 24 cm (9.4 inches) of sound wood.

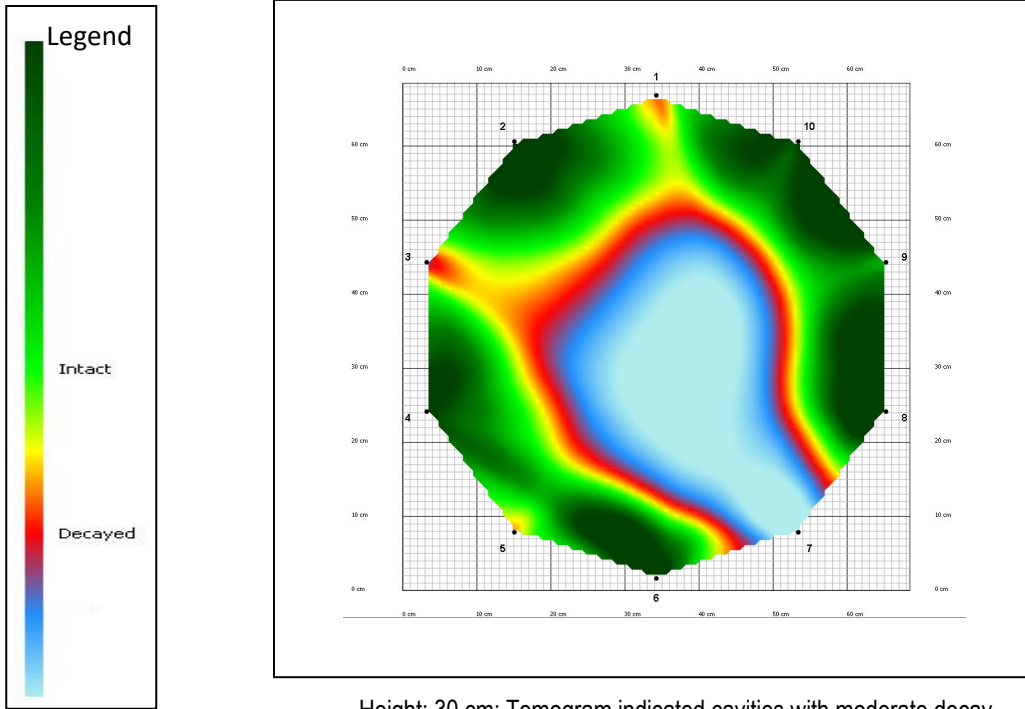
ArborSonic 3D™ Tomogram Live Oak #25 - 30 cm

Height: 30 cm; Tomogram indicated cavities with moderate decay.

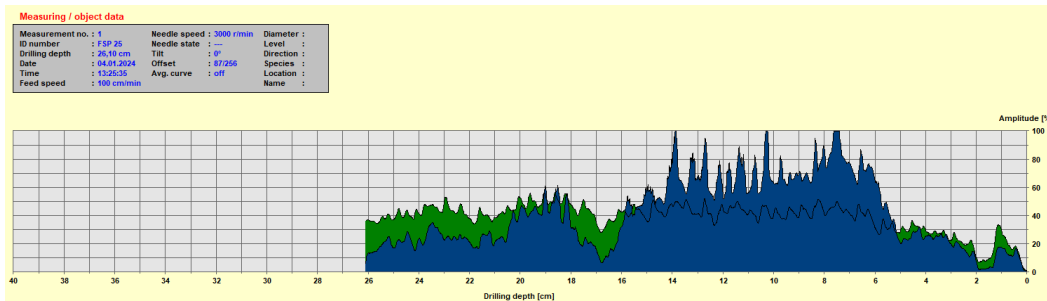
IML Resi-PD 400 Resistance Drill Readings: Live Oak #25 - 30cm

Drilling at 30 cm above grade, the sensor #7 position indicated 18 cm (7.1 inches) of sound wood.

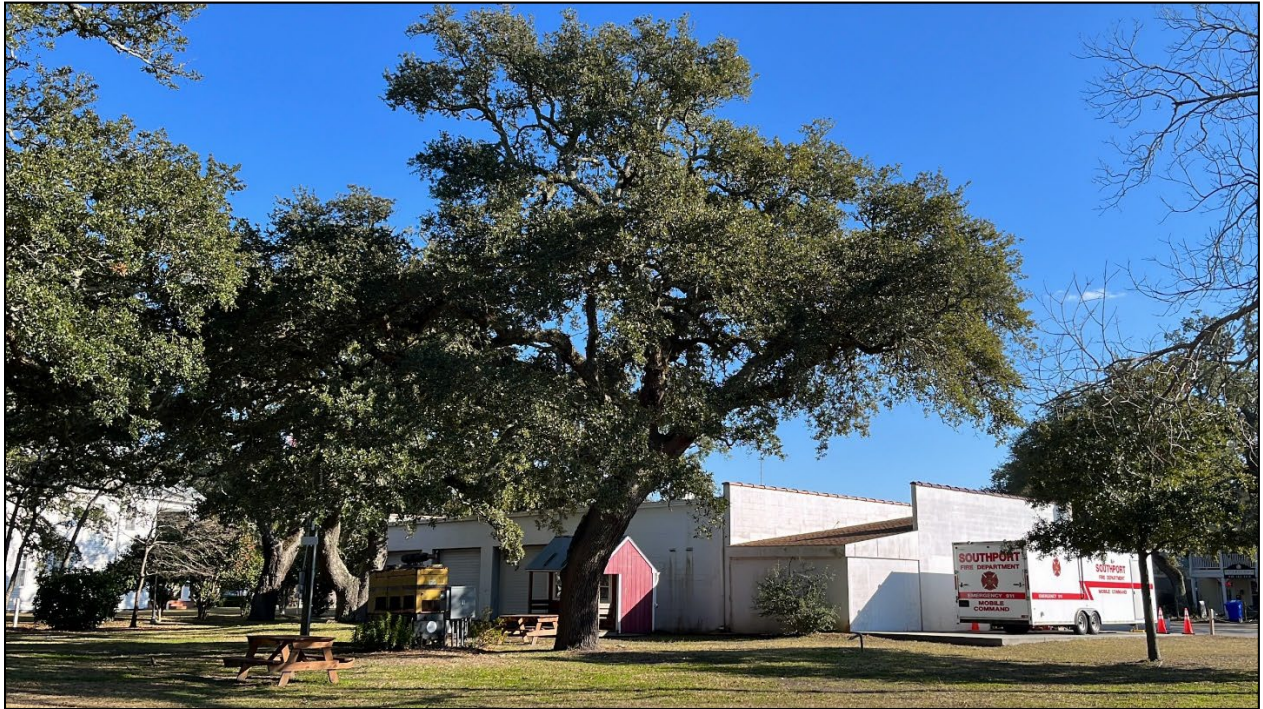
Photo 13: Looking west at live oak #29 showing the uneven crown.

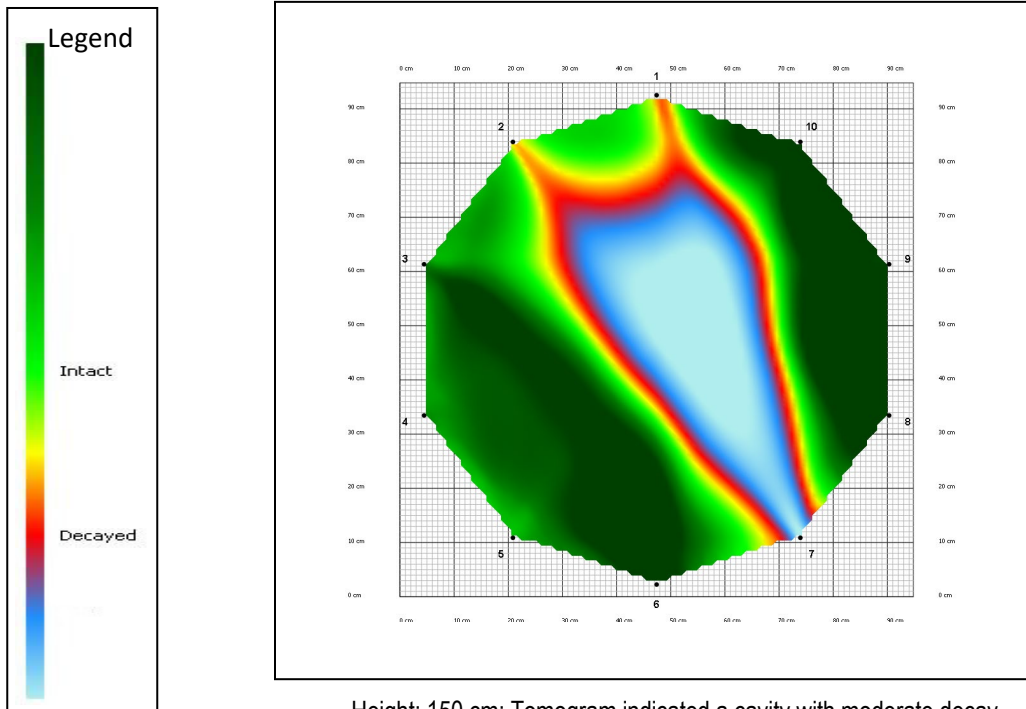
ArborSonic 3D™ Tomogram Live Oak #29 - 150 cm

Height: 150 cm; Tomogram indicated a cavity with moderate decay.

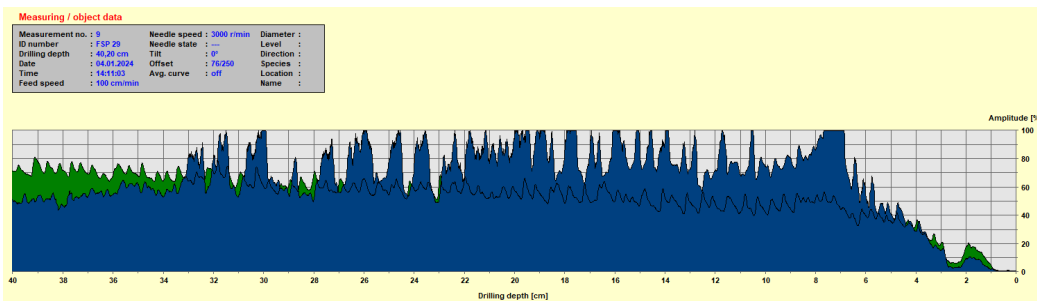
IML Resi-PD 400 Resistance Drill Readings: Live Oak #29 – 90 cm

Drilling at 150 cm above grade, the sensor #2 position indicated 40 cm (15.7 inches) of sound wood.

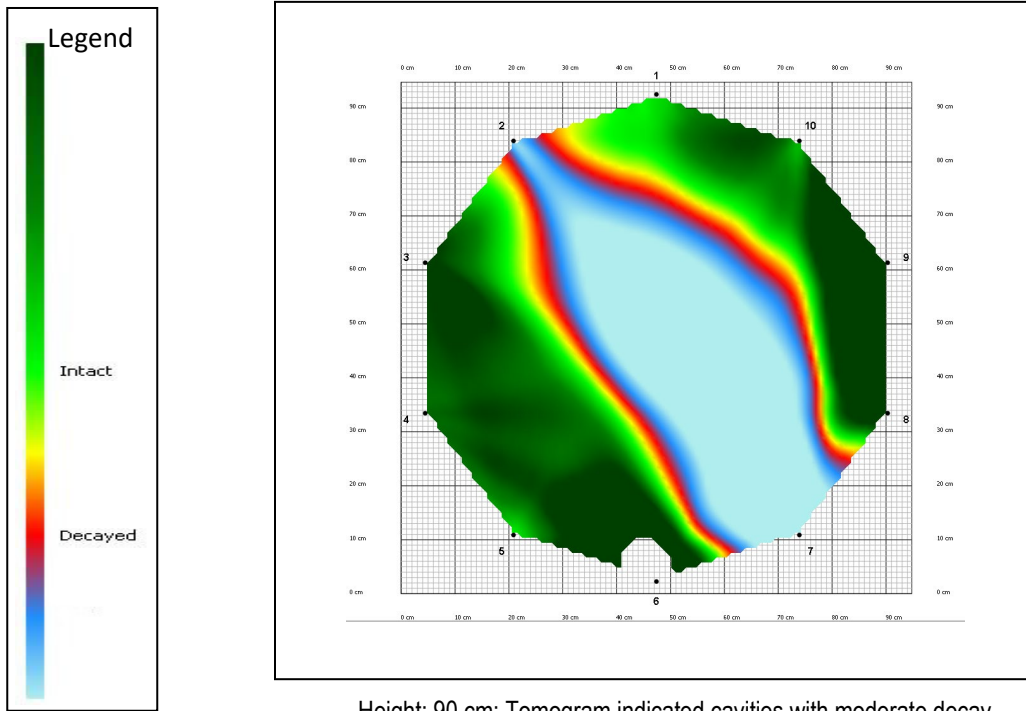
ArborSonic 3D™ Tomogram Live Oak #29 - 90 cm

Height: 90 cm; Tomogram indicated cavities with moderate decay.

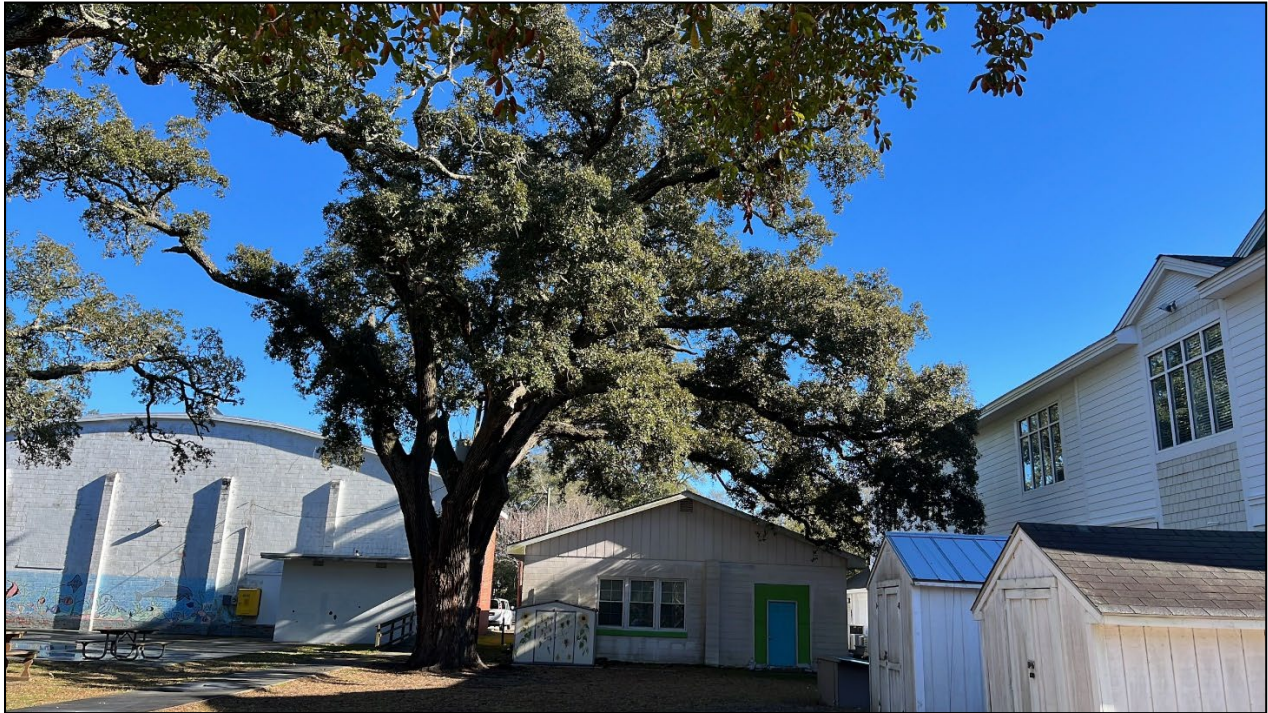
Photo 14: Looking northeast at live oak #35 showing the uneven crown and proximity to the building.

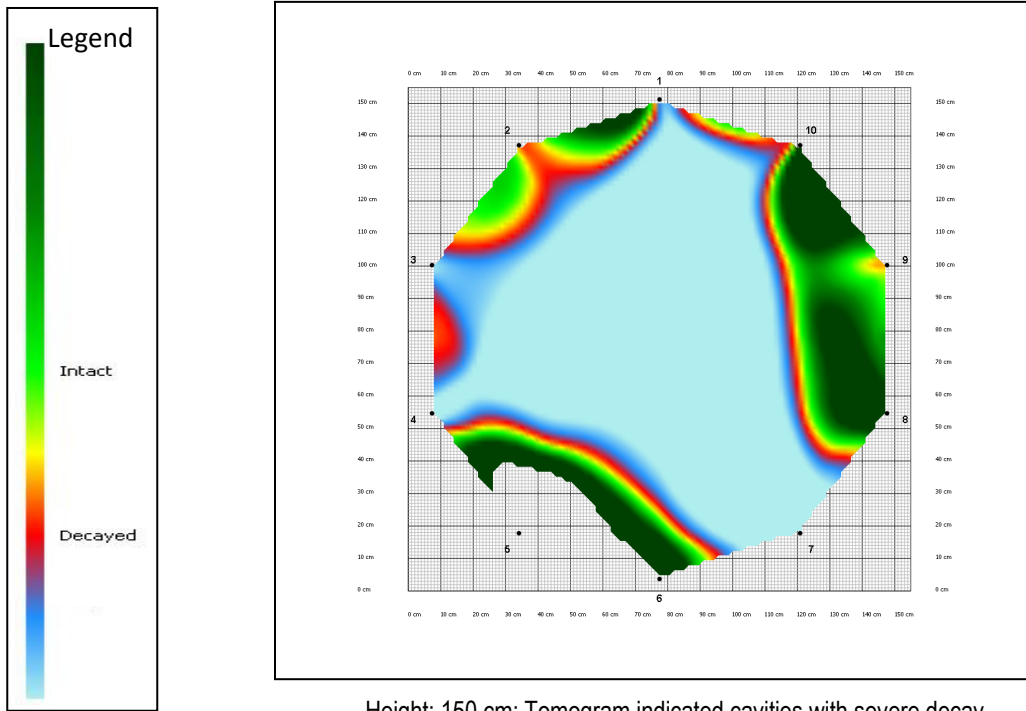
ArborSonic 3D™ Tomogram Live Oak #35 - 150 cm

Height: 150 cm; Tomogram indicated cavities with severe decay.

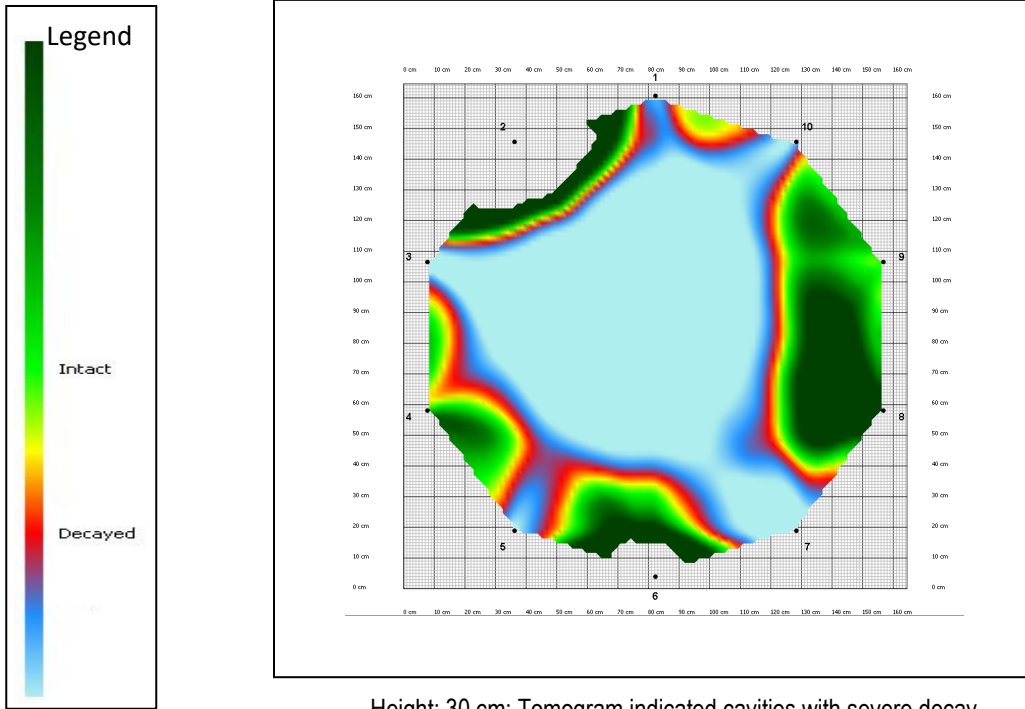
ArborSonic 3D™ Tomogram Live Oak #35 - 30 cm

Height: 30 cm; Tomogram indicated cavities with severe decay.

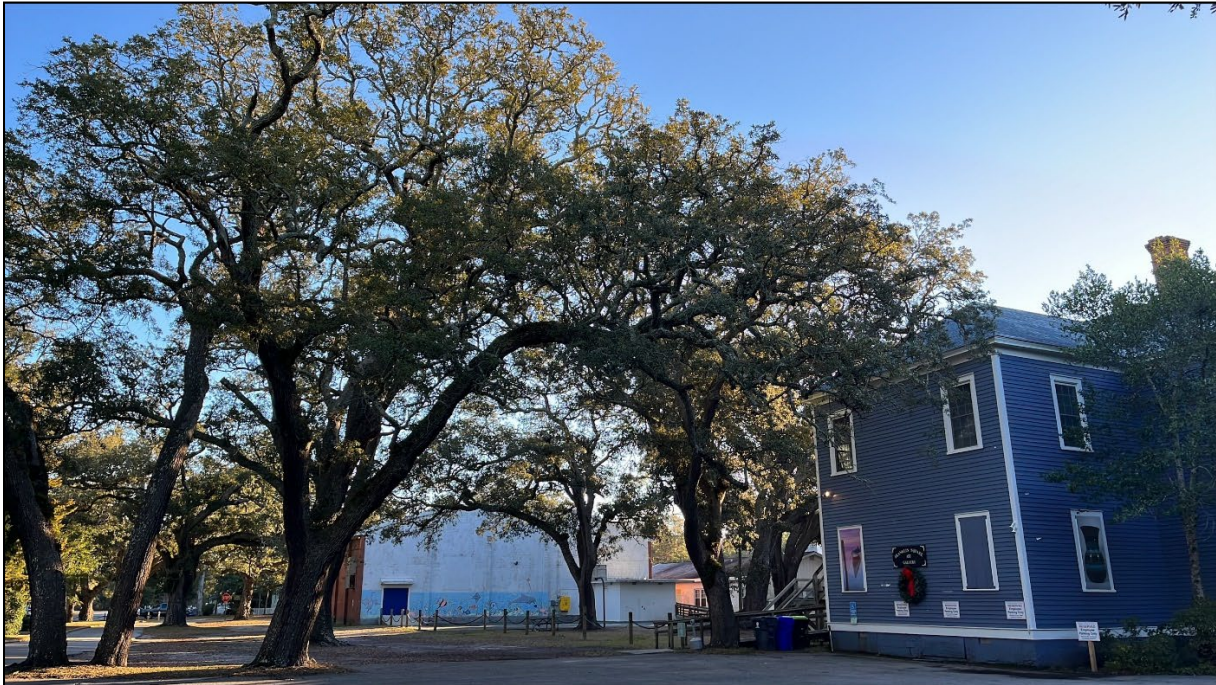
Photo15: Looking north at live oak #39 showing the uneven crown and co-dominant stems.

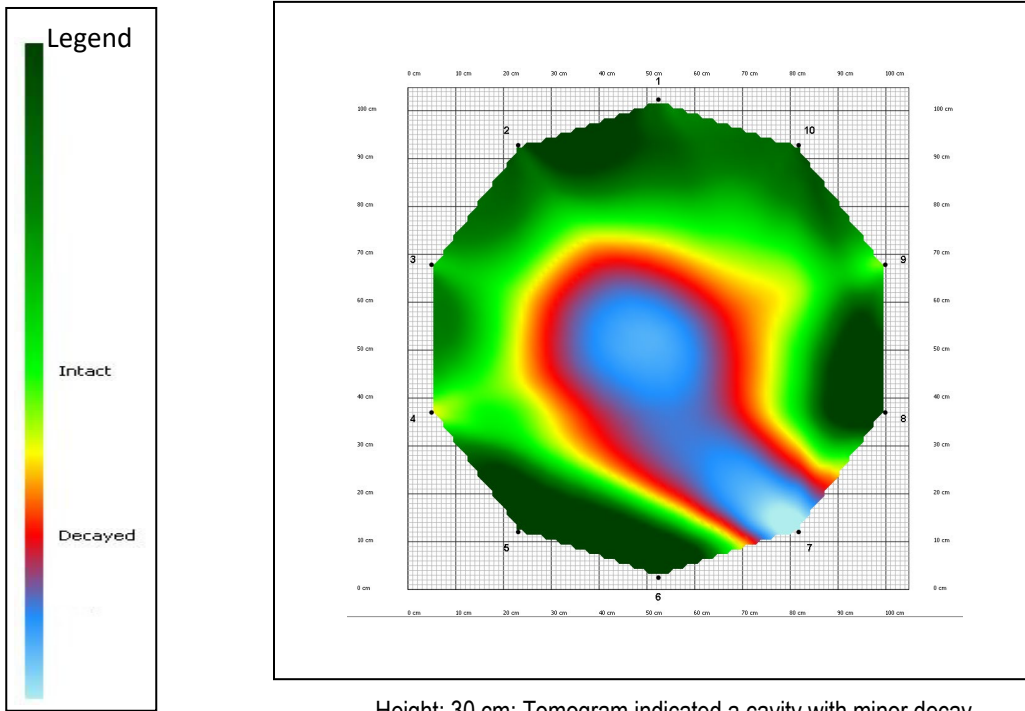
ArborSonic 3D™ Tomogram Live Oak #39 - 210 cm

Height: 30 cm; Tomogram indicated a cavity with minor decay.

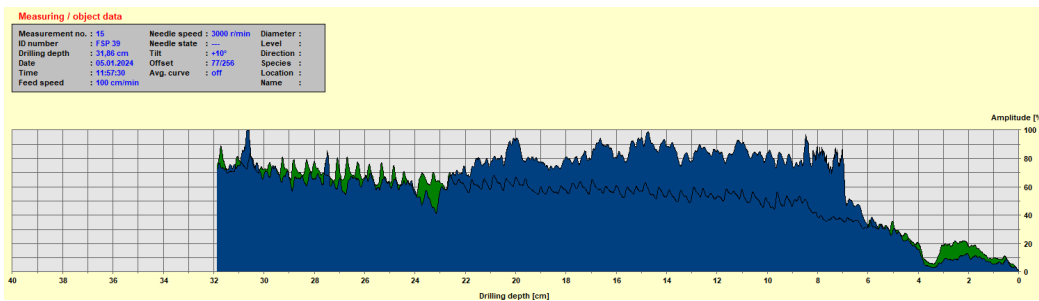
IML Resi-PD 400 Resistance Drill Readings: Live Oak #39 – 210 cm

Drilling at 210 cm above grade, the sensor #7 position indicated 31 cm (12.2 inches) of sound wood.

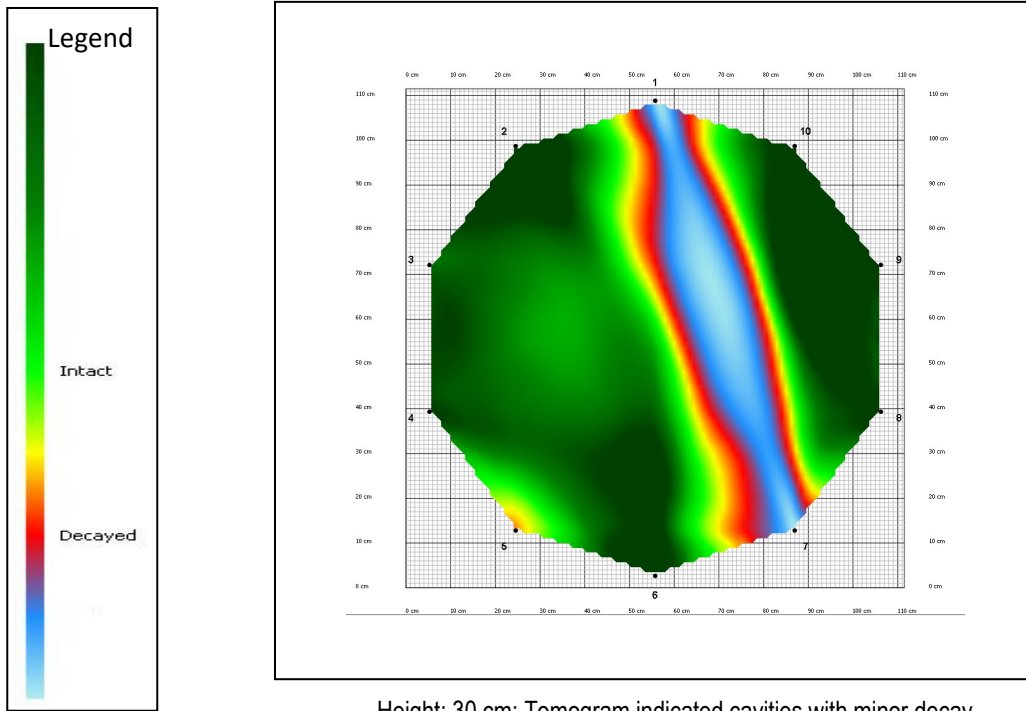
ArborSonic 3D™ Tomogram Live Oak #39 - 30 cm

Height: 30 cm; Tomogram indicated cavities with minor decay.

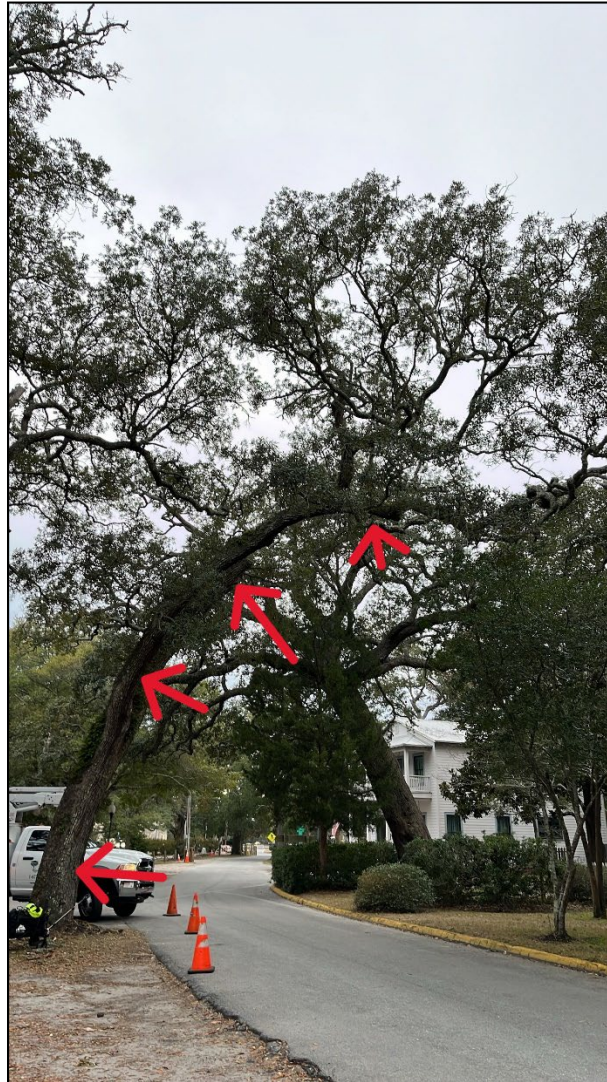
Photo 16: Looking west at live oak #40 showing the uneven crown and pavement restriction to the north.

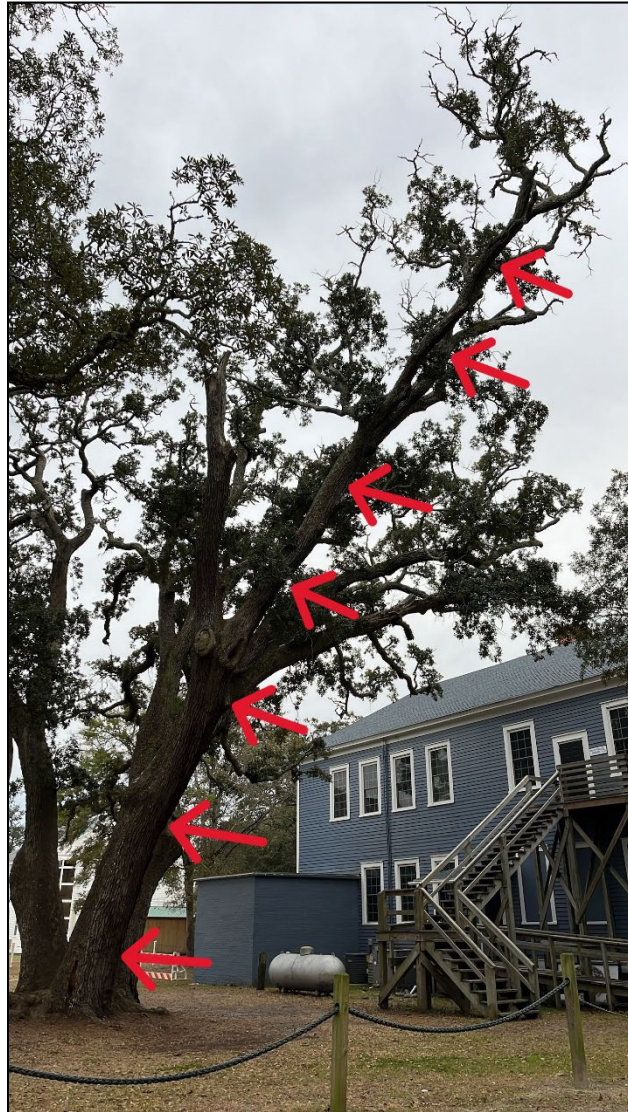
Photo 17: Looking east at live oak #43 showing the uneven crown.

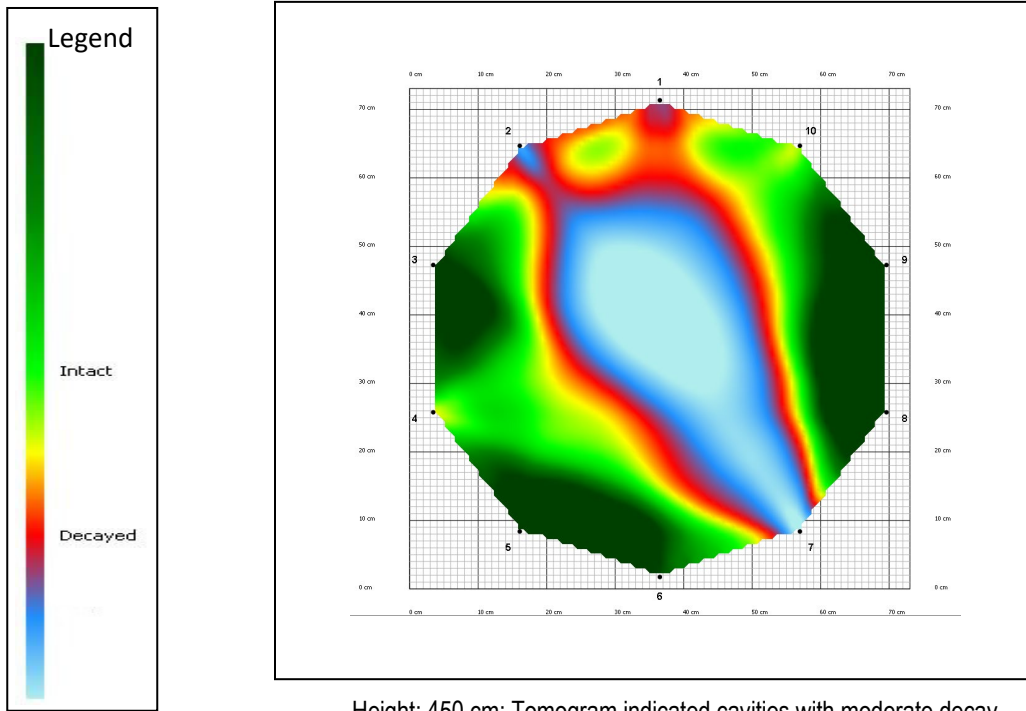
ArborSonic 3D™ Tomogram Live Oak #43 - 450 cm

Height: 450 cm; Tomogram indicated cavities with moderate decay.

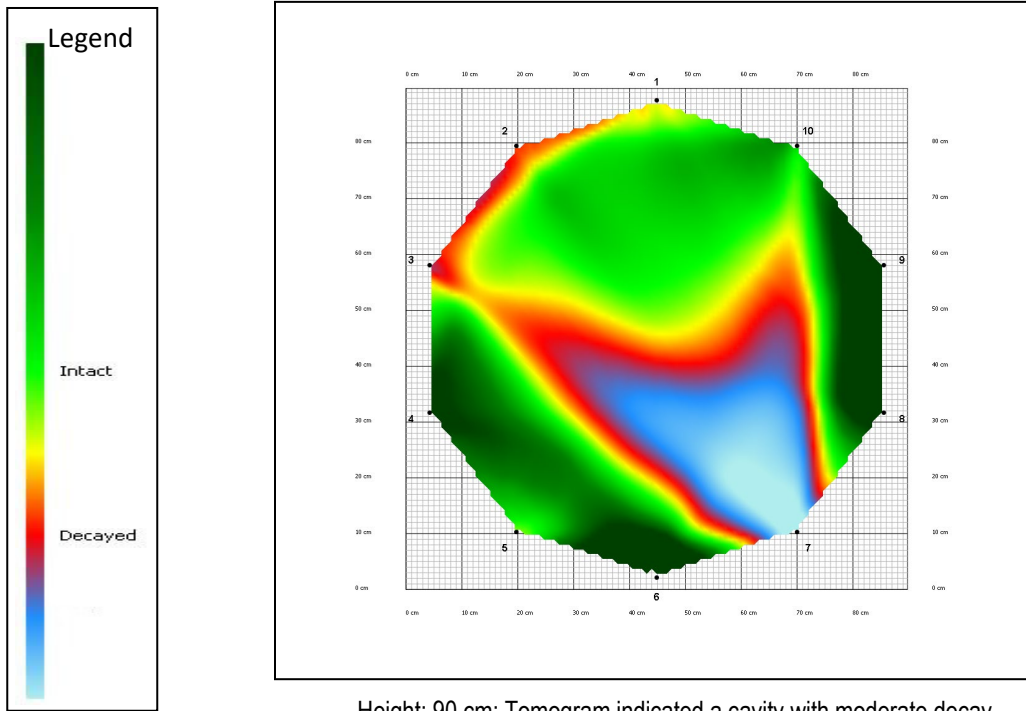
ArborSonic 3D™ Tomogram Live Oak #43 - 90 cm

Height: 90 cm; Tomogram indicated a cavity with moderate decay.

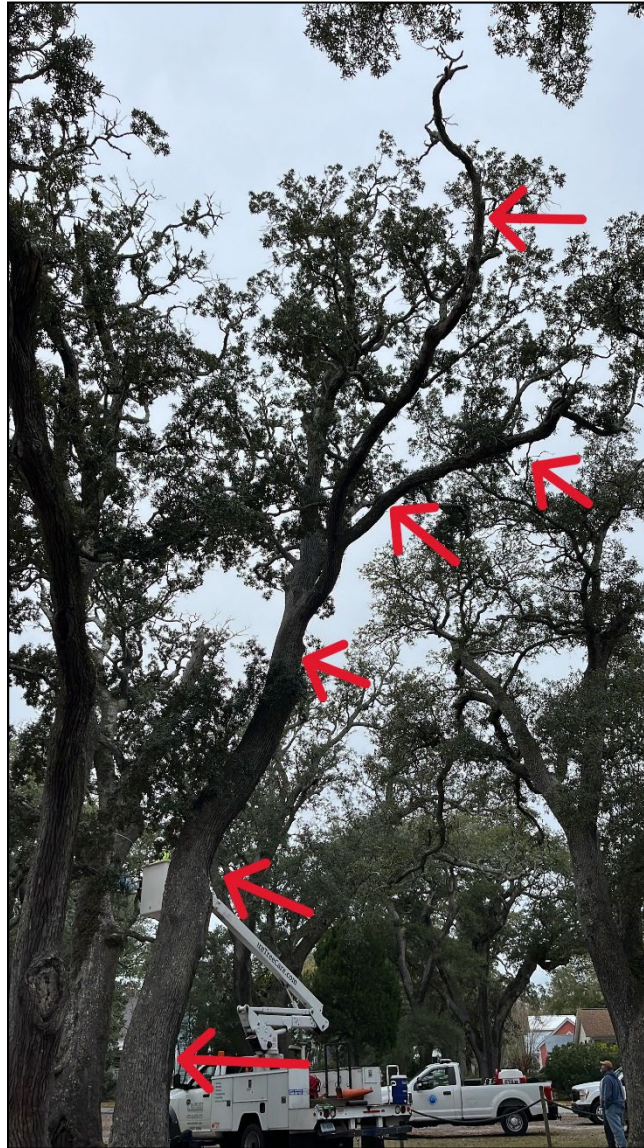
Photo 18: Looking southwest at live oak #44 showing the uneven crown.

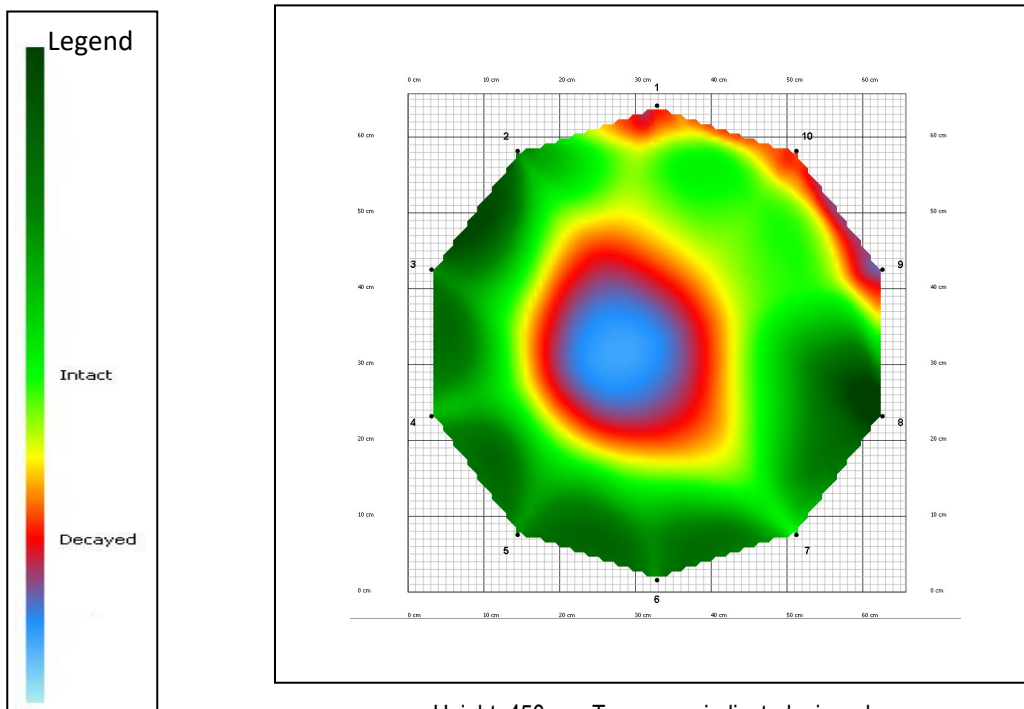
ArborSonic 3D™ Tomogram Live Oak #44 - 450 cm

Height: 450 cm; Tomogram indicated minor decay.

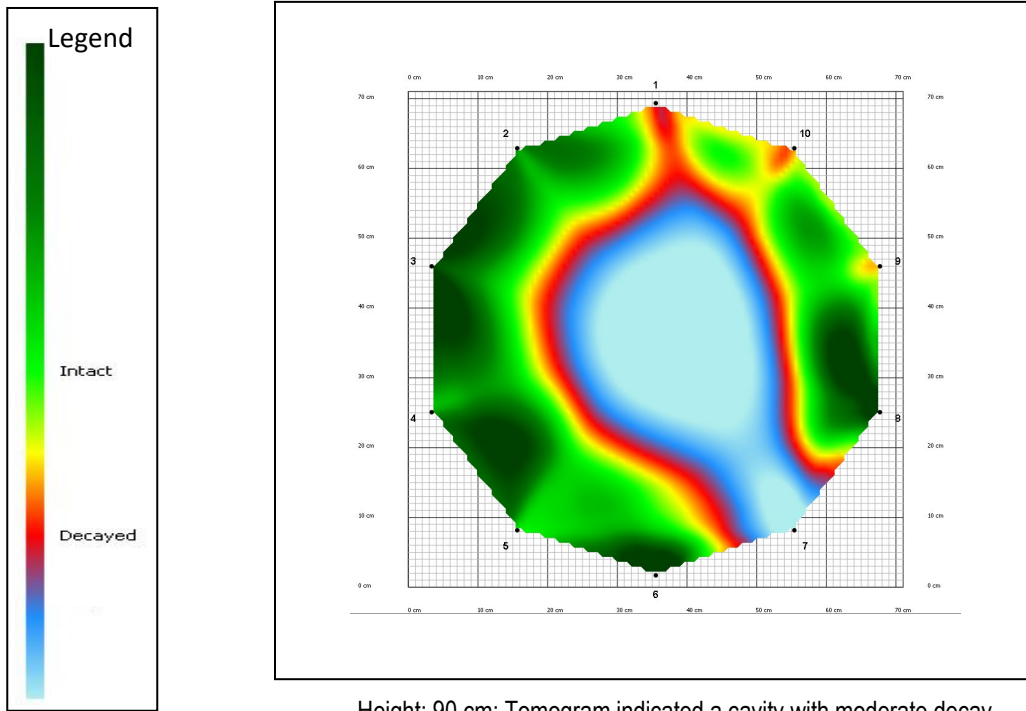
ArborSonic 3D™ Tomogram Live Oak #44 - 300 cm

Height: 90 cm; Tomogram indicated a cavity with moderate decay.

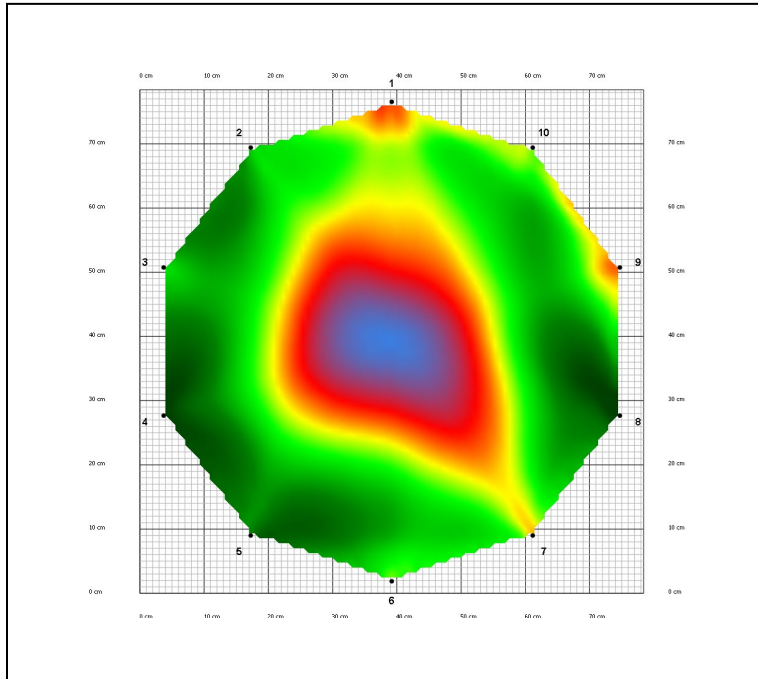
ArborSonic 3D™ Tomogram Live Oak #44 - 90 cm

Height: 90 cm; Tomogram indicated minor decay.

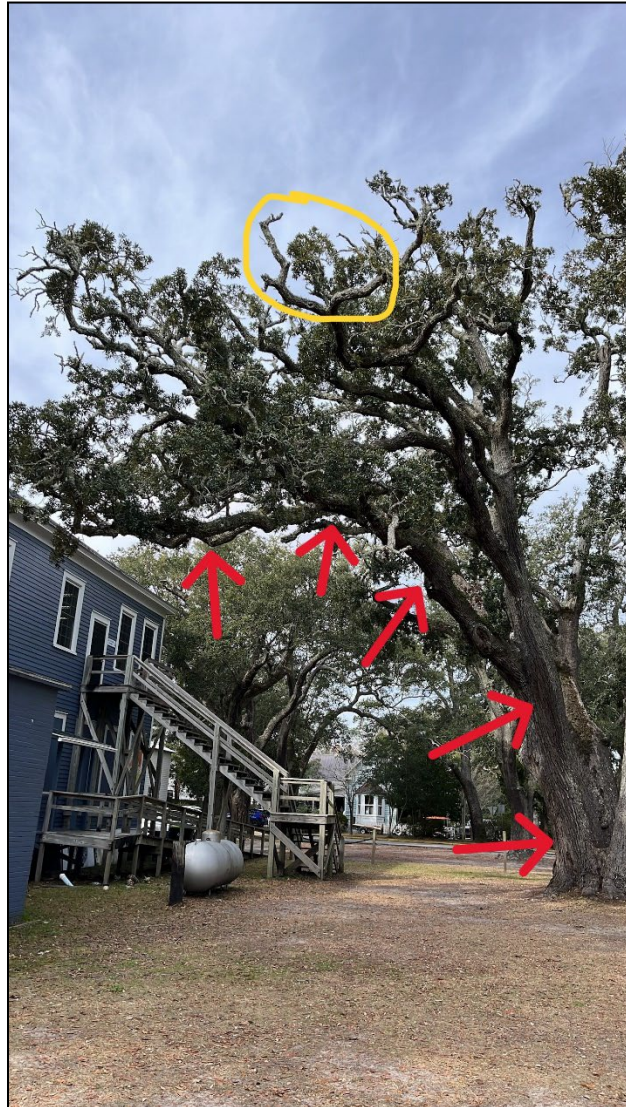
Photo 19: Looking north at live oak #45 showing the uneven crown and crown dieback (yellow circle).

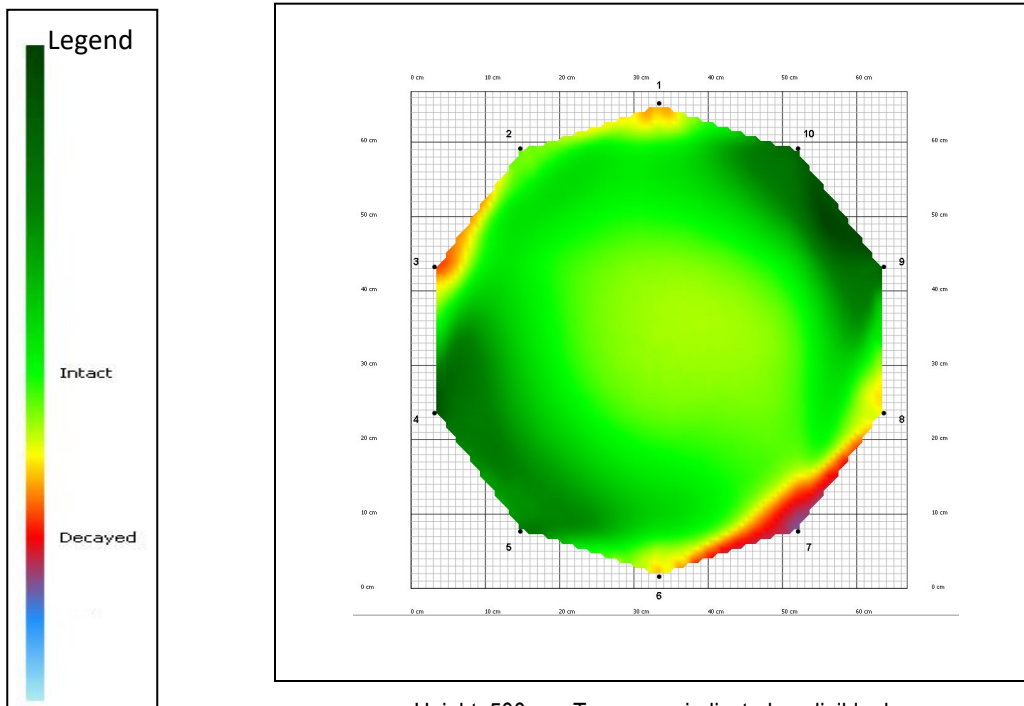
ArborSonic 3D™ Tomogram Live Oak #45 - 500 cm

Height: 500 cm; Tomogram indicated negligible decay.

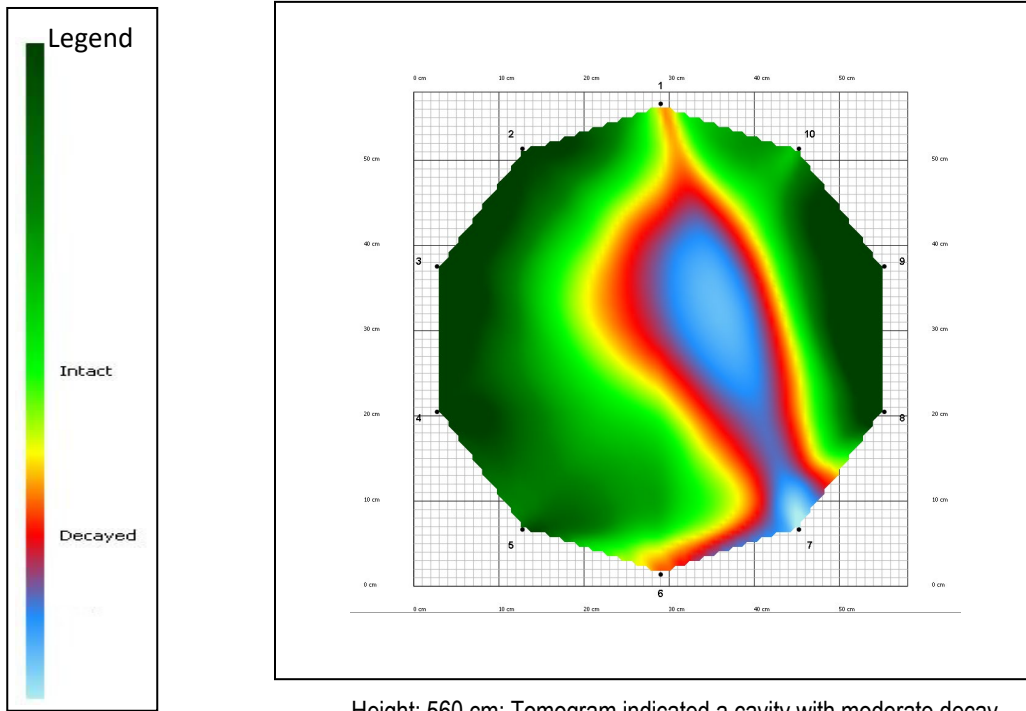
ArborSonic 3D™ Tomogram Live Oak #45 – South Scaffold Branch

Height: 560 cm; Tomogram indicated a cavity with moderate decay.

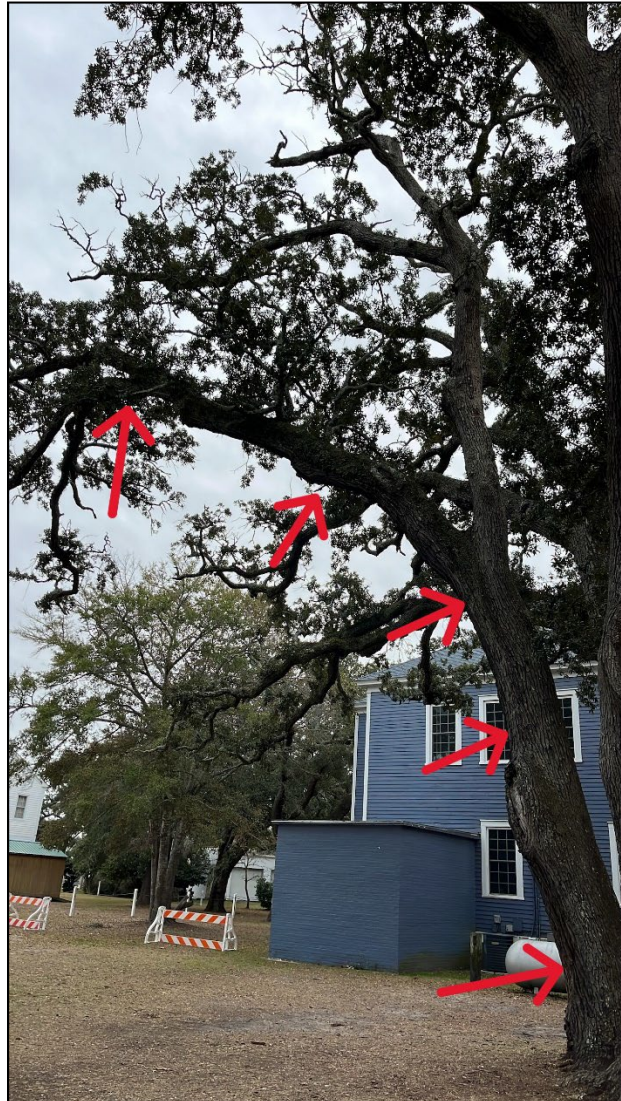
Photo 20: Looking west at live oak #46 showing the uneven crown.

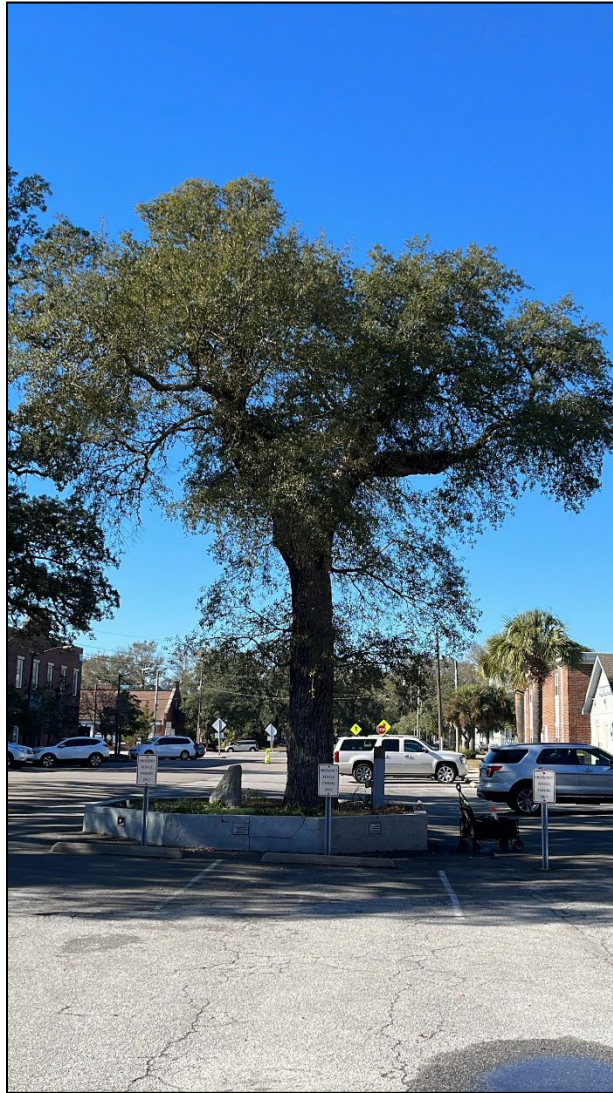
Photo 21: Looking west at live oak #49 showing the raised planting bed.

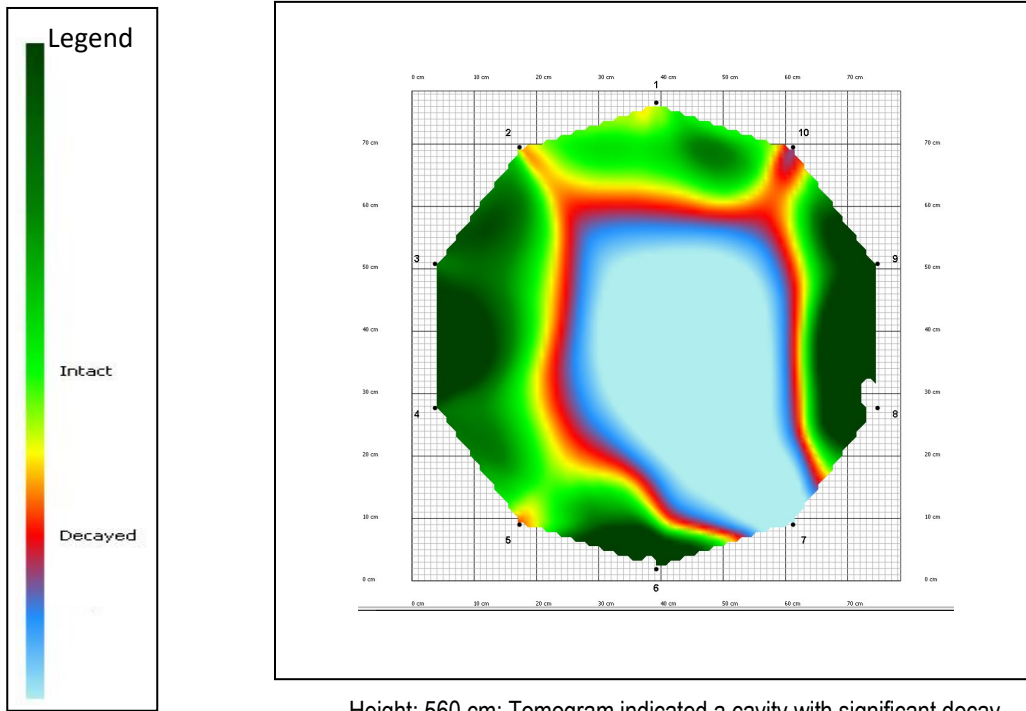
ArborSonic 3D™ Tomogram Live Oak #49 – 100 cm

Height: 560 cm; Tomogram indicated a cavity with significant decay.

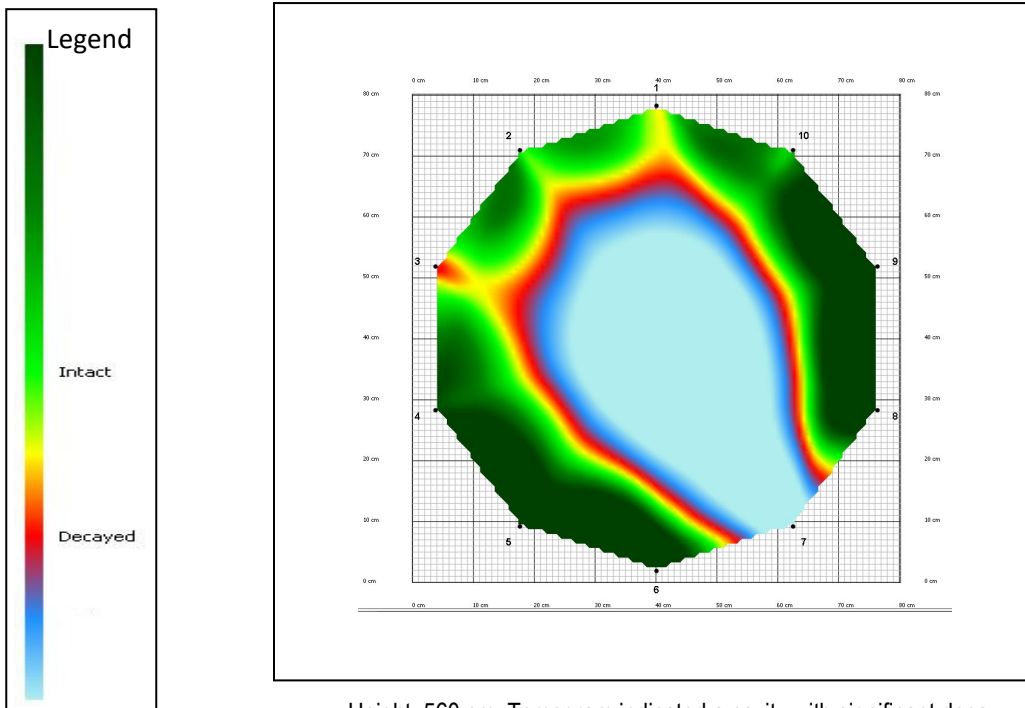
ArborSonic 3D™ Tomogram Live Oak #49 – 40 cm

Height: 560 cm; Tomogram indicated a cavity with significant decay.

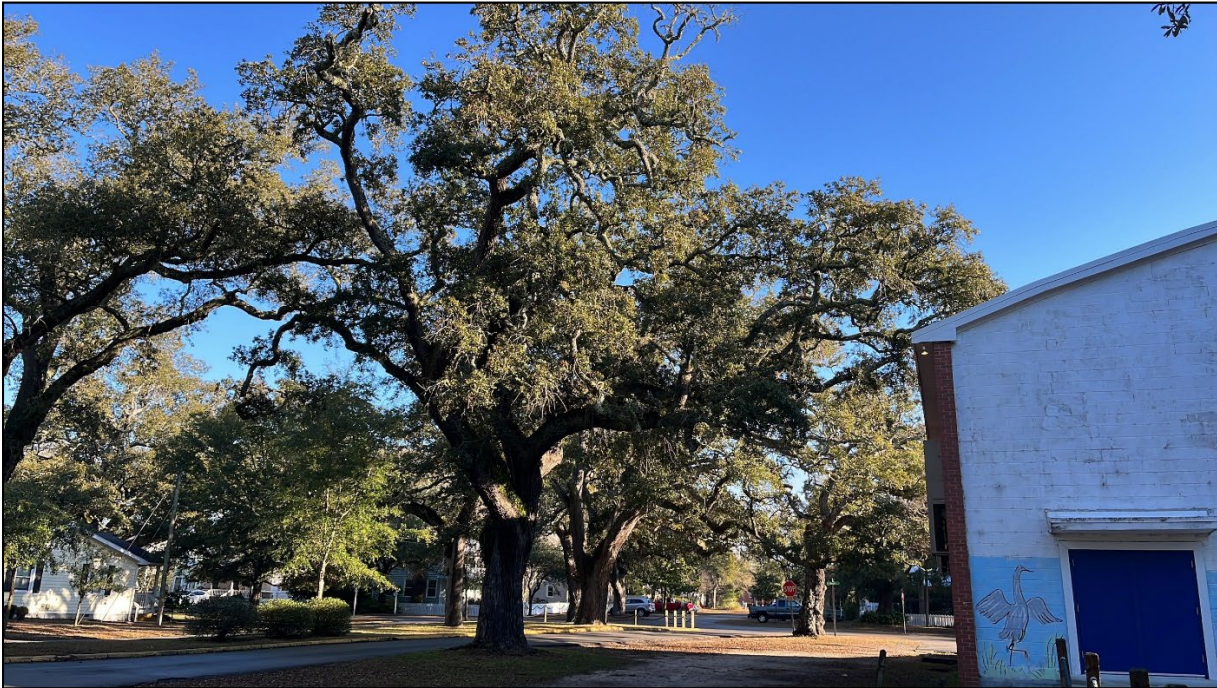
Photo 22: Looking east at live oak #50 showing the co-dominant stems.
