Franklin Square Park

Level 3 Advanced Assessments Report

Tree Risk Assessment Report

Franklin Square Park
130 E West Street
Southport, NC 28461
February 2, 2024

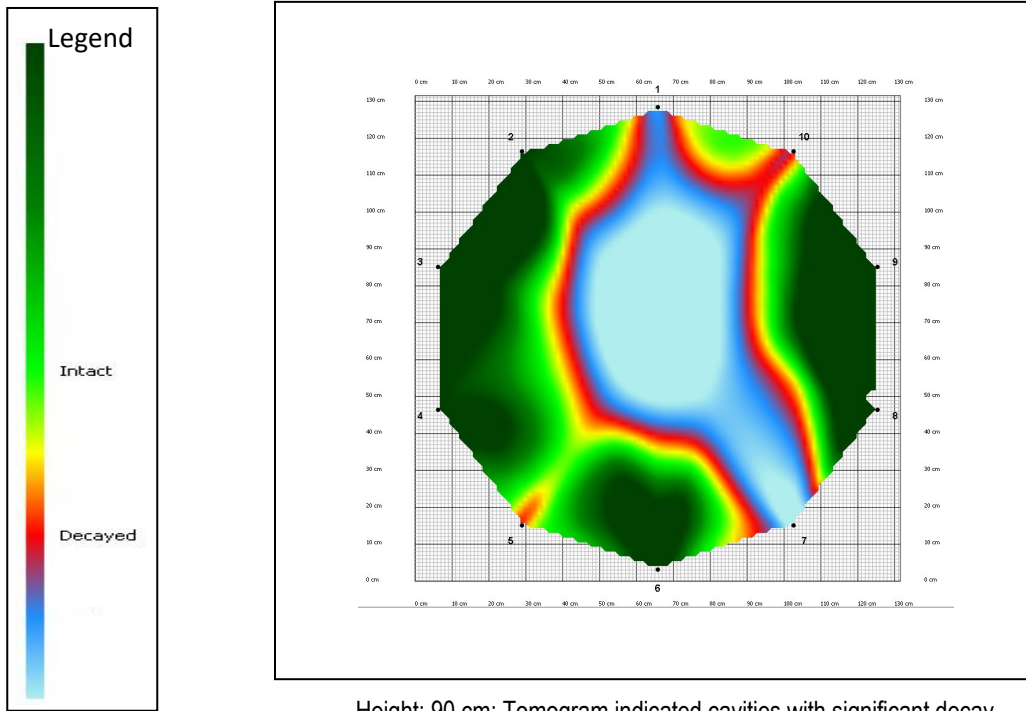
ArborSonic 3D™ Tomogram Live Oak #50 – 90 cm

Height: 90 cm; Tomogram indicated cavities with significant decay.

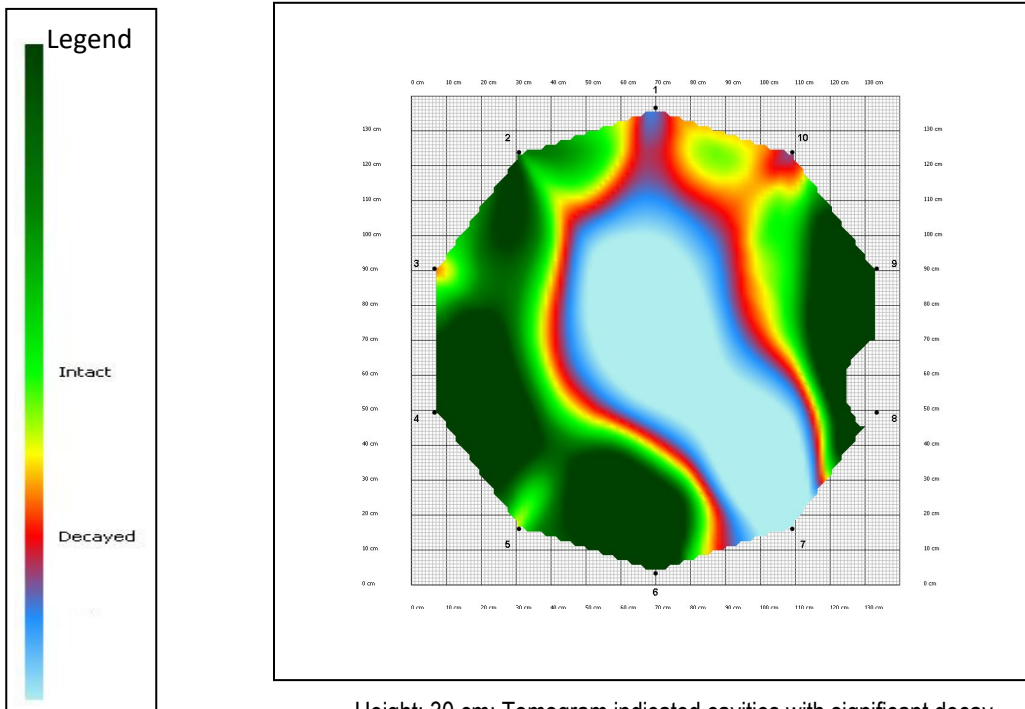
ArborSonic 3D™ Tomogram Live Oak #50 – 30 cm

Height: 30 cm; Tomogram indicated cavities with significant decay.
