Re: Indoor Environmental Quality Assessment Report
Southport Former City Hall
201 E. Moore Street
Southport, North Carolina 28461
Terracon Project No. K6237078

Indoor Environmental Quality Report

Southport Former City Hall

October 27, 2023 | Terracon Project No. K6237078

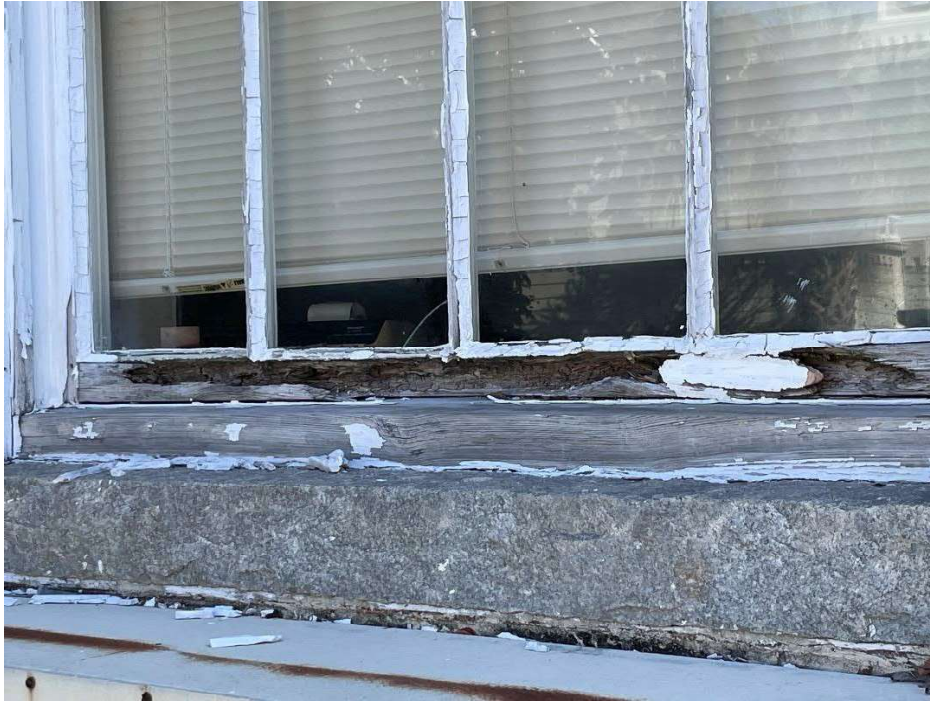
Photograph 3 – View of typical exterior window damage on the east side of the building of the original section.

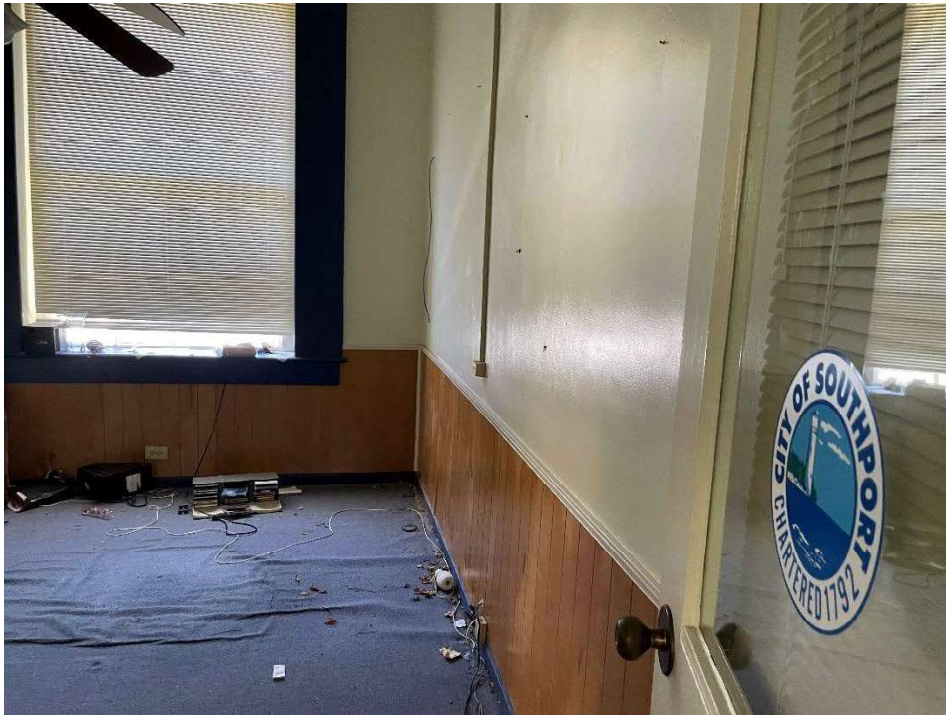
- Contains carpeted floors, wooden baseboards, plaster walls, suspended drop ceiling tiles with original wooden ceiling above. HVAC duct work is located between the suspended ceiling tiles and the original wooden ceiling.
- Water damage was observed on the carpet, ceiling tiles, plaster walls, and lower metal door casings.

Photograph 5 – View of typical water damage in Rooms 1 and 2.

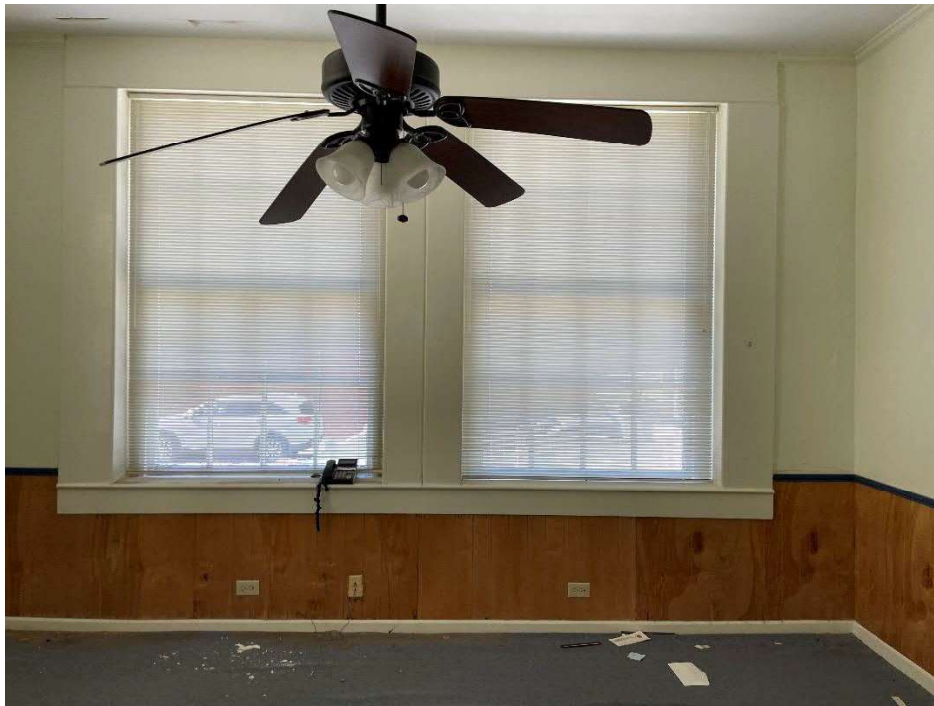
Photograph 6 – View of typical humidity impacted ceiling fan in Rooms 1 and 2.

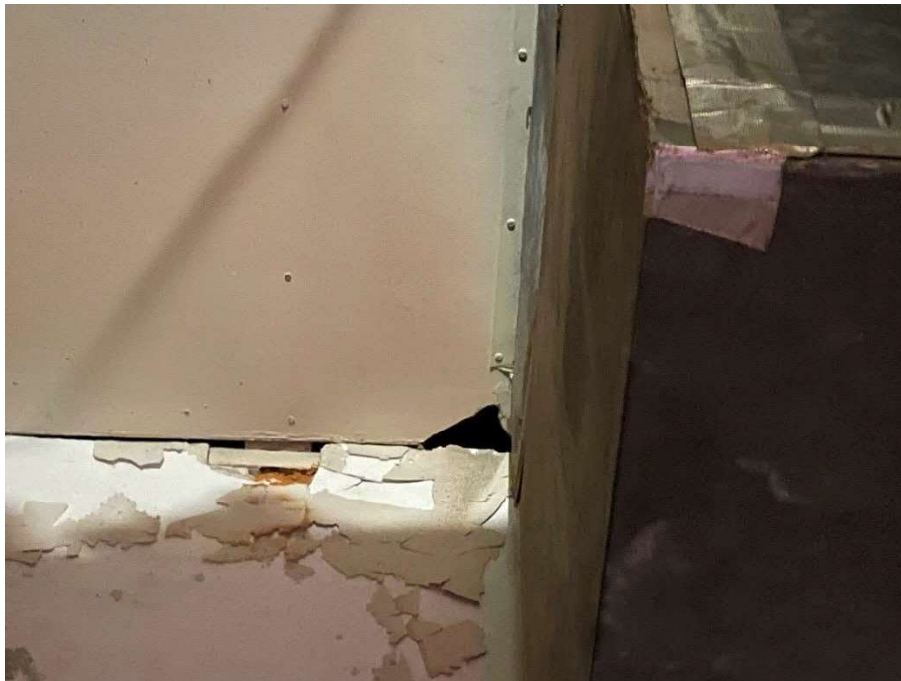
- Room contains carpeted and concrete floor, CMU and brick walls, possible cement board ceiling.
- Water damage was observed to plaster and brick walls.
- Rust and damage were observed along door frame.

Photo 8 – View of suspect ACM cement board ceiling in the mechanical room.

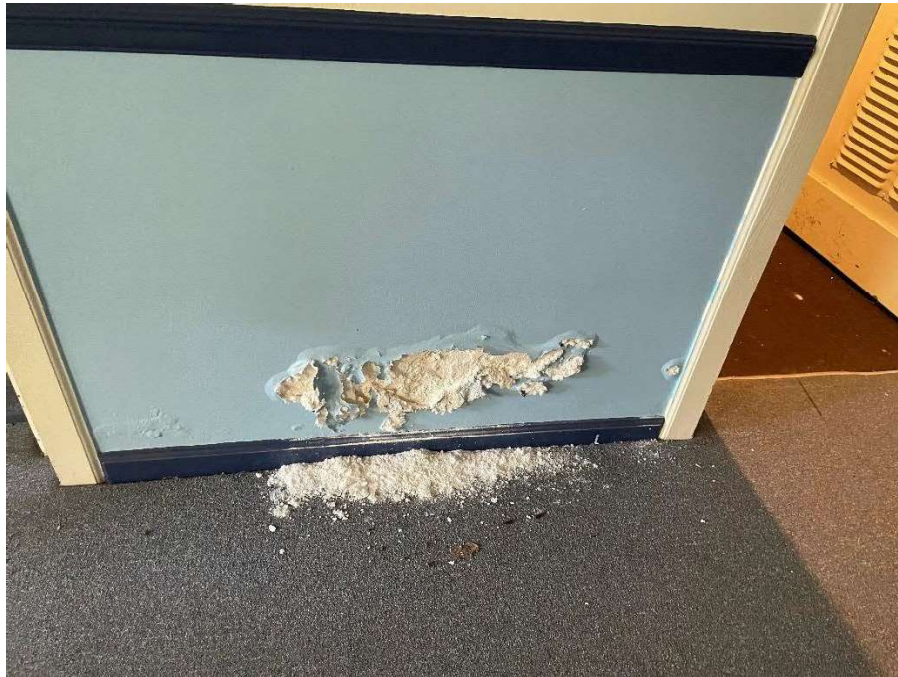
Photo 9 – View of water damage on wall in the first floor hallway.

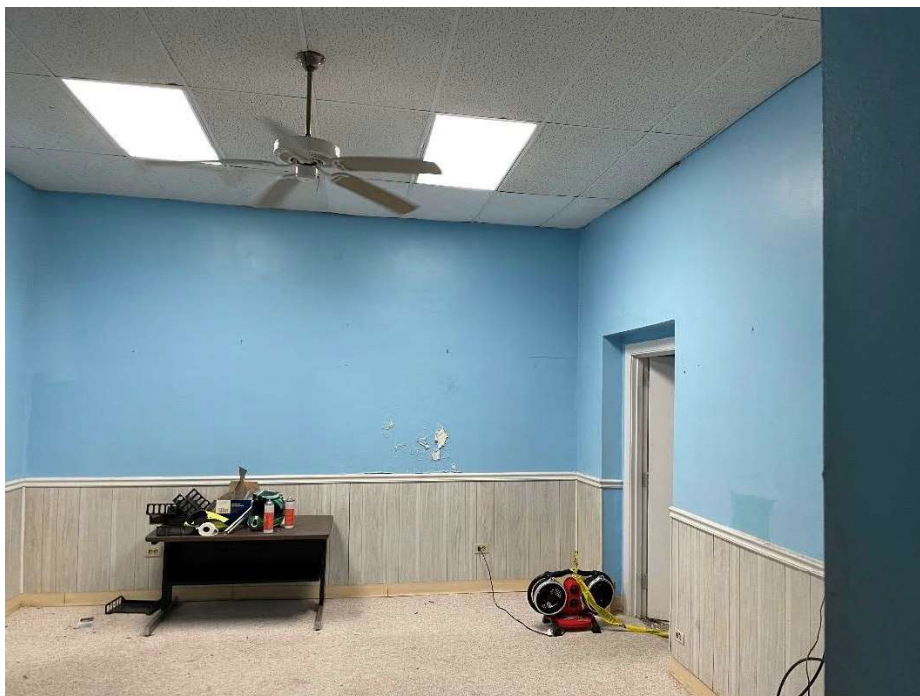
- Rooms contain carpeted and concrete floors, plaster, CMU and brick walls with wood panel wainscoting in Room 11, and suspended ceiling tiles.
- Water damage was observed on the exterior CMU walls.
- Significant water damage and suspected mold was observed on the ceiling tiles.
- Water damage was observed on the carpet and around the windows
- Significant suspected mold was observed on the exterior wall in Room 12. Appears to be possible ceiling leak which corresponds with damage in second floor room above this one.

Photo 10 – View of Room 11 with exterior wall water damage.

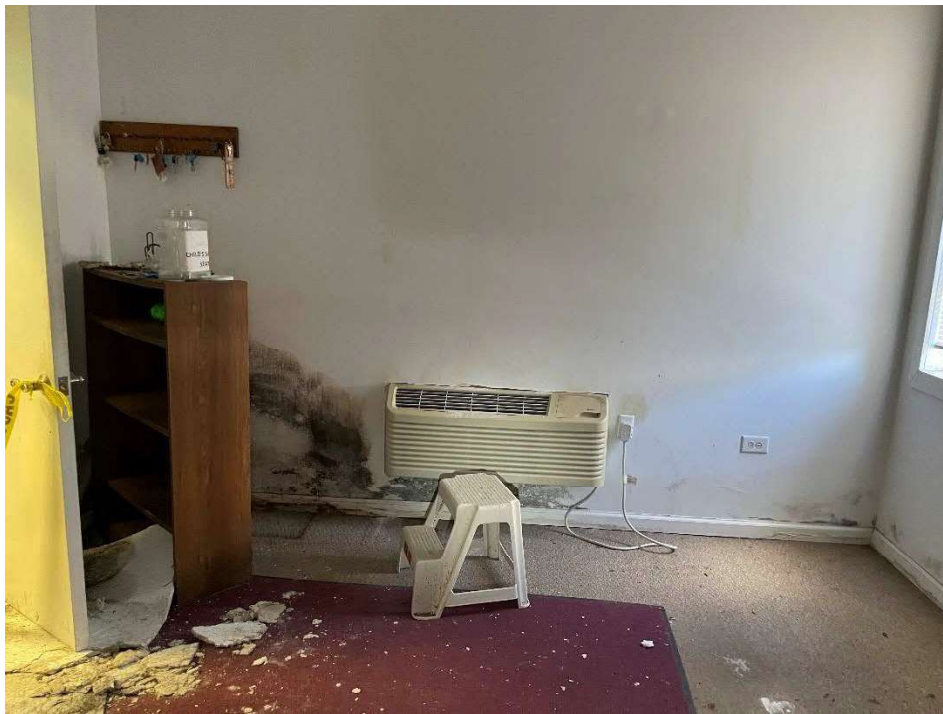
Photo 12 – View of the suspected mold and water intrusion in Room 12.

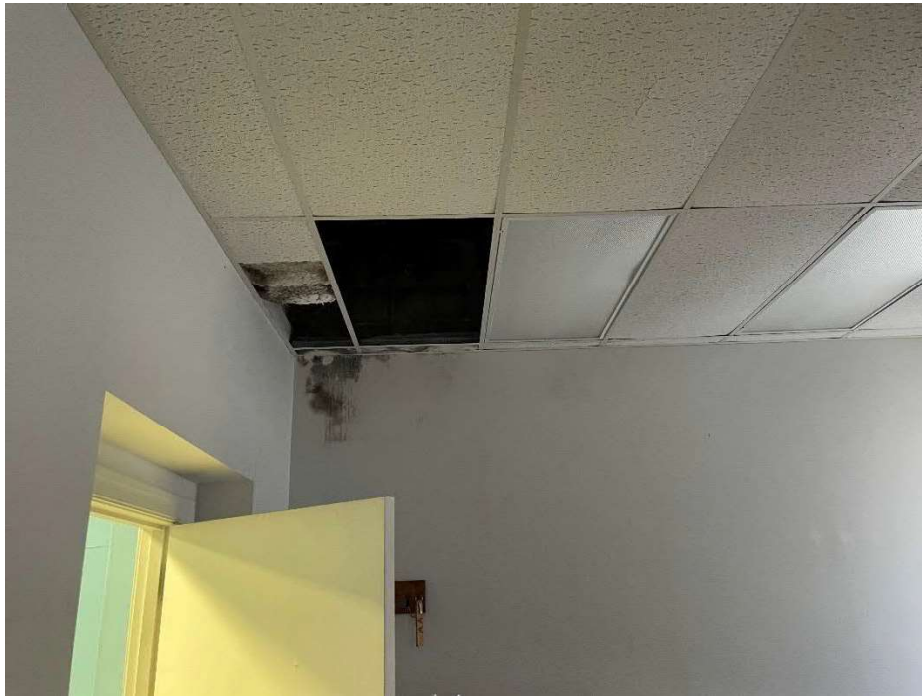
Photo 13 – View of suspected mold and water damage ceiling in Room 12.

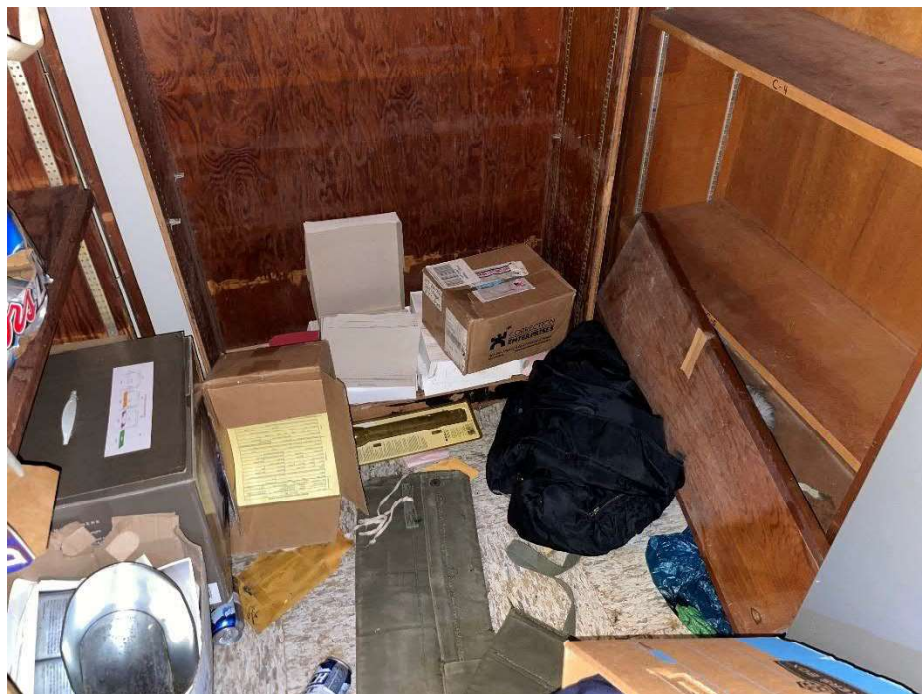
- The rooms contain vinyl floor tile, drywall and CMU walls, and suspended ceiling tiles.
- Room 14 appears to be used as a storage locker. Visibility behind the lockers was limited and mold growth should be assumed to be present behind the lockers.
- Water damage was observed was observed on the floors, walls, and ceiling.

Photo 14 – View of the humidity related suspected mold growth on furniture in Room 14.

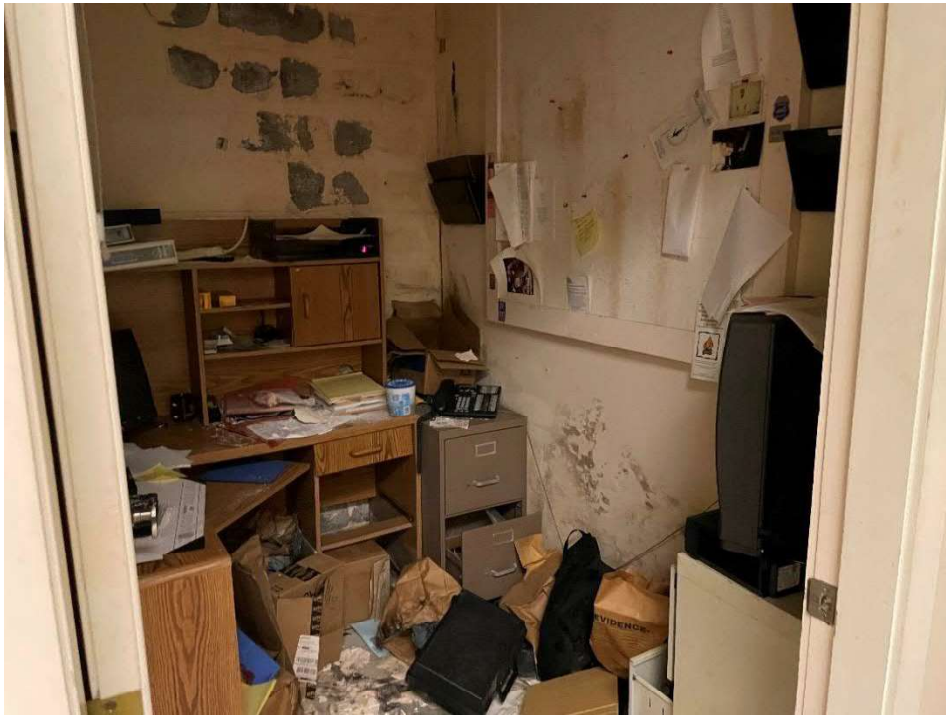
- The rooms contain vinyl floor tile in Room 15 with sheet vinyl floor in the bathroom, drywall and CMU walls, and suspended ceiling tiles.
- Significant suspected mold was observed on the drywall in Room 15 along with water damage to the CMU wall.

Photo 15 – View of the water damage and suspected mold growth in Room 15.

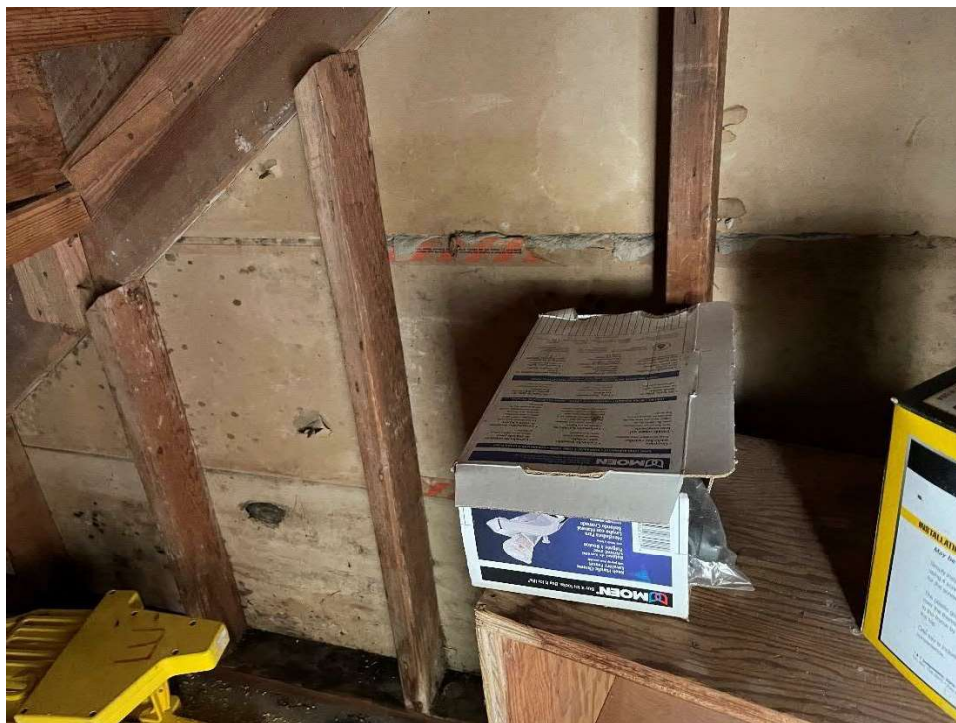
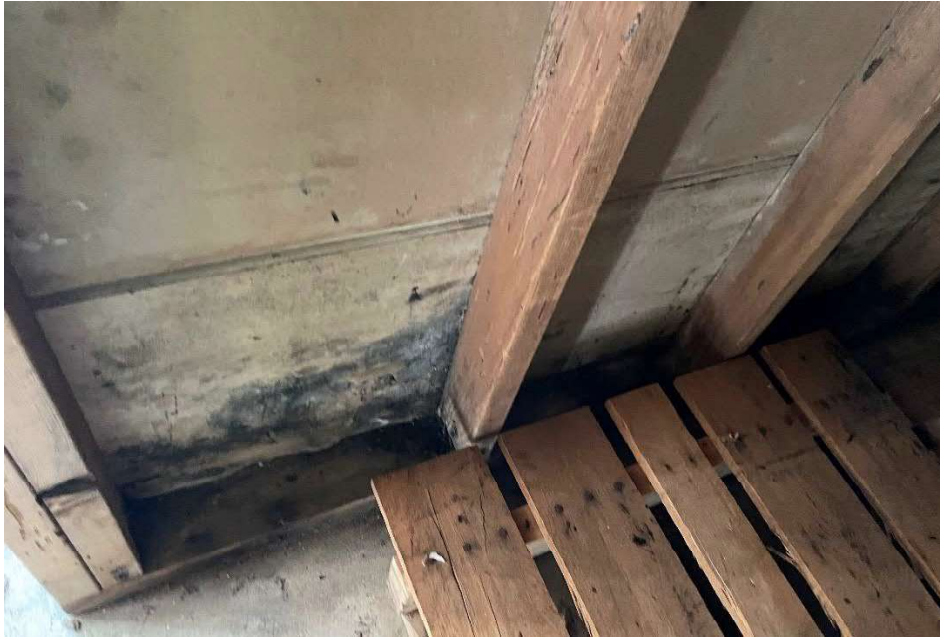
- Rooms contain ceramic floor tiles with plaster walls
- Gypsum lath observed behind the plaster in the understairs closet
- Residual 9"x9" floor tile (likely ACM) present in the under stairs closet
- Suspected mold was observed on the backside of gypsum walls in the understairs closet
- Water damage was observed around windows

Photo 16 – View of the understairs closet by the bathroom with suspected mold growth on the gypsum lath.

Photo 17 – View of the understairs closet by the bathroom with suspected mold growth on the gypsum lath.

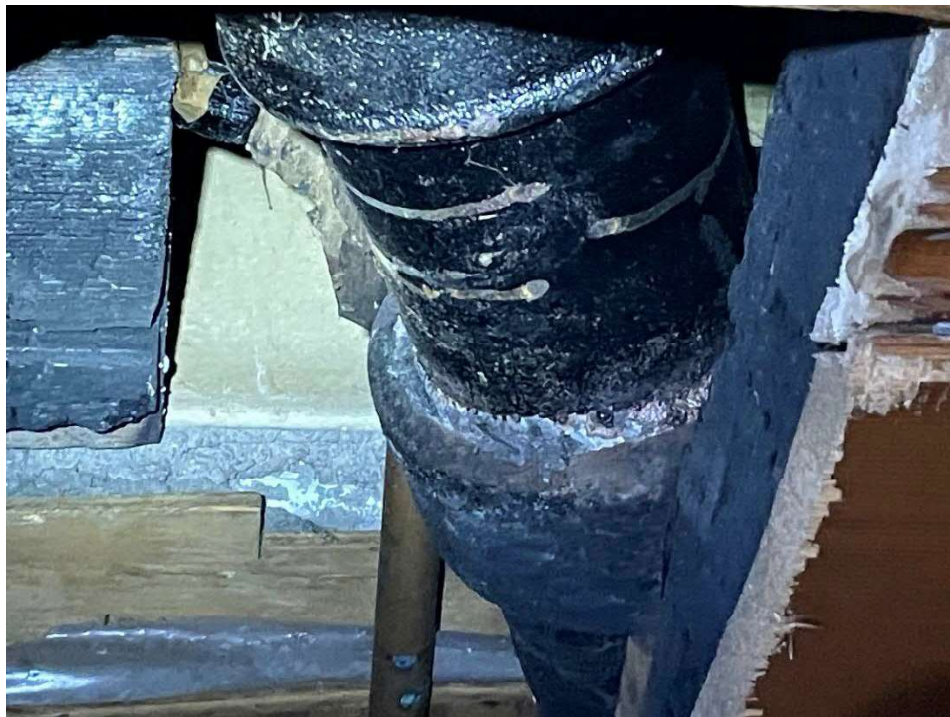
Photo 18 – View of the suspect ACM pipe insulation (black wrap) within the interstitial space between the first and second floor, above the wooden ceiling.

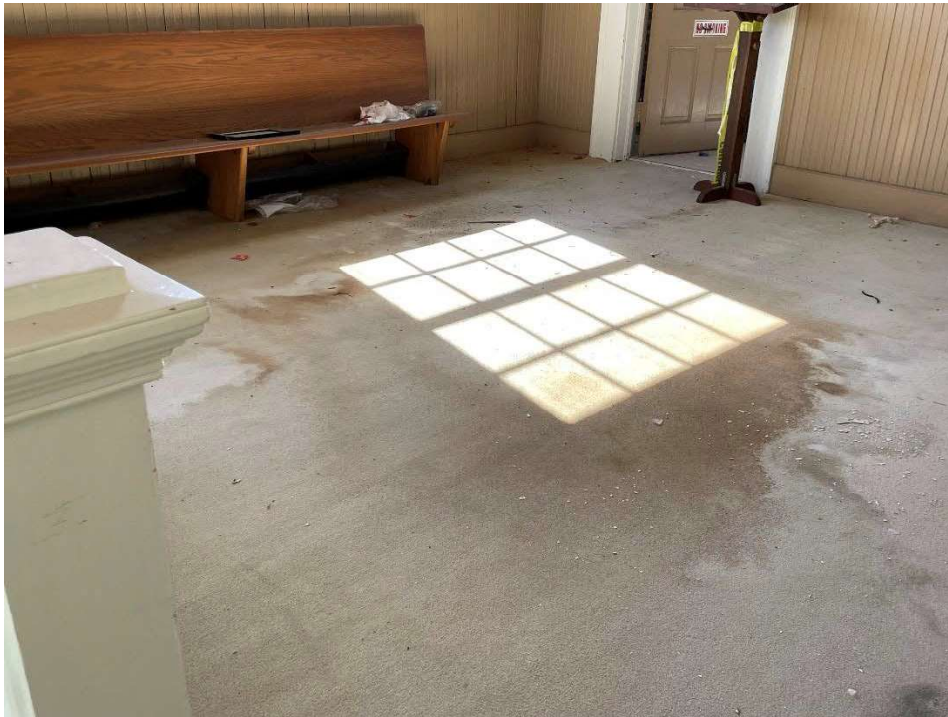
- The attic access was visible in the 2nd floor landing; however, significant water damage was visible on the carpeted floor under the access.
- Water damage was observed on the wood panel walls, plaster walls and the wood ceiling at the light fixture.
- There appears to have been a prior roof leak at this location.
- Suspected mold was observed on the duct chase located above the courtroom door.

Photo 19 – View of water damage on floor on the second floor landing from a presumed roof leak.

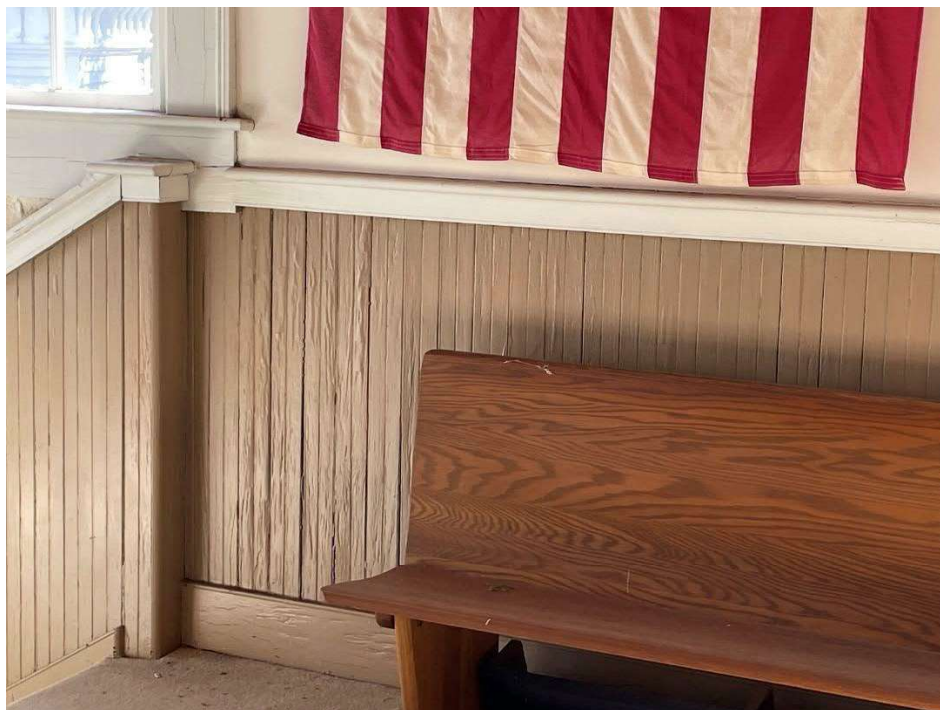
Photo 20 – View of water damage on wainscoting on the second floor landing.

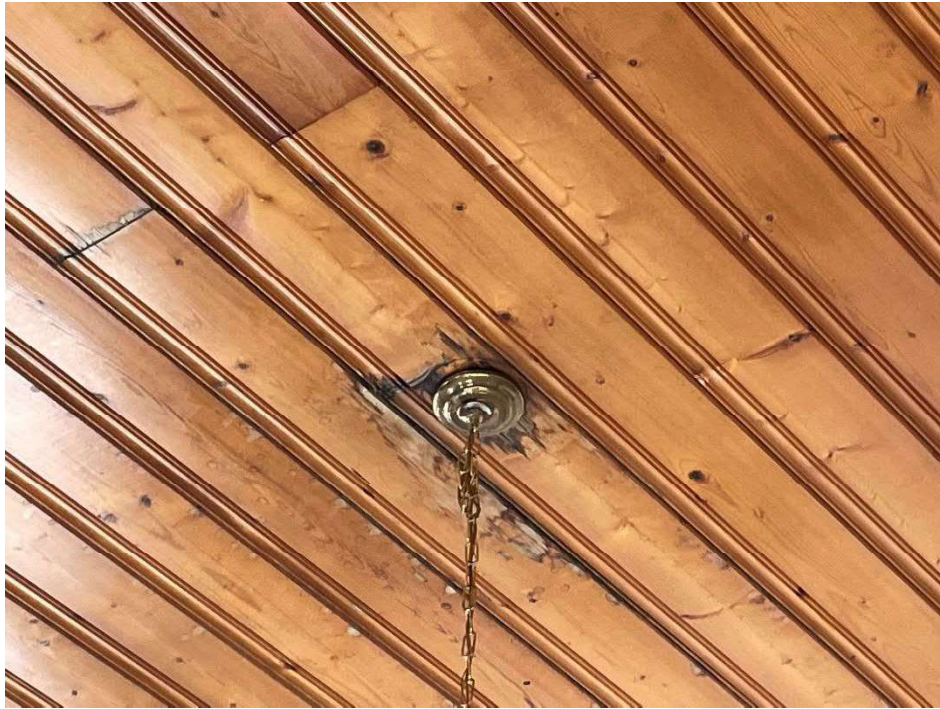
Photo 21 – View of water damage to the wood ceiling on the second floor landing. This ceiling is present throughout the first floor original section.

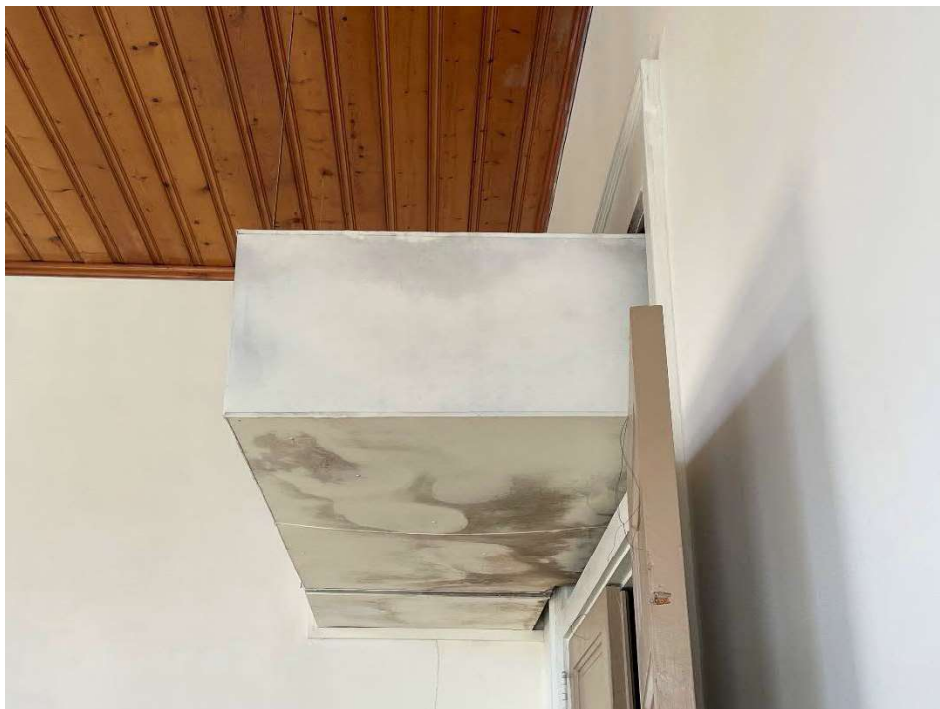
Photo 22 – View of suspected mold on the duct insulation leading into the courtroom.

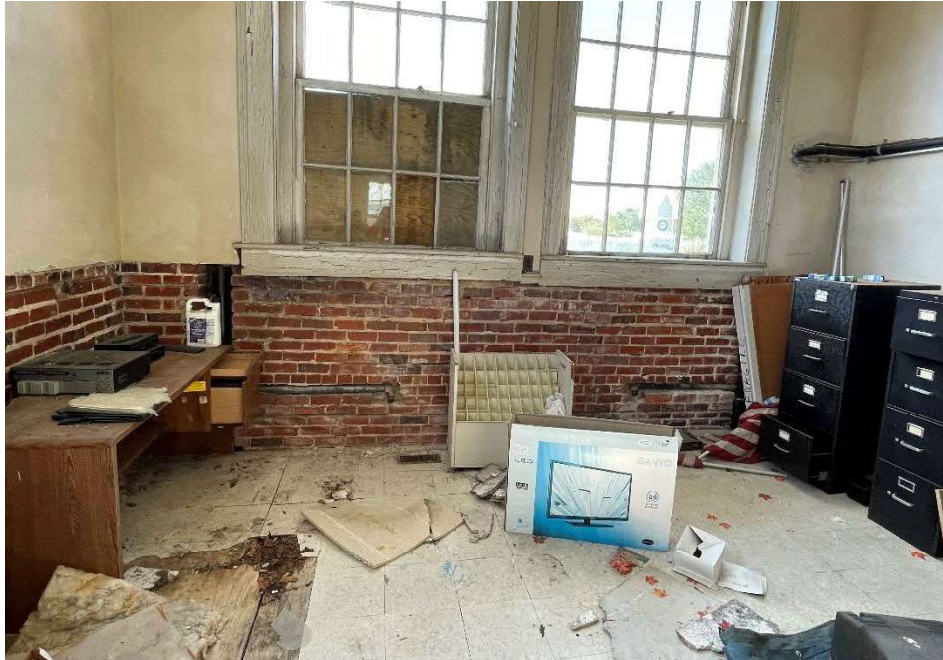
Photo 23 – View of significant water damage in the mechanical room on the second floor.

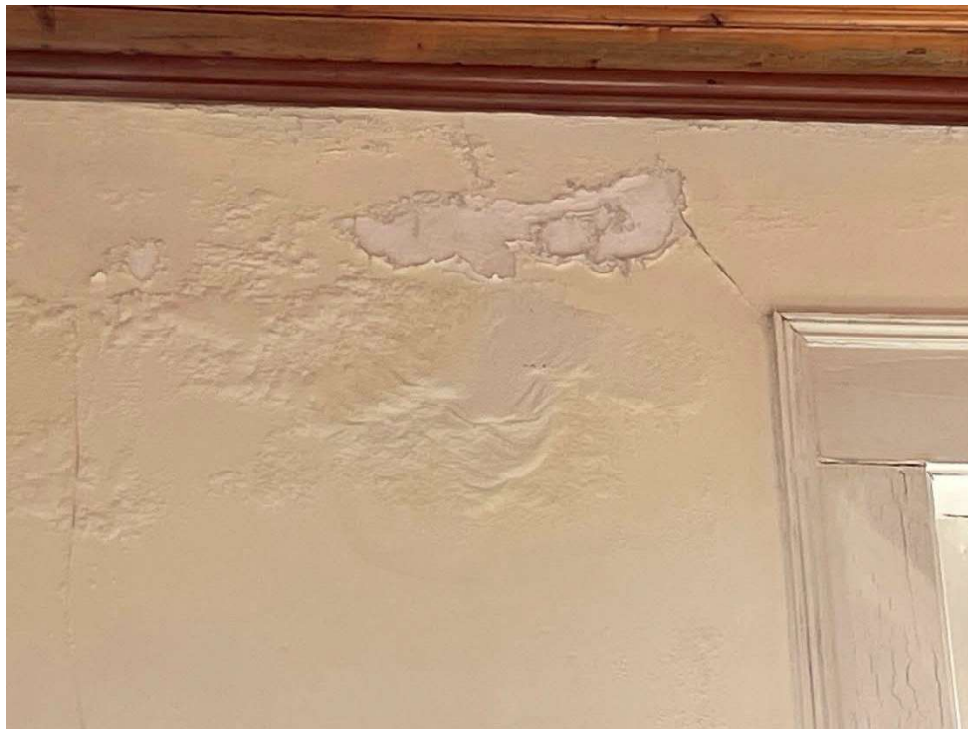
Photo 24 – View of water damaged plaster on the second floor landing.

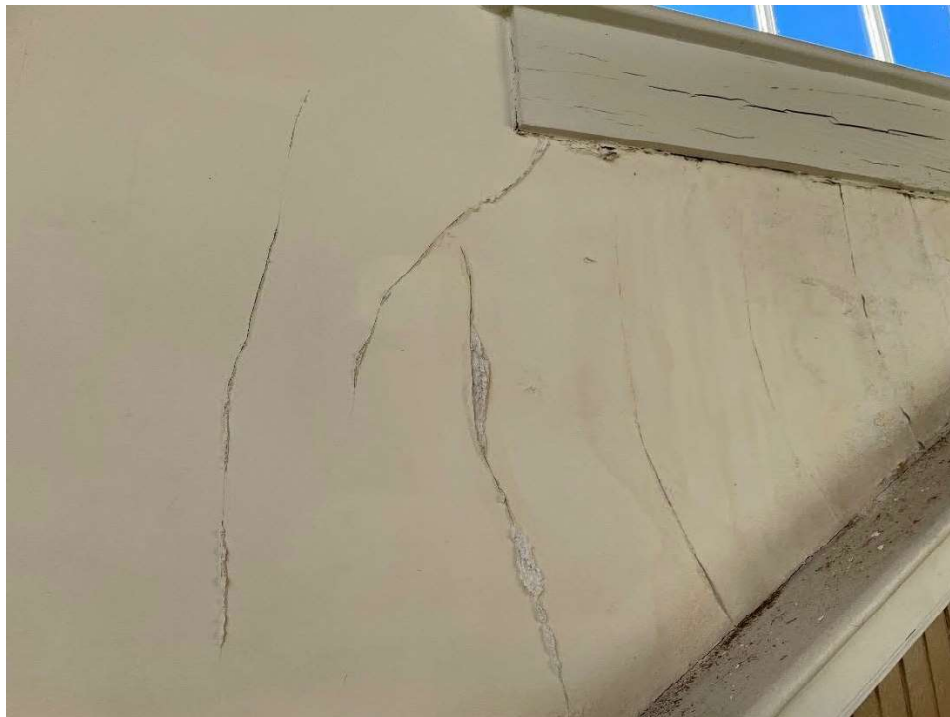
Photo 26 – View of plaster damage on the second floor landing.

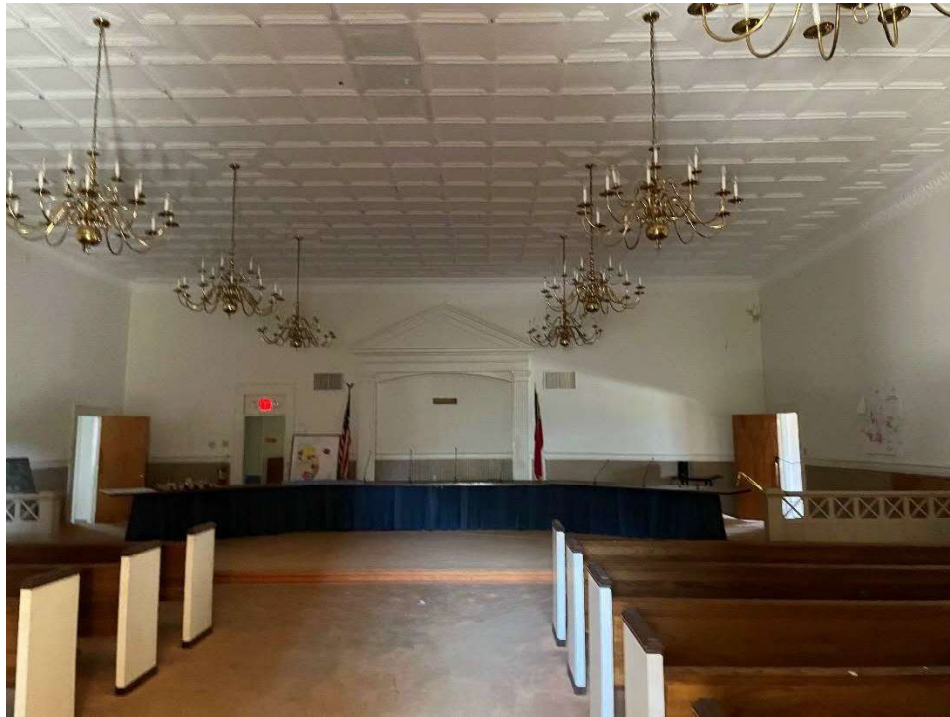
Photo 27 – View of courtroom on the second floor. Assume porous materials are mold impacted (carpet, fabric, benches, etc.).

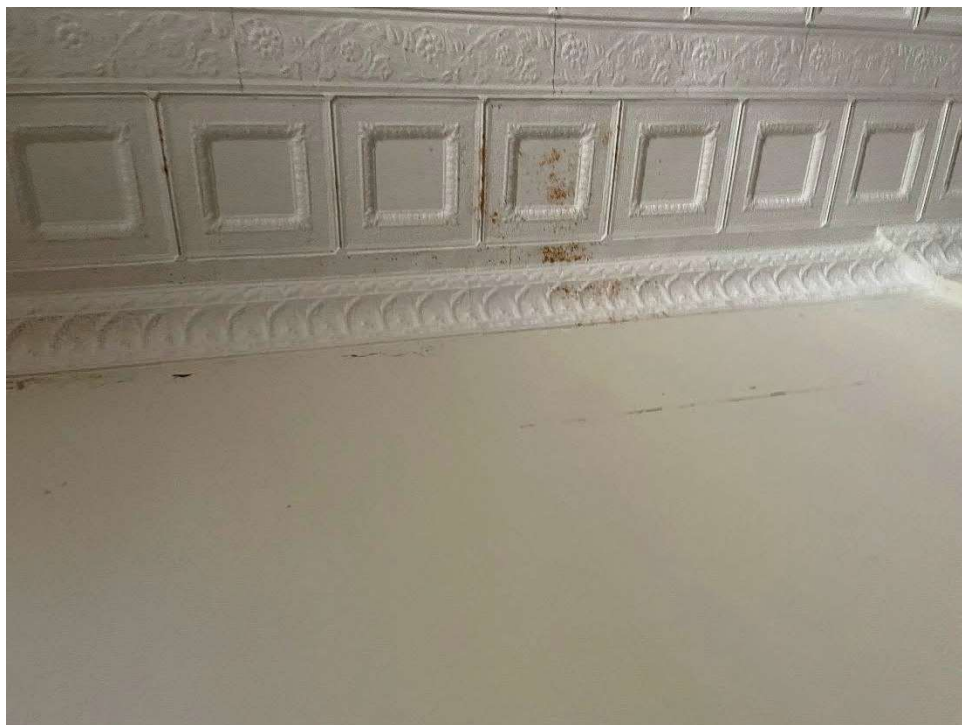
- This room contains carpeted floors, wood wainscoting, and plaster walls with an ornamental tiled ceiling.
- Water damage was observed on the wood wainscoting and plaster walls on the exterior walls.
- Water damage was observed on the wooden portions of the windows (framing and panes)
- Rust was observed on the ceiling tiles

Photo 28 – View of rust on the ceiling tiles in the courtroom.

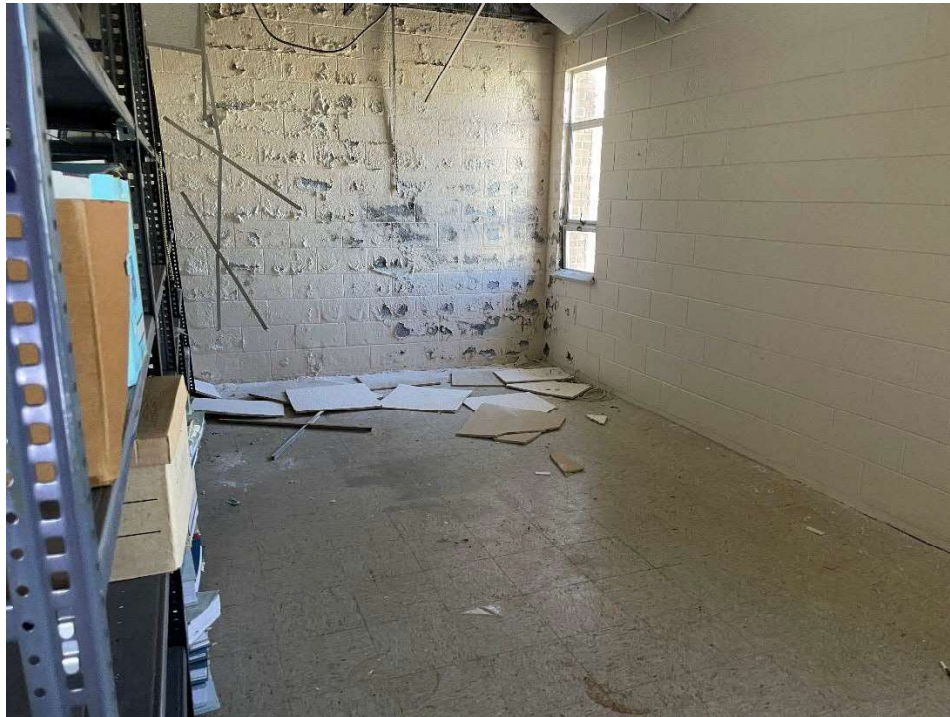
Photo 29 – View of room 203 with water damaged CMU walls.

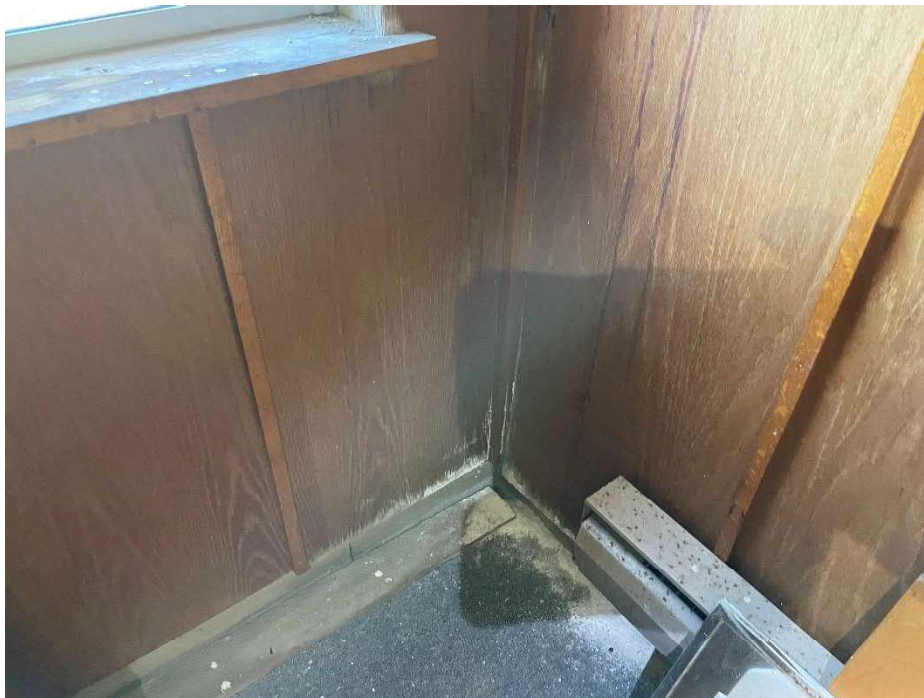
Photo 30 – View of room 207 with suspected mold on the wood paneling and carpet with evidence of CMU wall damage behind.

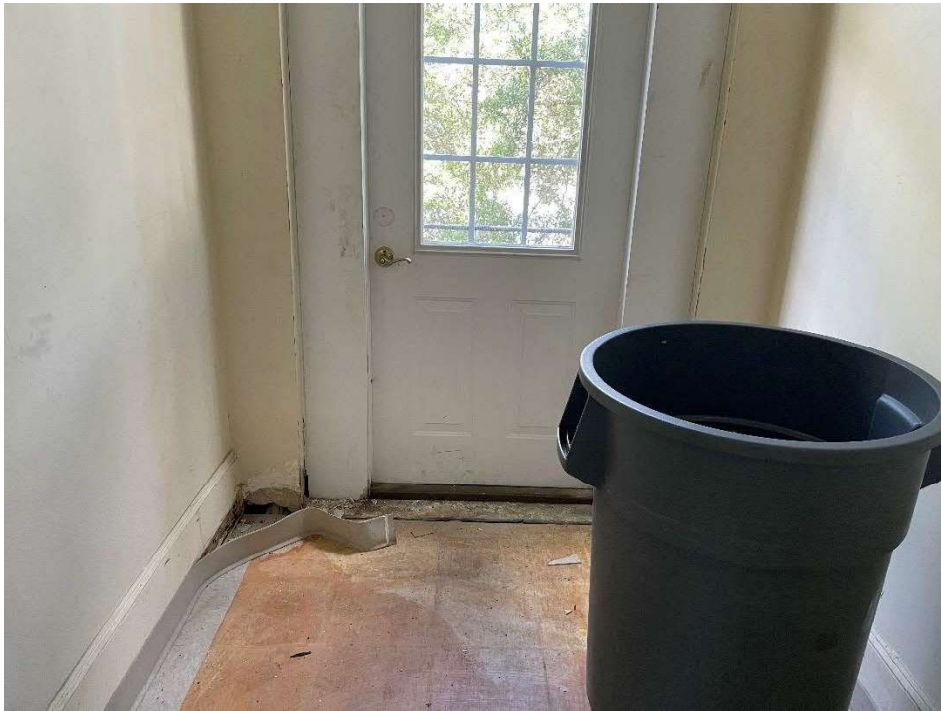
- Evidence of interstitial space between the plaster walls and the brick exterior wall.
- Water damage observed around the base of the back door.

Photo 31 – View of the second floor back door with evidence of water damage around the base.

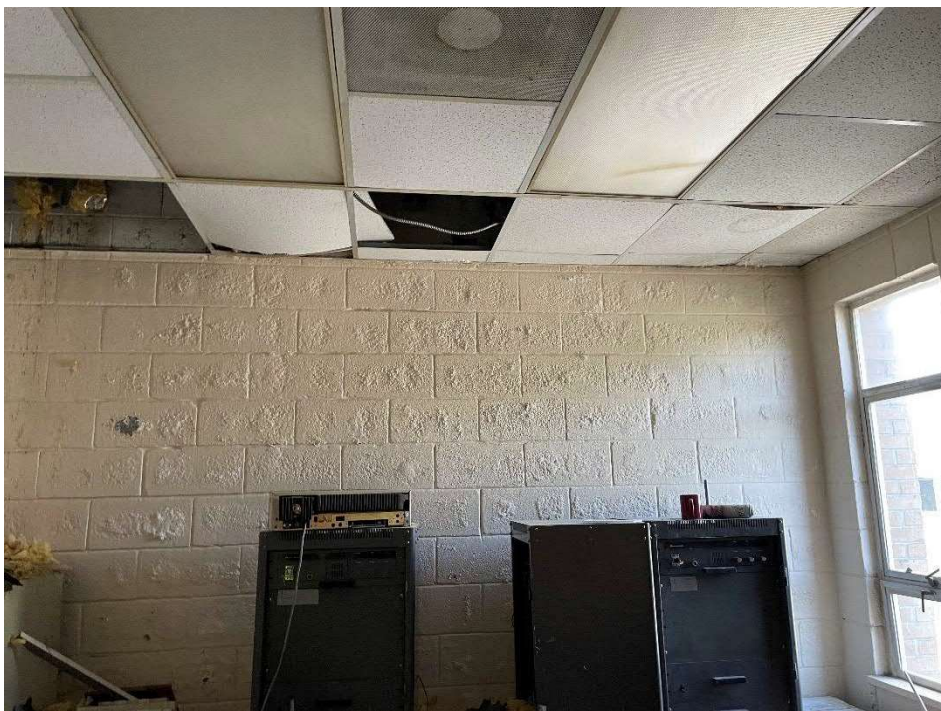
- This room contains carpeted floors, CMU wall and suspended ceiling tiles.
- Significant water damage and suspected mold growth to ceiling tiles with efflorescence on CMU walls.
- Potential animal activity above the ceiling tiles.
- Sunlight was observed at the penetrations above the ceiling tiles and cracks were present at the junction of the original building and the wing addition.

Photo 32 – View of the second floor back room to the right where sunlight (exterior penetrations) were observed along with animal activity.

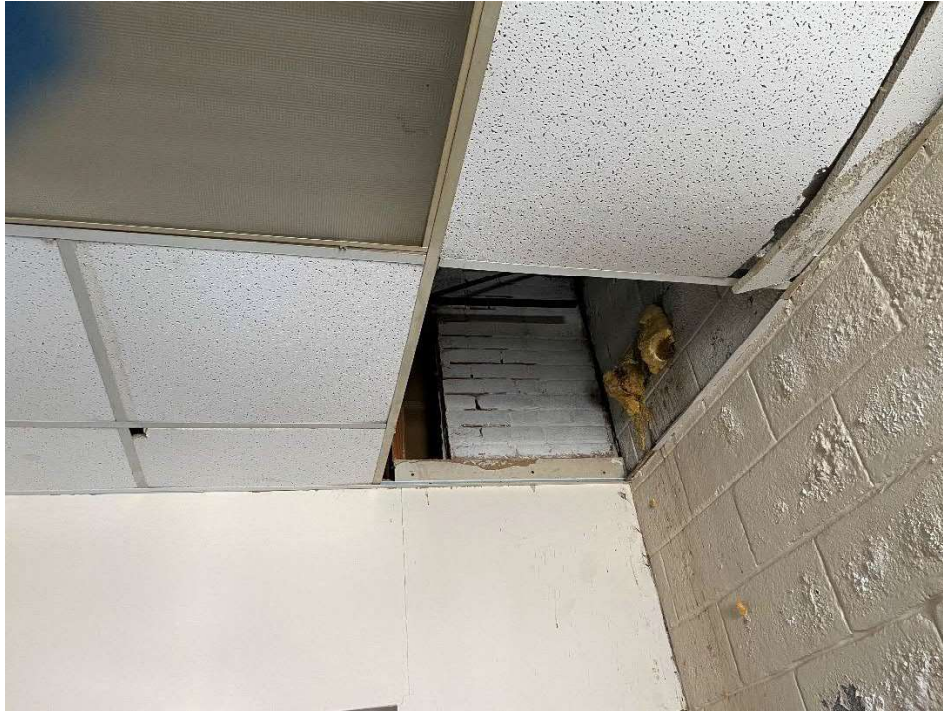
Photo 33 – View of the second floor back area joint of original building to east wing addition, area of suspected mold growth on the first floor.

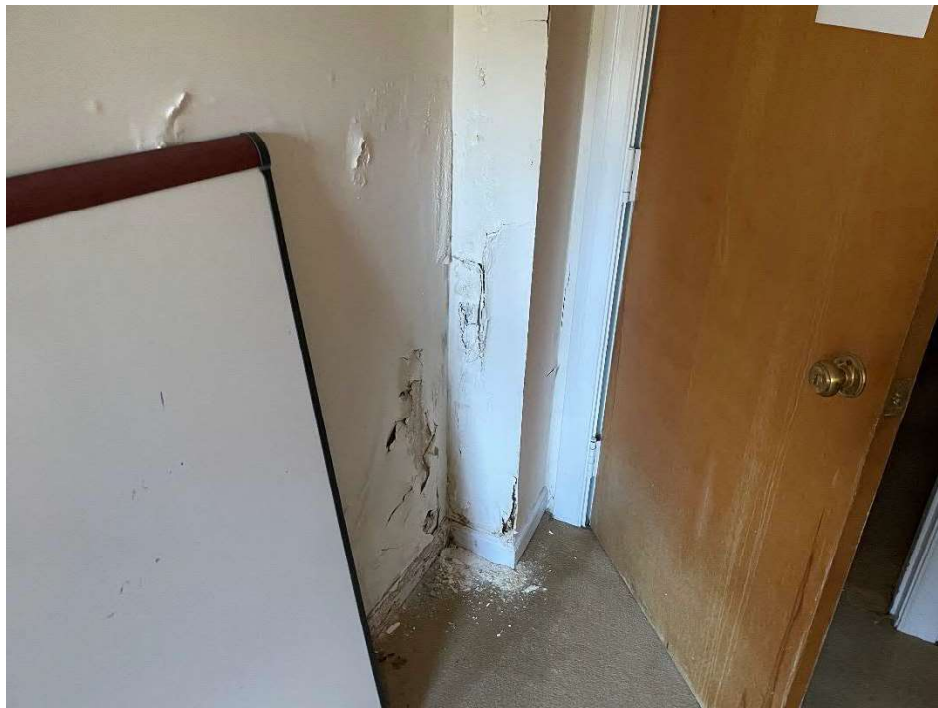
- This room contains carpeted floor, plaster walls and suspended ceiling tiles
- Water damage was observed to the ceiling tiles
- Significant damage was observed to wall adjacent to courtroom, at the junction of the wing addition and the original structure.

Photo 34 – View of the water damage at second floor conference room, where the east wing abuts the original structure.
