SITE LOCATION MAP
 Southport Former Town Hall
 201 E. Moore Street
 Southport, North Carolina

ASBESTOS INSPECTION SAMPLE SUMMARY Southport Former City Hall 201 E. Moore Street Southport, North Carolina Terracon Project No. K6247038

MATERIALS CONTAINING ASBESTOS SUMMARY Southport Former City Hall 201 E. Moore Street Southport, North Carolina Terracon Project No. K6247038

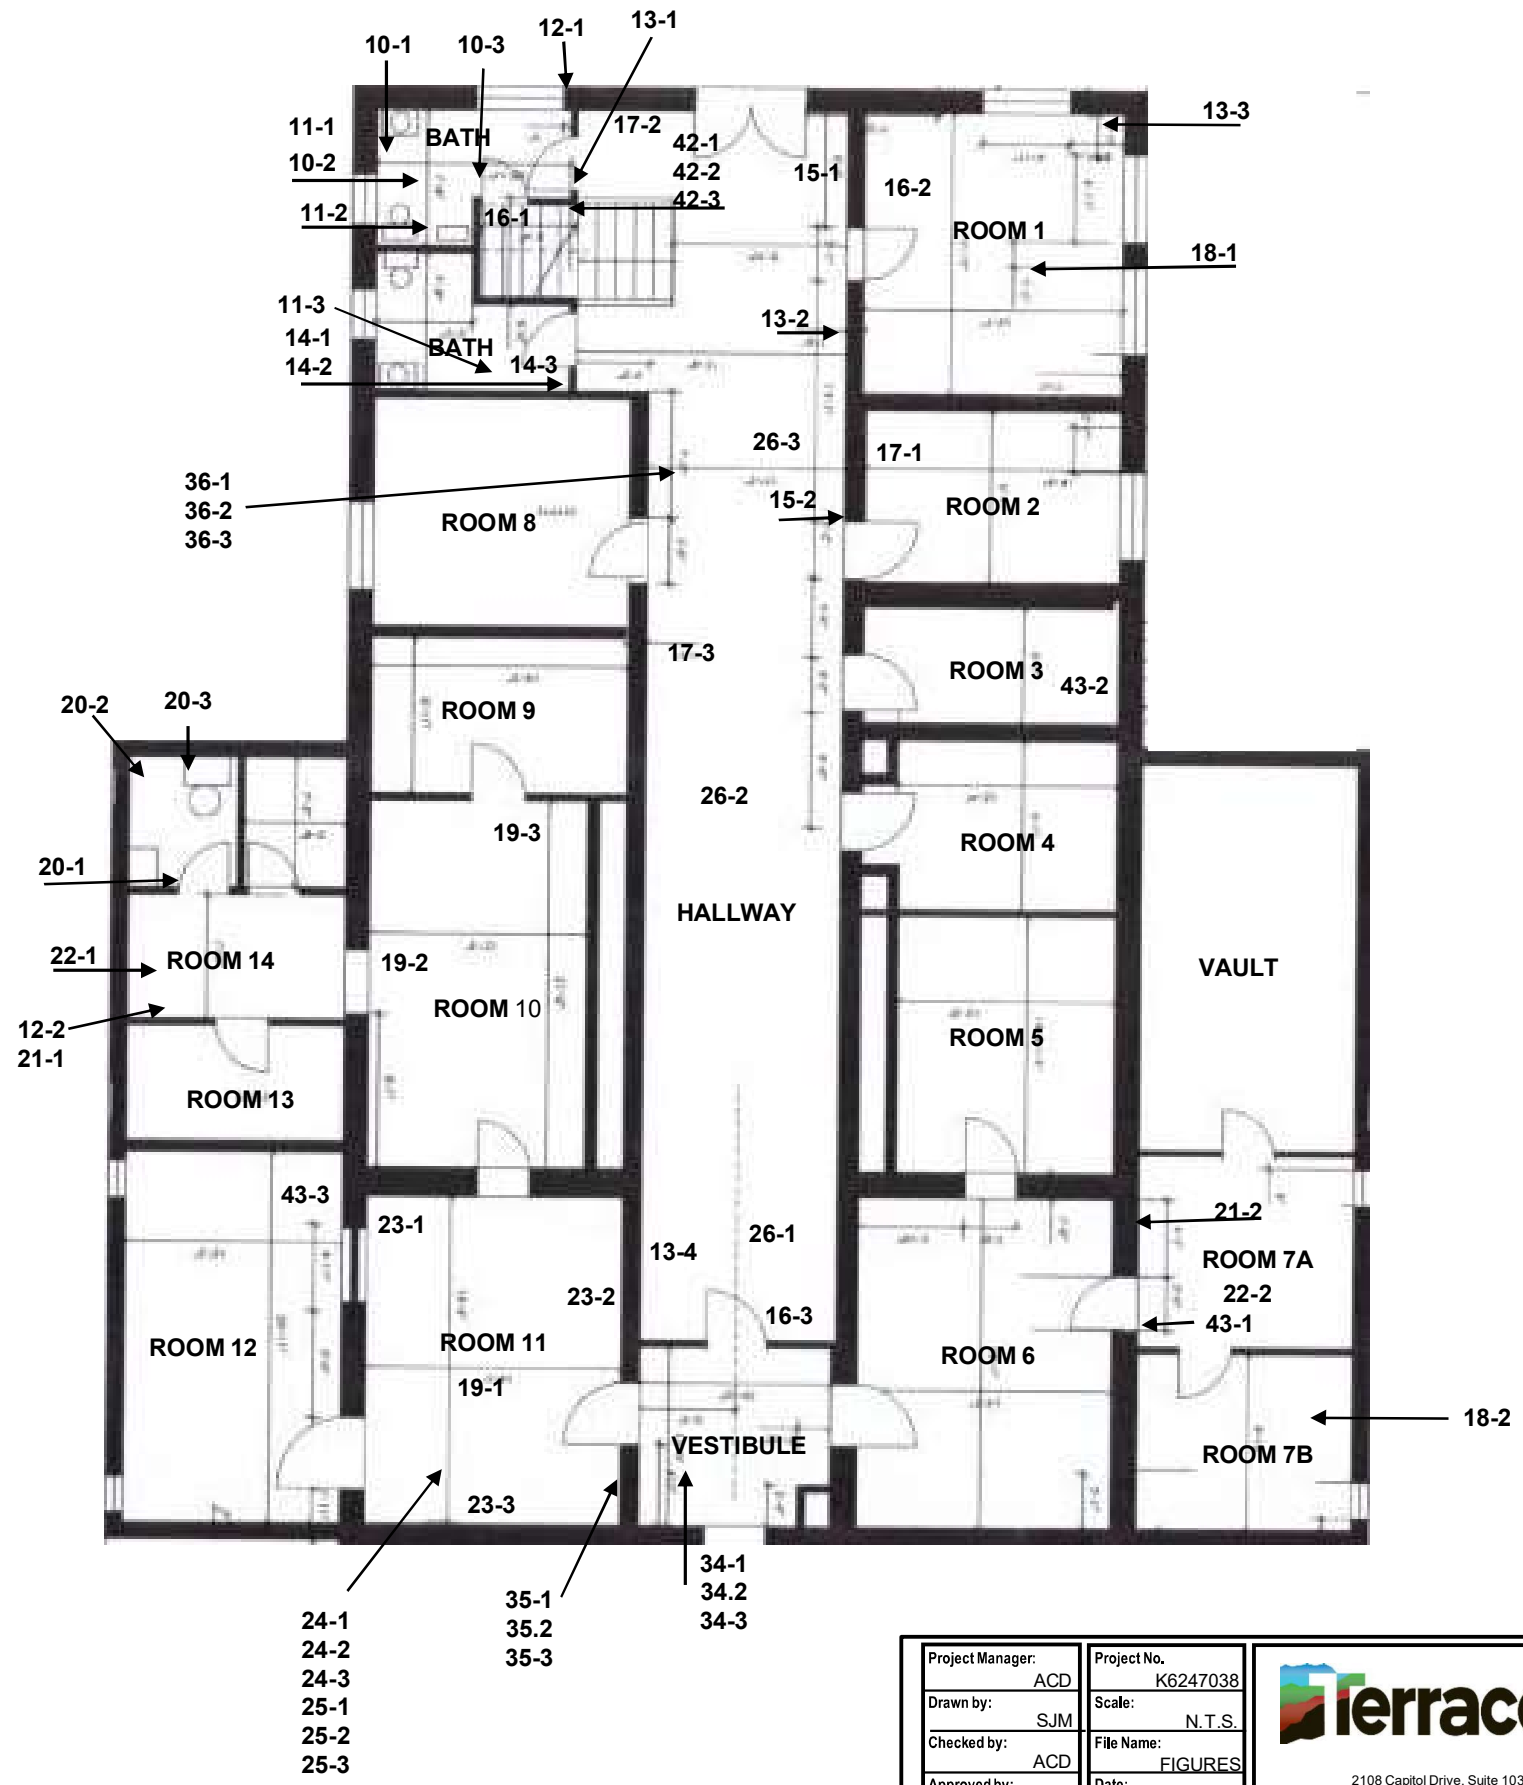
INTERIOR 1 ST FLOOR SAMPLE LOCATION MAP	FIGURE
Southport Former Town Hall 201 E. Moore Street Southport, North Carolina	4

- 24-1
- 24-2
- 24-3
- 25-1
- 25-2
- 25-3

- 35-1
- 35-2
- 35-3

- 34-1
- 34-2
- 34-3

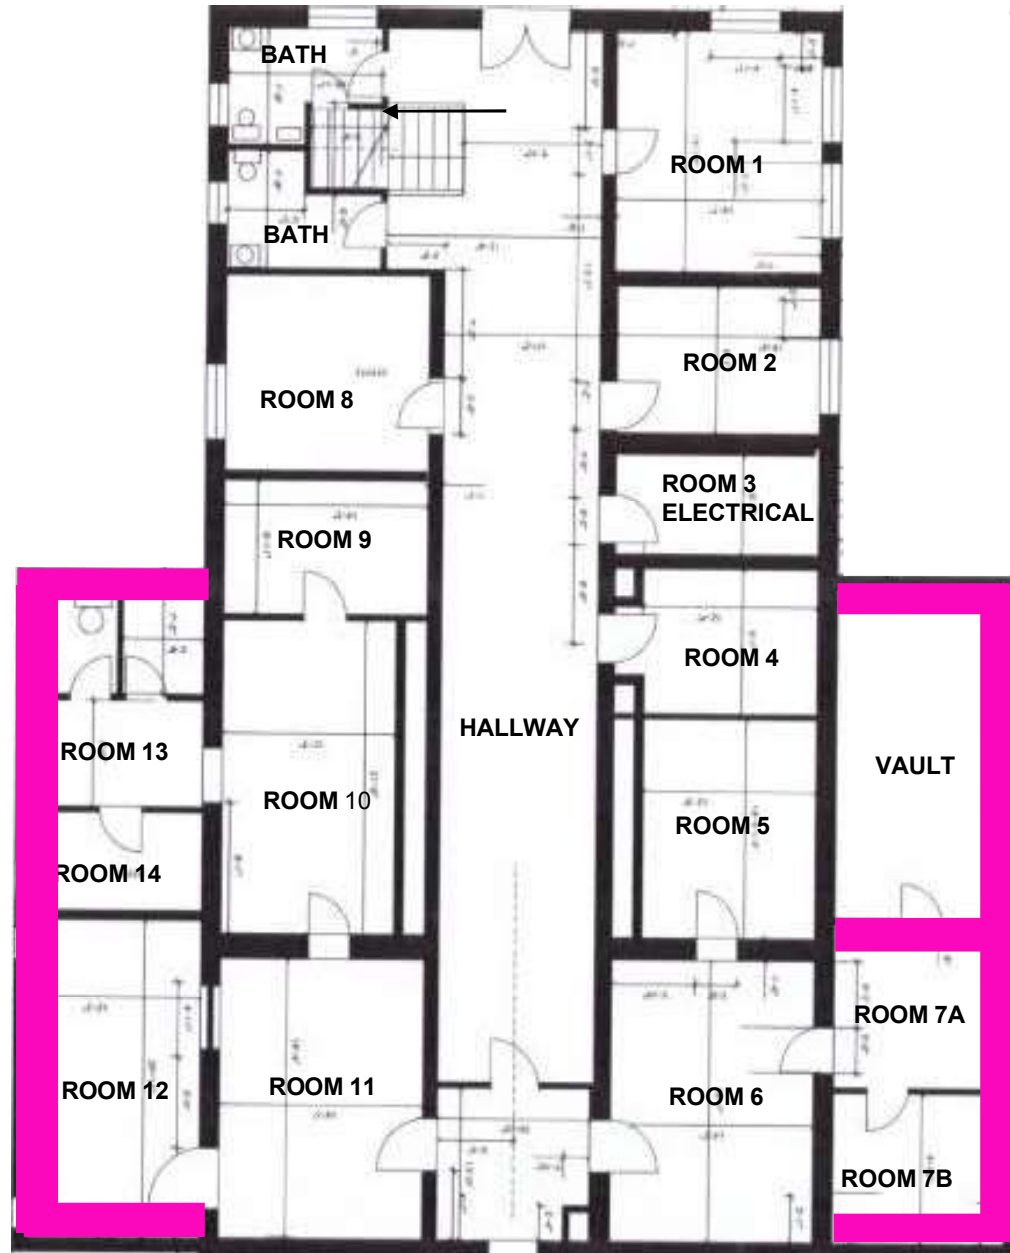
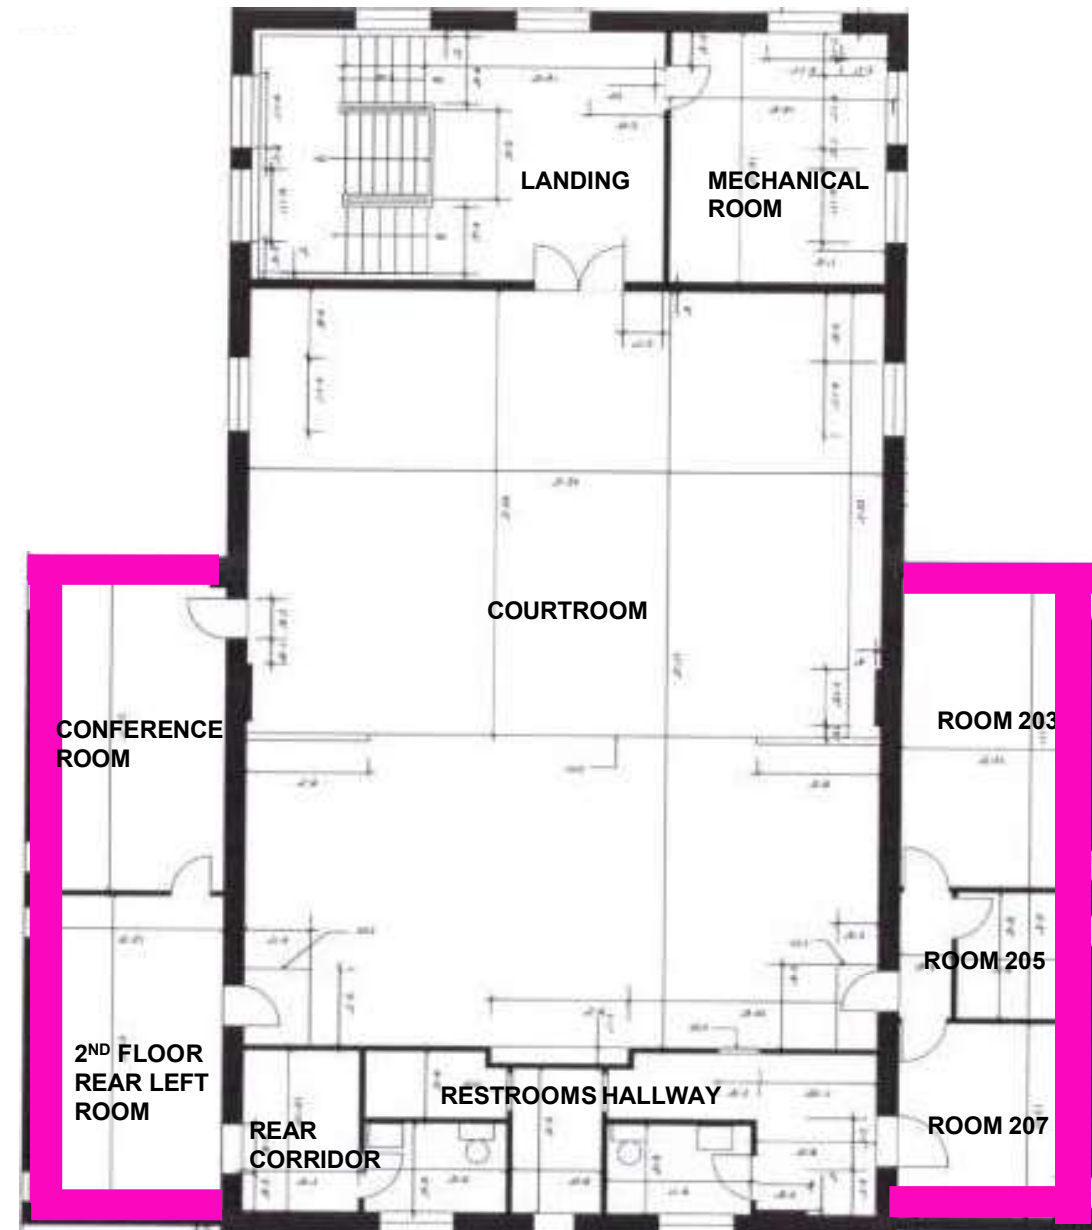
INTERIOR FRIABLE ACM LOCATION MAP	FIGURE
Southport Former Town Hall 201 E. Moore Street Southport, North Carolina	6

IDENTIFIED ASBESTOS CONTAINING CMU BLOCK FILLER (ACM)	SYMBOL
CMU BLOCK FILLER (HA 22)

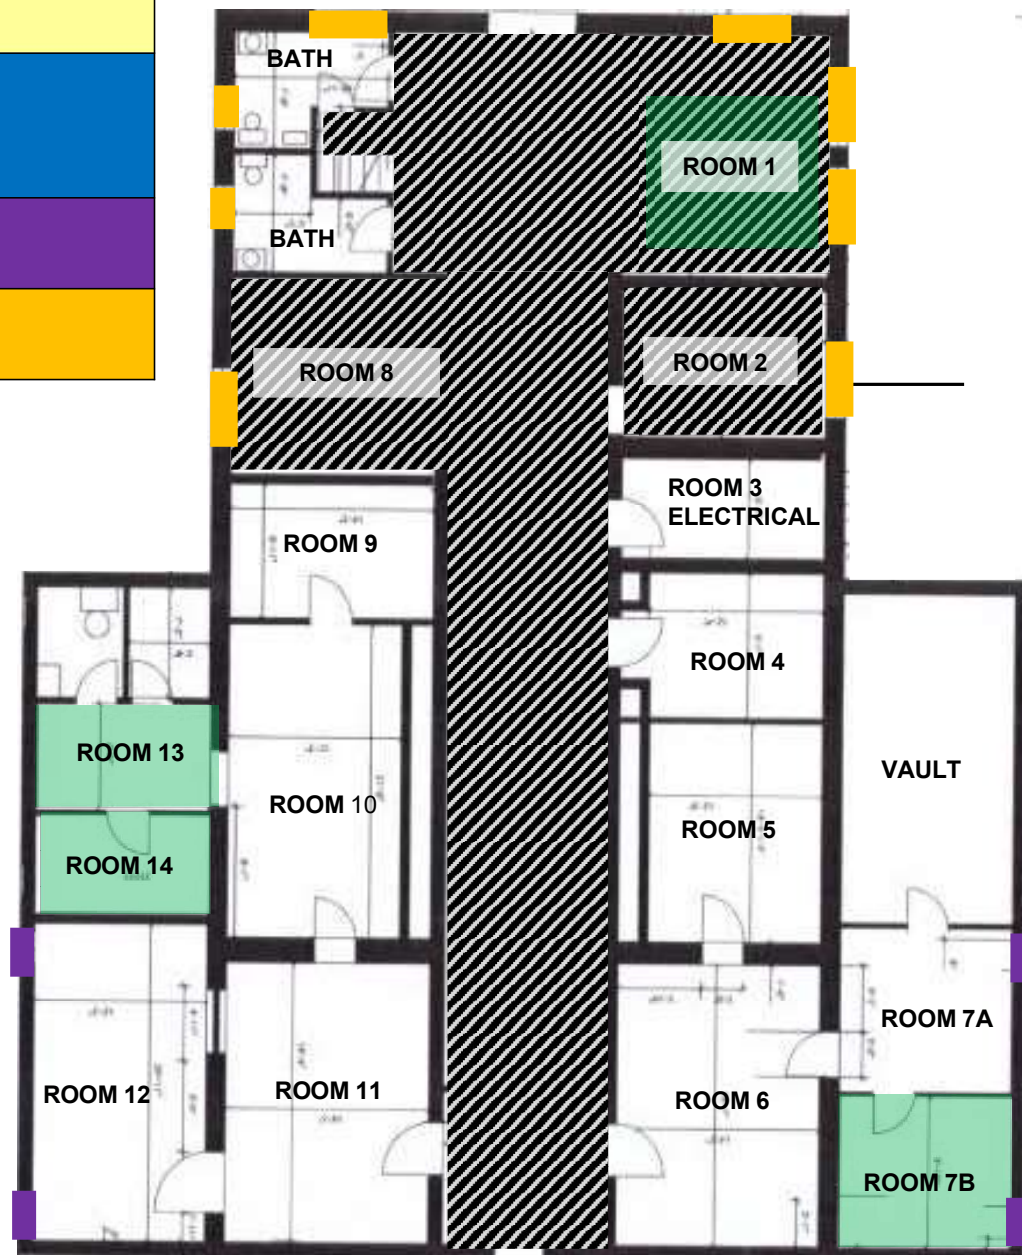
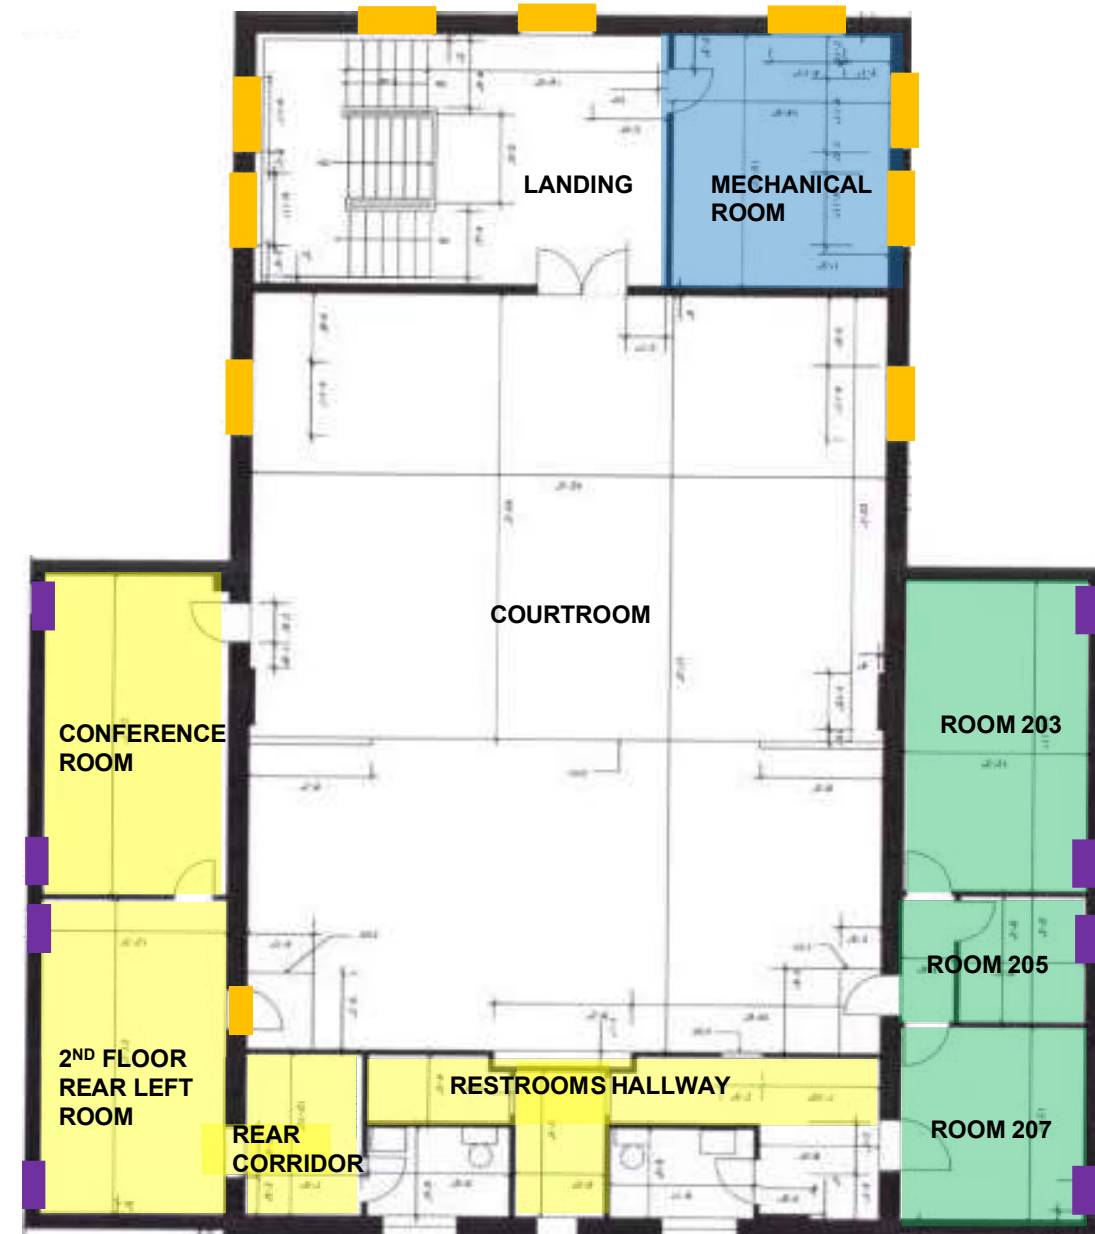
INTERIOR NON_FRIABLE ACM LOCATION MAP	FIGURE
Drawn by: SJM	Scale: N.T.S.			
Checked by: ACD	File Name: FIGURES	2108 Capitol Drive, Suite 103 Wilmington, NC 28405	Southport Former Town Hall 201 E. Moore Street Southport, North Carolina	7
Approved by: AC	Date: 4/5/2024

IDENTIFIED ASBESTOS CONTAINING MATERIAL (ACM)	SYMBOL
9X9 BLACK AND GRAY FLOOR TILES (HA'S 16 AND 17)

12X12 GRAY STREAKED FLOOR TILE AND MASTIC (HA 18)

12X12 OFF WHITE WITH GRAY STREAKS FLOOR TILE RESIDUAL MASTIC (HA28)

12X12 OFF WHITE RESIDUAL FLOOR TILE (HA 29) UNDER HA28 AND HA18 WITH PLYWOOD SEPARATING THE LAYERS

INTERIOR ADDITION WINDOW GLAZING (HA 31)

RESIDUAL ORIGINAL WINDOW CAULK

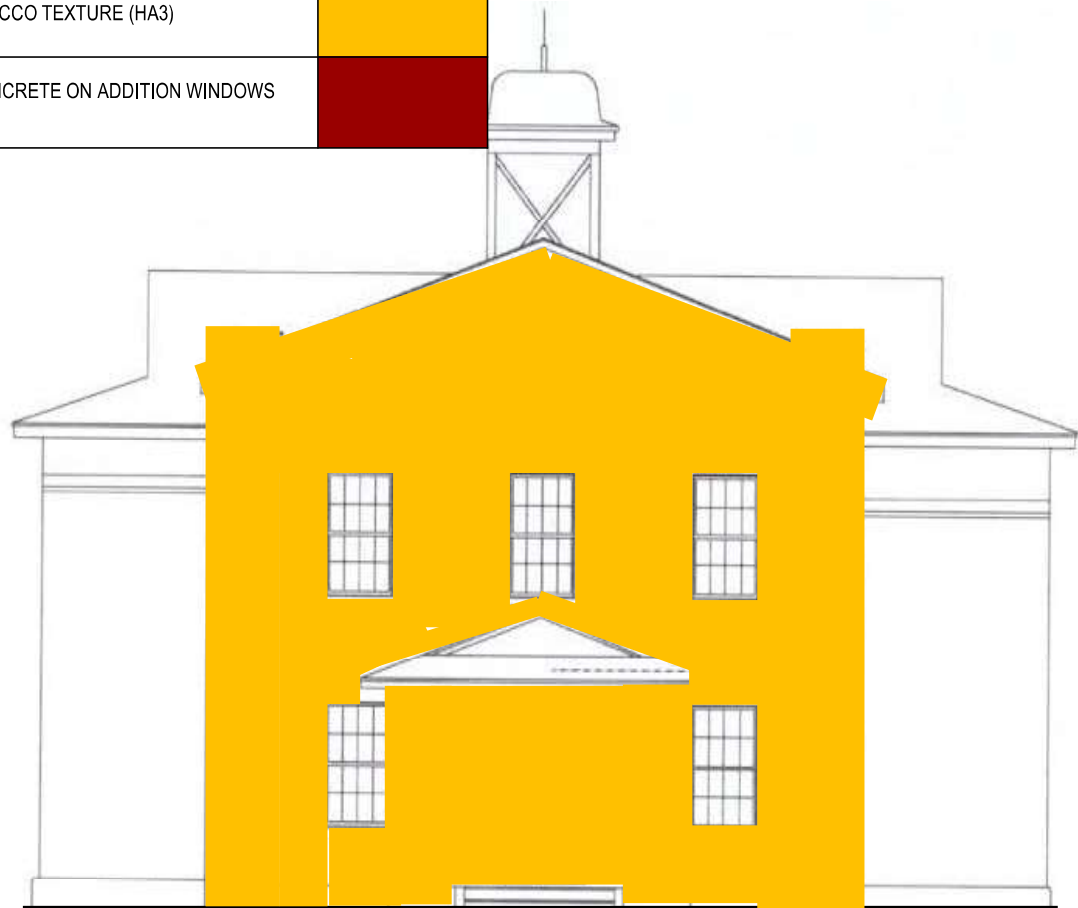
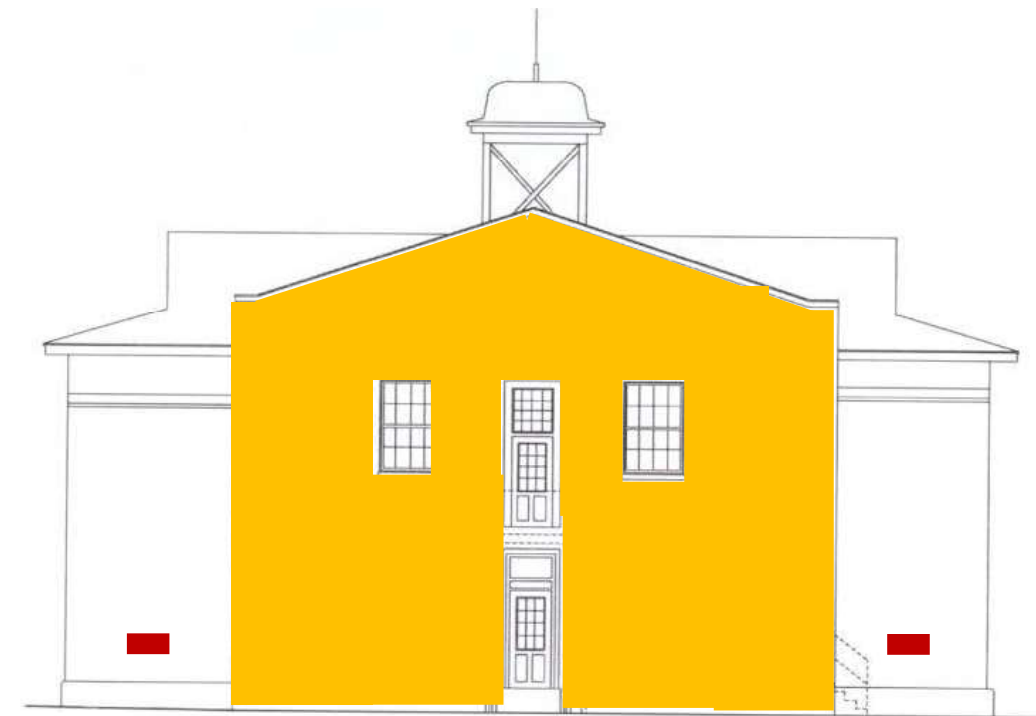
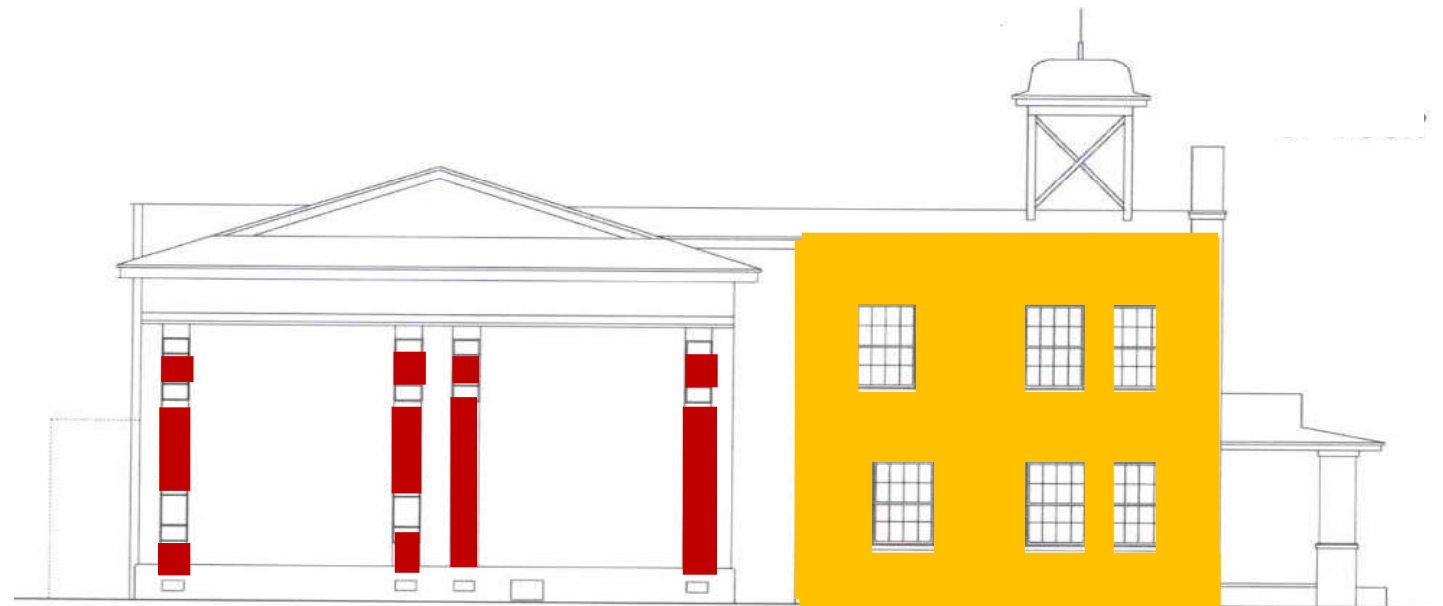
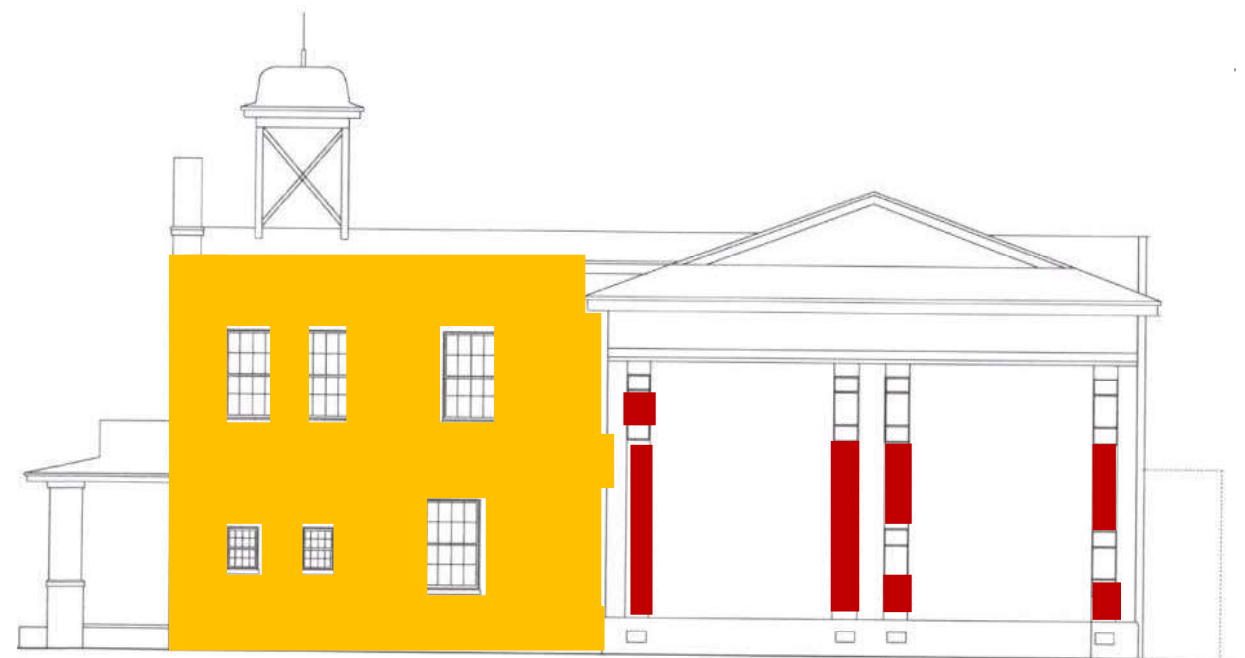
EXTERIOR FRONT ACM SAMPLE LOCATION MAP	FIGURE
Drawn by: SJM	Scale: N.T.S.			
Checked by: ACD	File Name: FIGURES	2108 Capitol Drive, Suite 103 Wilmington, NC 28405	Southport Former Town Hall 201 E. Moore Street Southport, North Carolina	8
Approved by: AC	Date: 4/5/2024

IDENTIFIED ASBESTOS CONTAINING MATERIAL (ACM)	SYMBOL
EXTERIOR STUCCO TEXTURE (HA3)

EXTERIOR CONCRETE ON ADDITION WINDOWS (HA 6)
