Southport Old City Hall Police Conversion

PROPERTY CONDITION ASSESSMENT REPORT

PROPERTY CONDITION ASSESSMENT
OF
SOUTHPORT OLD CITY HALL / UYA
201 E. MOORE STREET
SOUTHPORT, NC 28461

Re: Property Condition Assessment: City of Southport Municipal Building Assessments
201 East Moore Street
Southport, NC 28461

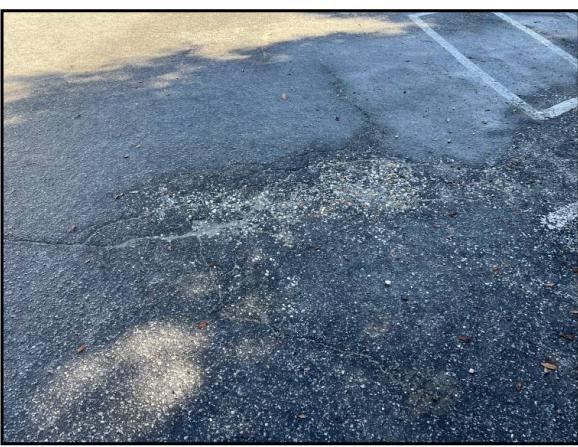
The asphalt drives and parking areas exhibit deteriorated asphalt pavement conditions, characterized by faded striping, alligator cracking, and latitudinal and longitudinal cracking.

Deterioration of the asphalt paved parking area

Recommendation: In the near future, we suggest allocating a budget for comprehensive measures, including complete crack sealing, seal coating, and restriping for all asphalt surfaces. Applying seal coating and crack sealing should be repeated every three to five years. This routine maintenance not only revitalizes the appearance of your parking lot but also prolongs the lifespan of the pavement by an additional 10 to 15 years.

Recommendation	EUL	EFF AGE	RUL	Year	Cost
Complete asphalt replacement w/ restriping				Immed	\$45,000
Total					\$45,000

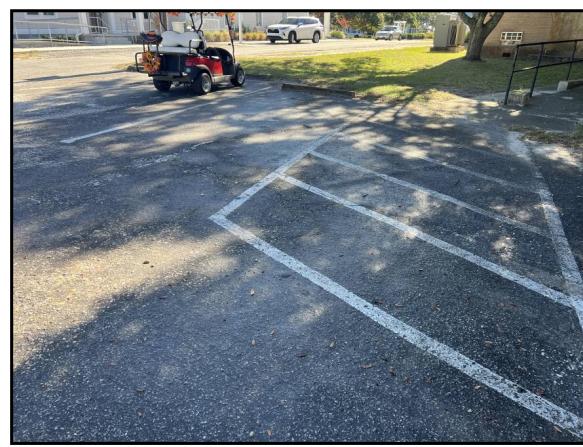
Deterioration of the asphalt paved parking area

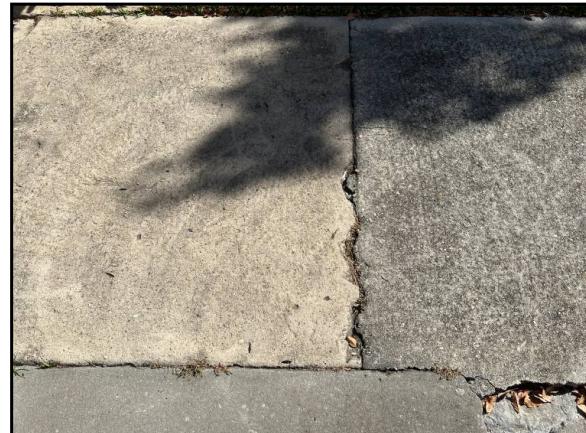
Recommendation: The pedestrian concrete walkways were noted to be generally in fair to poor condition, with isolated instances of cracking and deterioration evident. Similar issues, including cracking and deterioration, were observed along the concrete ADA ramp. Additionally, moderate rusting was noted in various locations along the metal post-supported stairway. It is advisable to address these identified deficiencies, and their correction should be taken into account during budget planning for the subject property.

Cracked and deteriorated concrete walkway

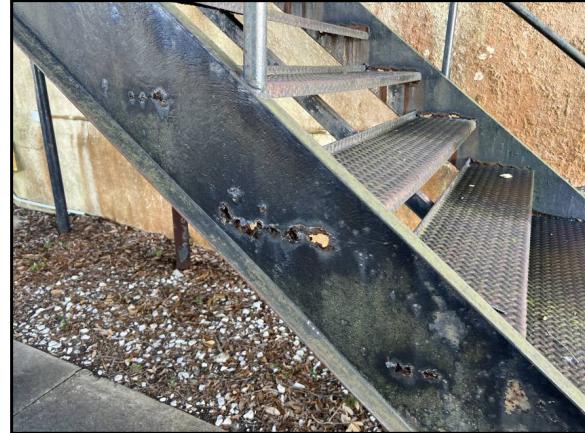
Observed rust at the metal pole supported stairs

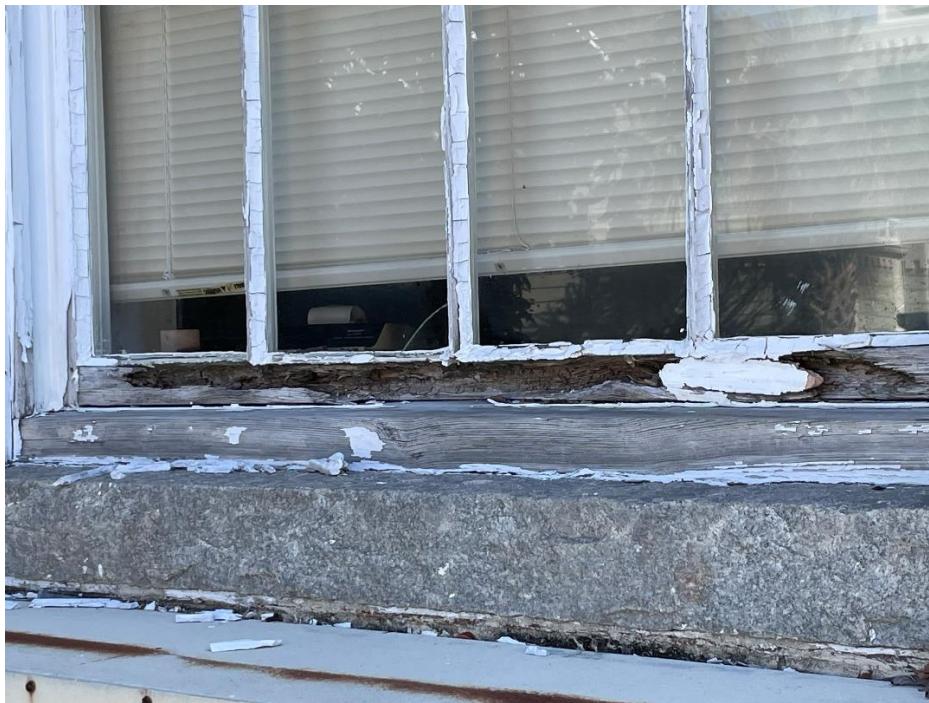
Photograph 3 – View of typical exterior window damage on the east side of the building of the original section.

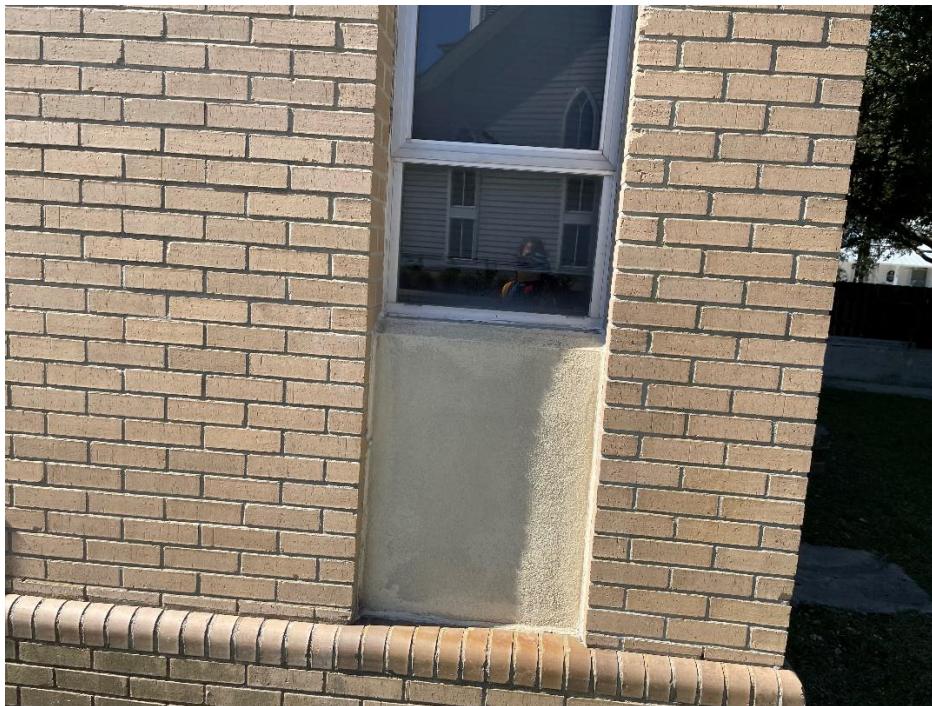
Photograph 4 – View of typical exterior on the east or west wing additions.

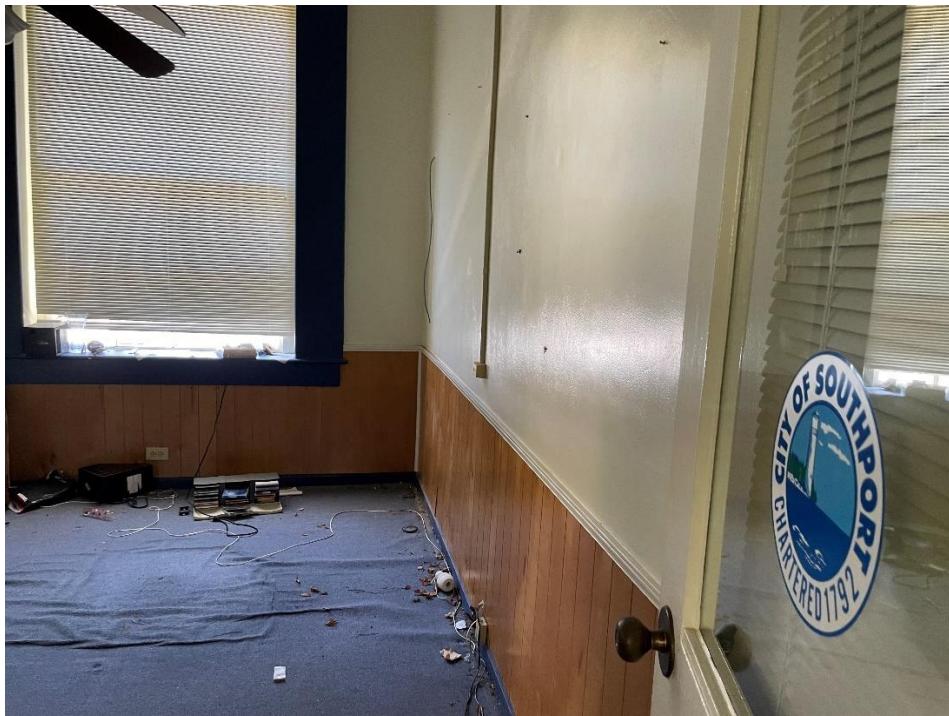
Photograph 5 – View of typical water damage in Rooms 1 and 2.

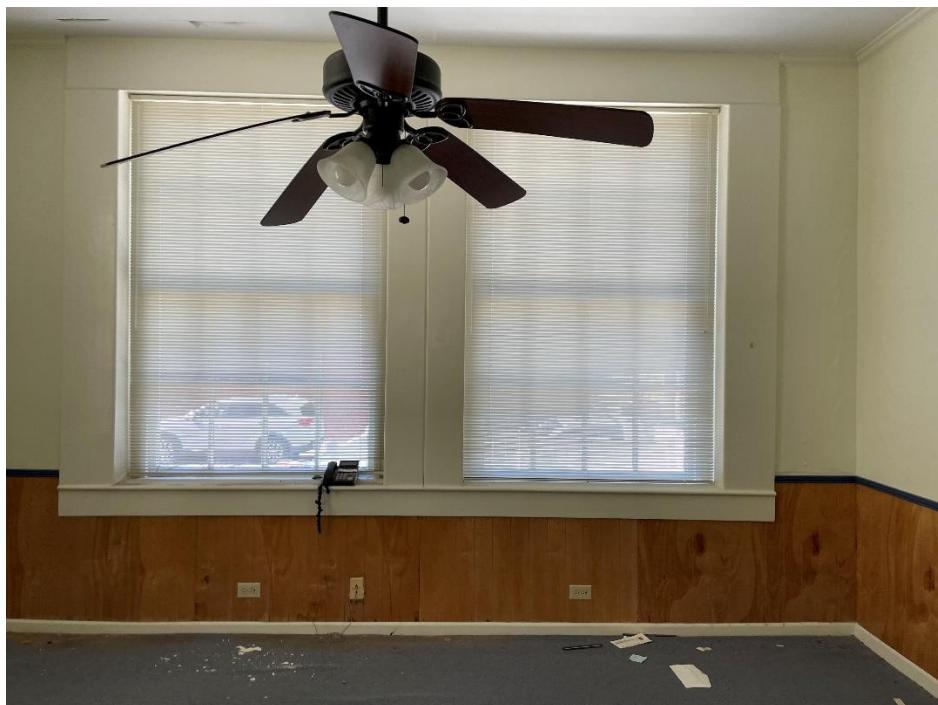
Photograph 6 – View of typical humidity impacted ceiling fan in Rooms 1 and 2.

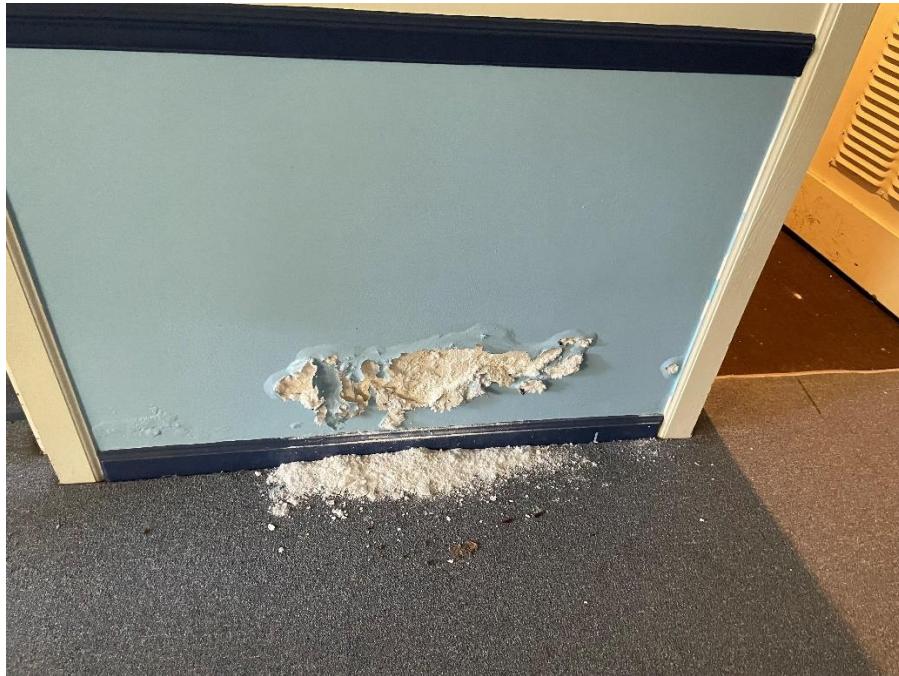
Photo 9 – View of water damage on wall in the first floor hallway.

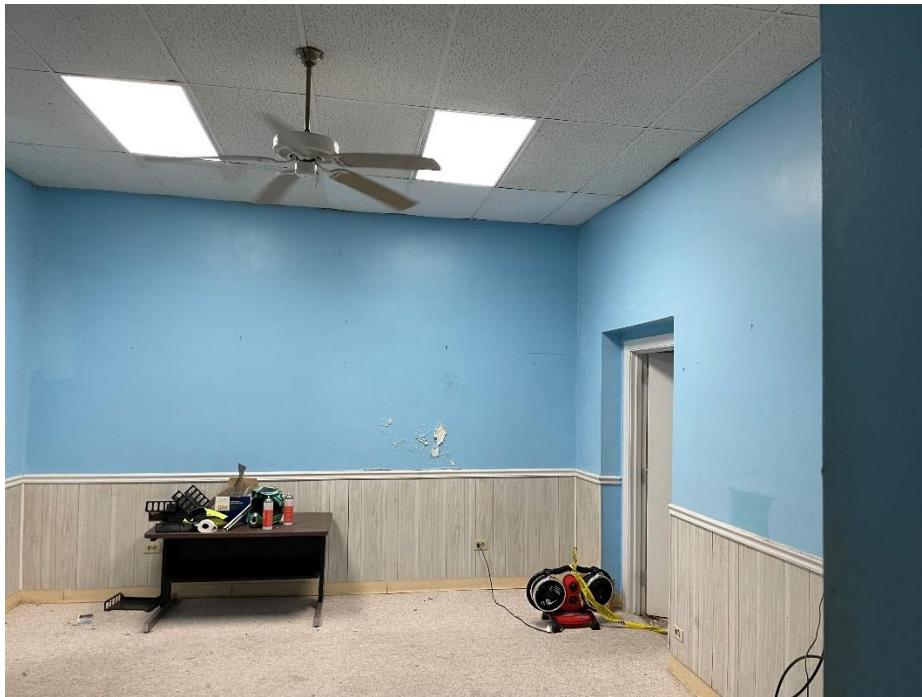
Photo 10 – View of Room 11 with exterior wall water damage.

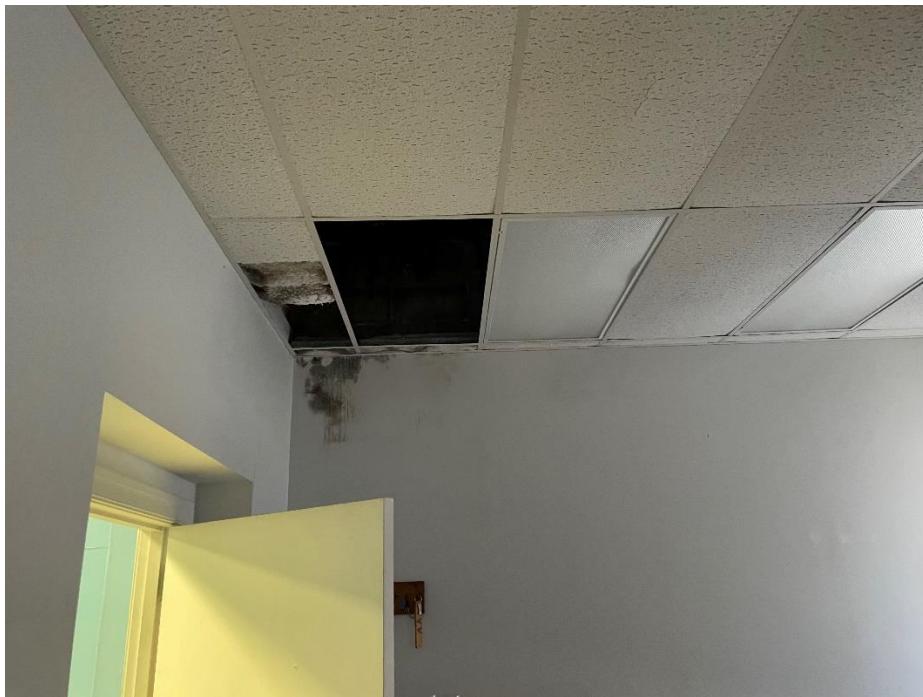
Photo 13 – View of suspected mold and water damage ceiling in Room 12.

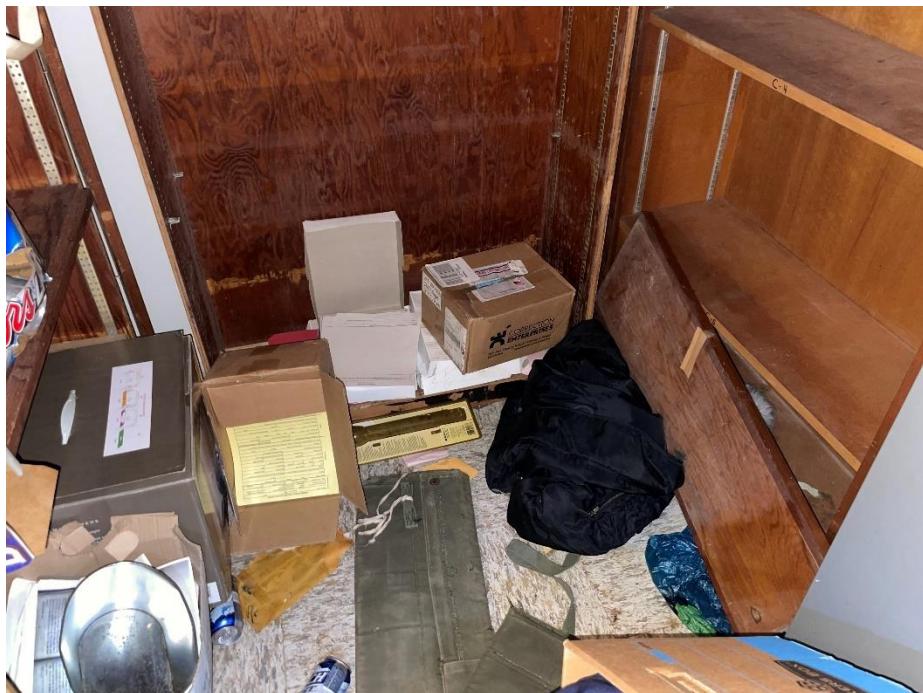
Photo 14 – View of the humidity related suspected mold growth on furniture in Room 14.

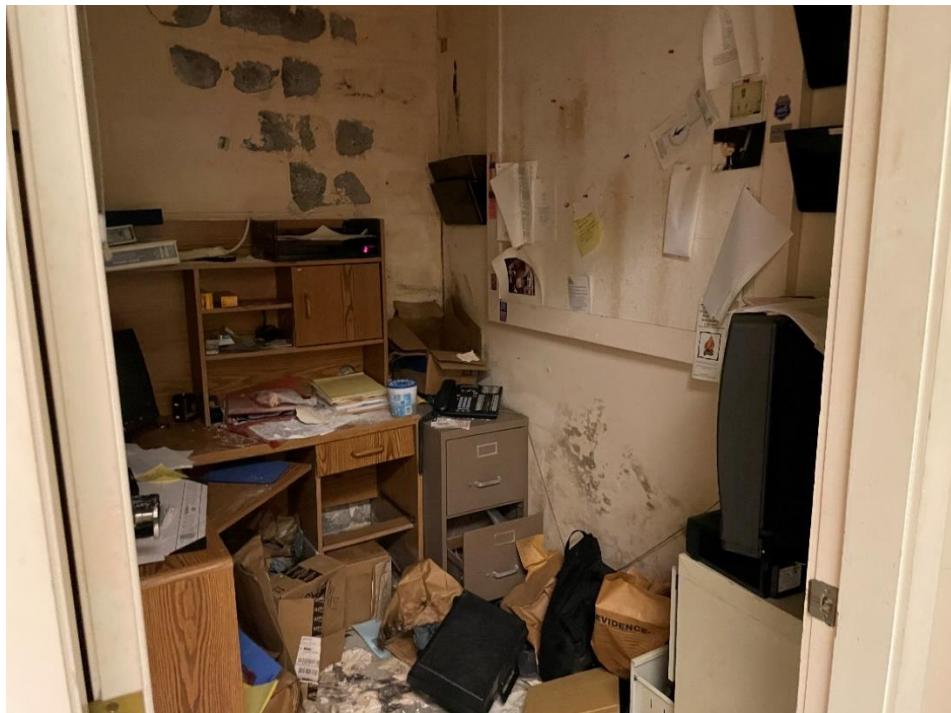
Photo 15 – View of the water damage and suspected mold growth in Room 15.

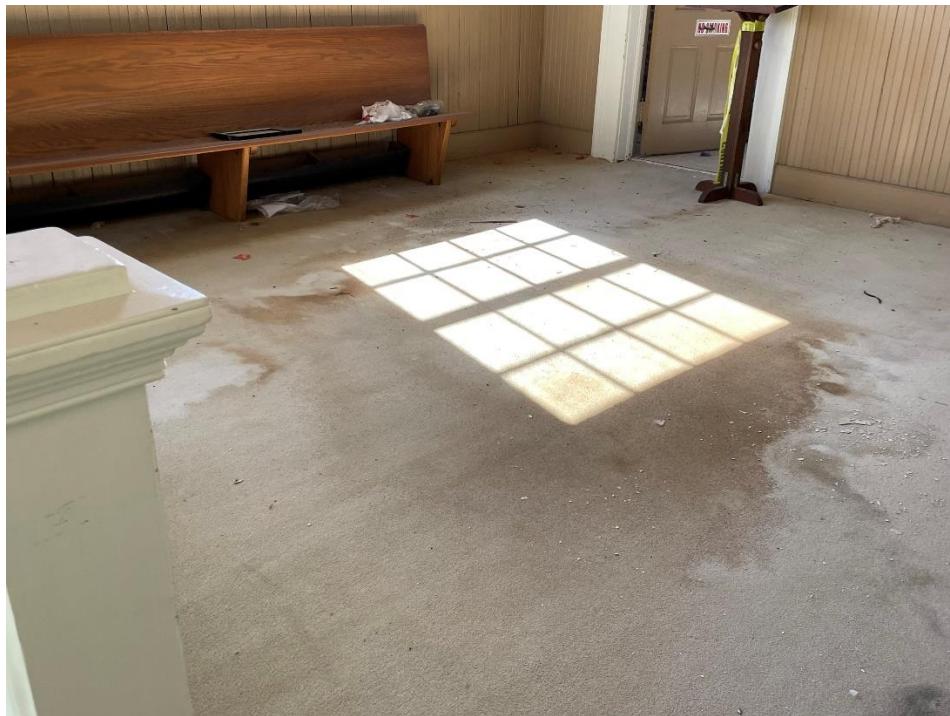
Photo 19 – View of water damage on floor on the second floor landing from a presumed roof leak.

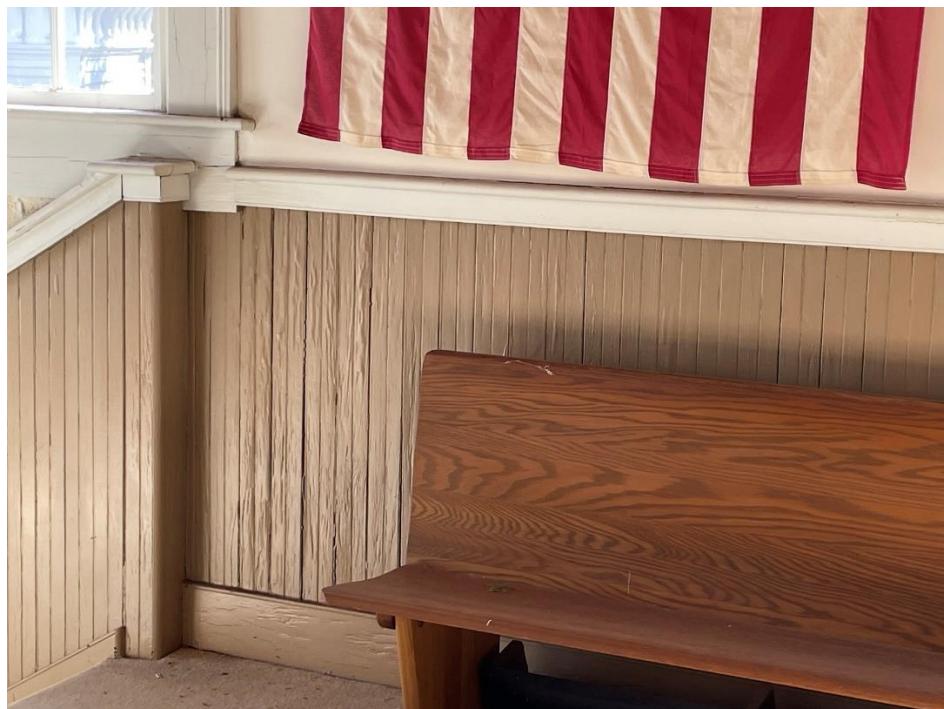
Photo 20 – View of water damage on wainscoting on the second floor landing.

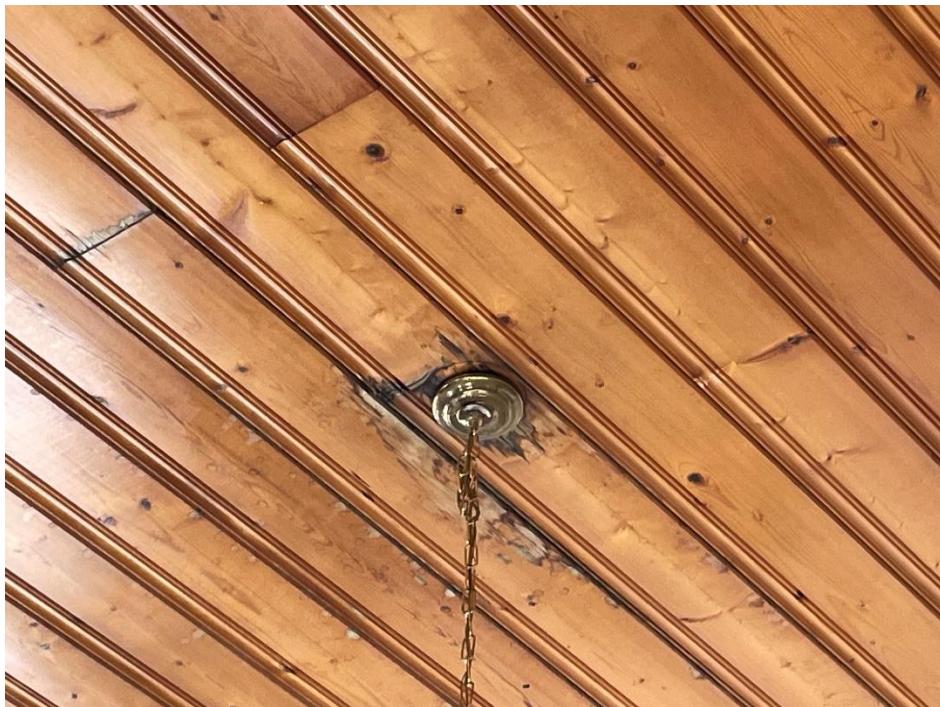
Photo 21 – View of water damage to the wood ceiling on the second floor landing.
This ceiling is present throughout the first floor original section.

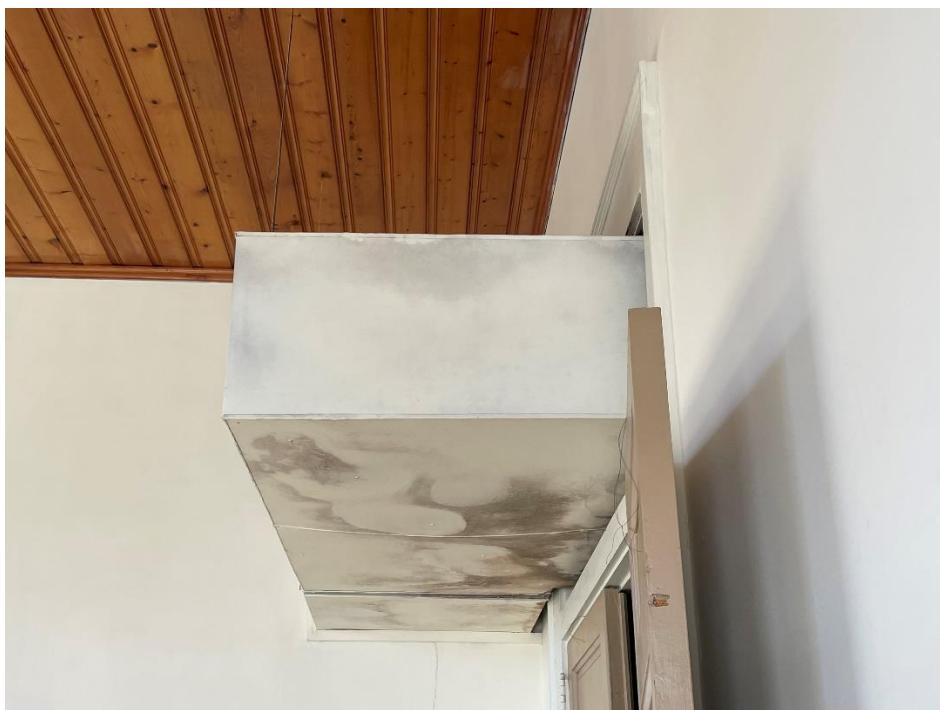
Photo 22 – View of suspected mold on the duct insulation leading into the courtroom.

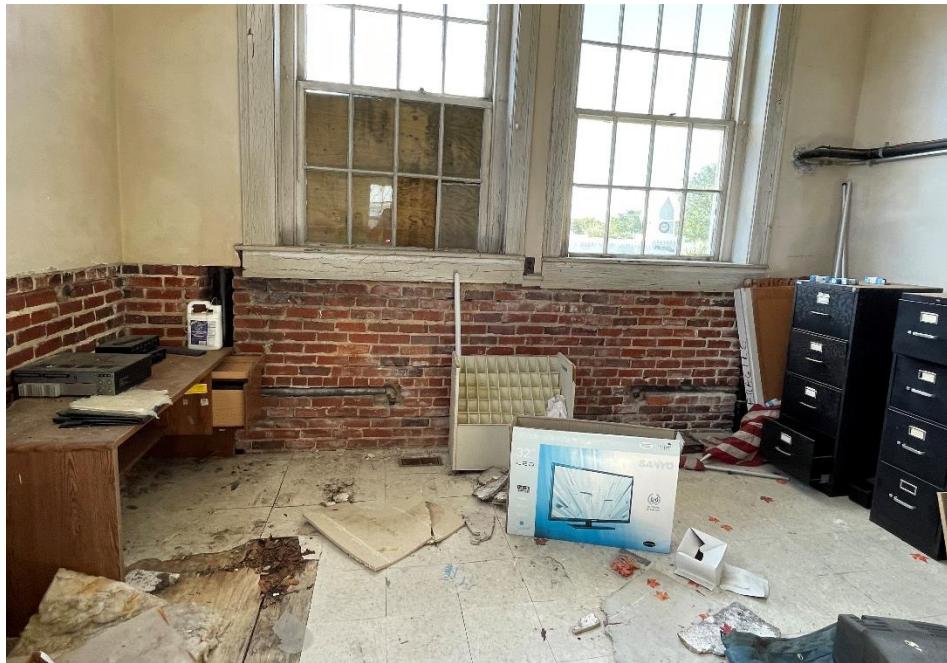
Photo 23 – View of significant water damage in the mechanical room on the second floor.

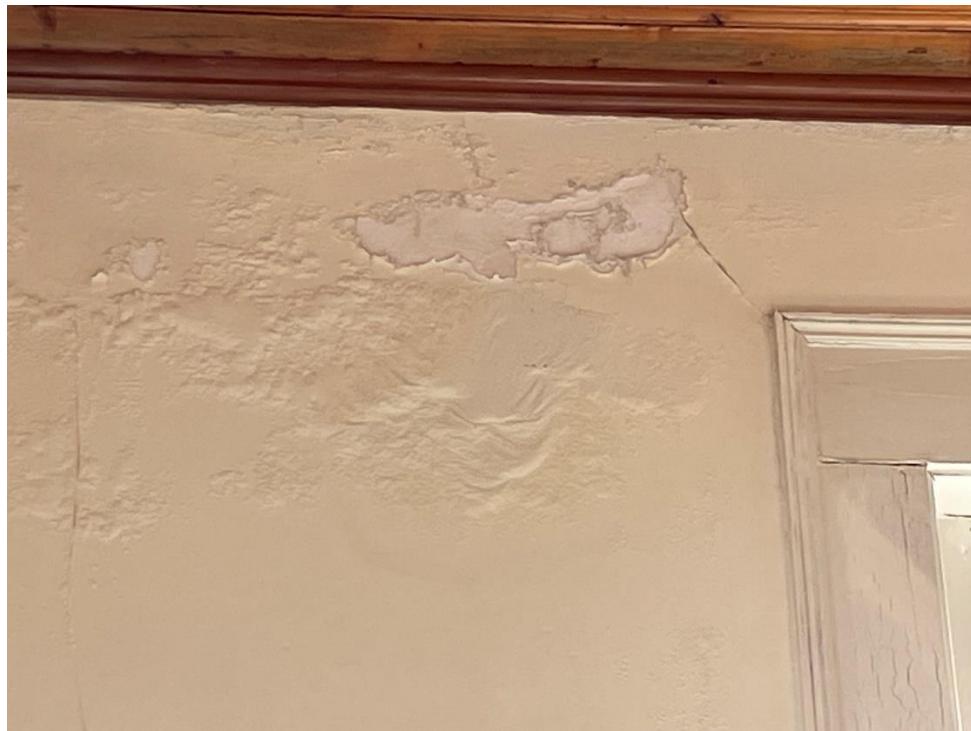
Photo 24 – View of water damaged plaster on the second floor landing.

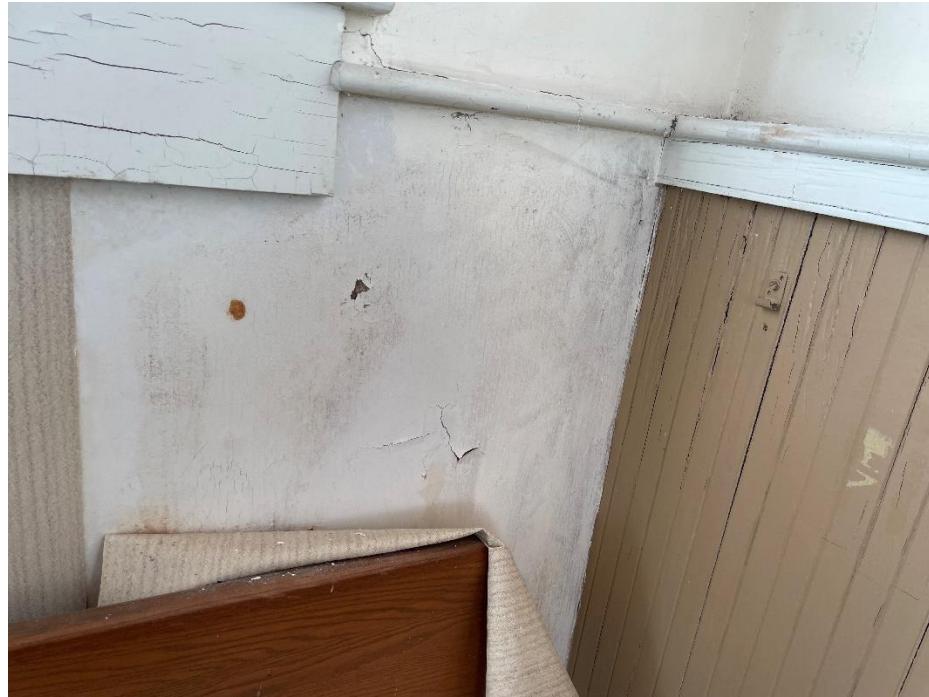
Photo 25 – View of plaster on the second floor landing behind the wallpaper.

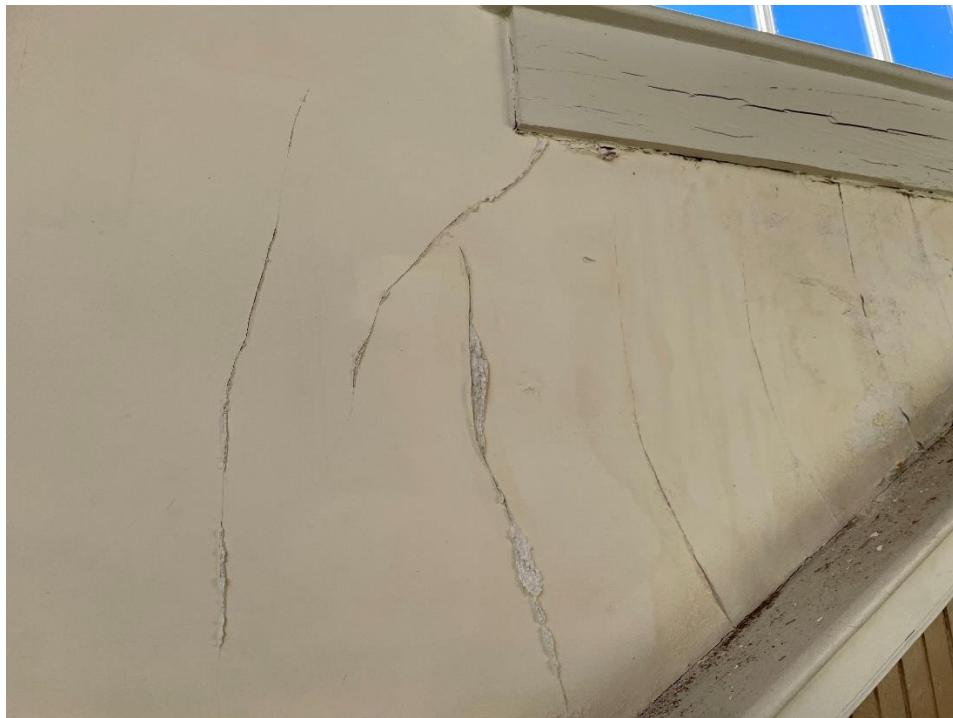
Photo 26 – View of plaster damage on the second floor landing.

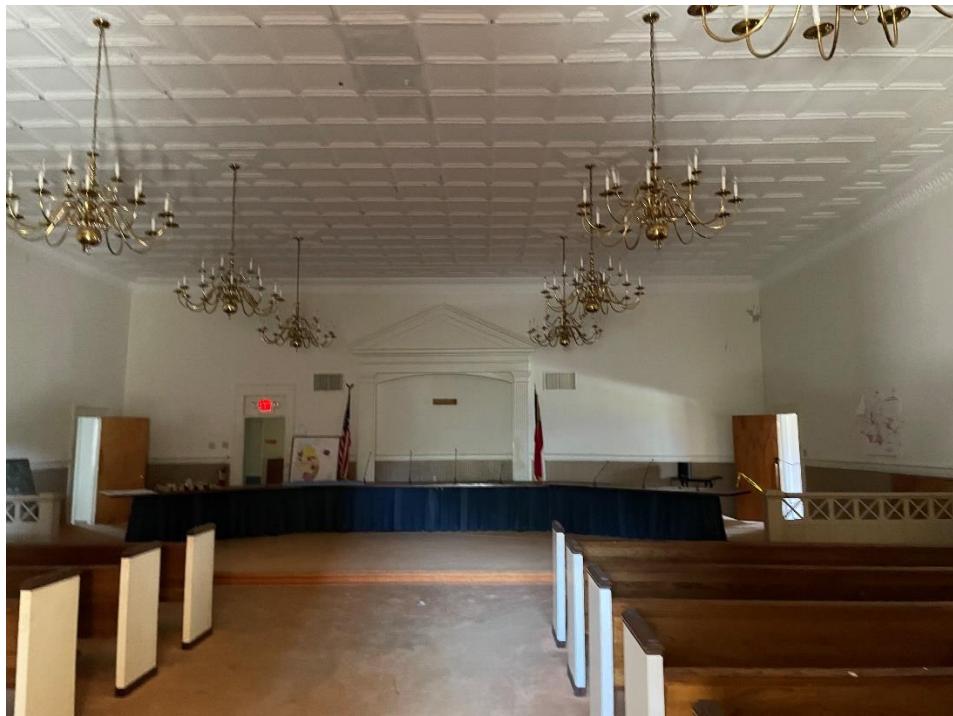
Photo 27 – View of courtroom on the second floor. Assume porous materials are mold impacted (carpet, fabric, benches, etc.).

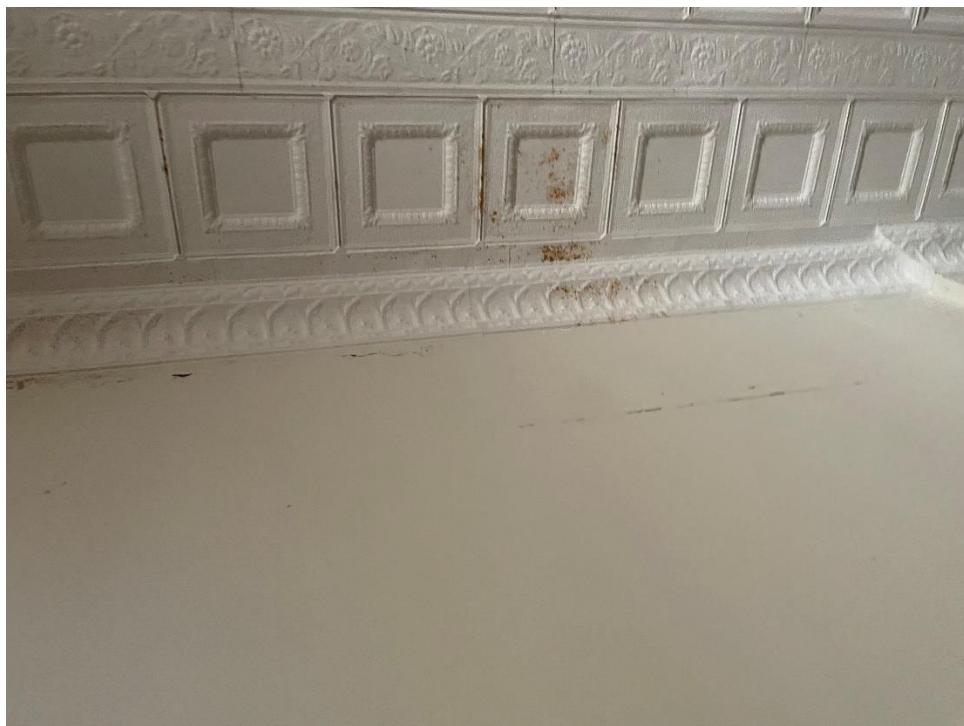
Photo 28 – View of rust on the ceiling tiles in the courtroom.

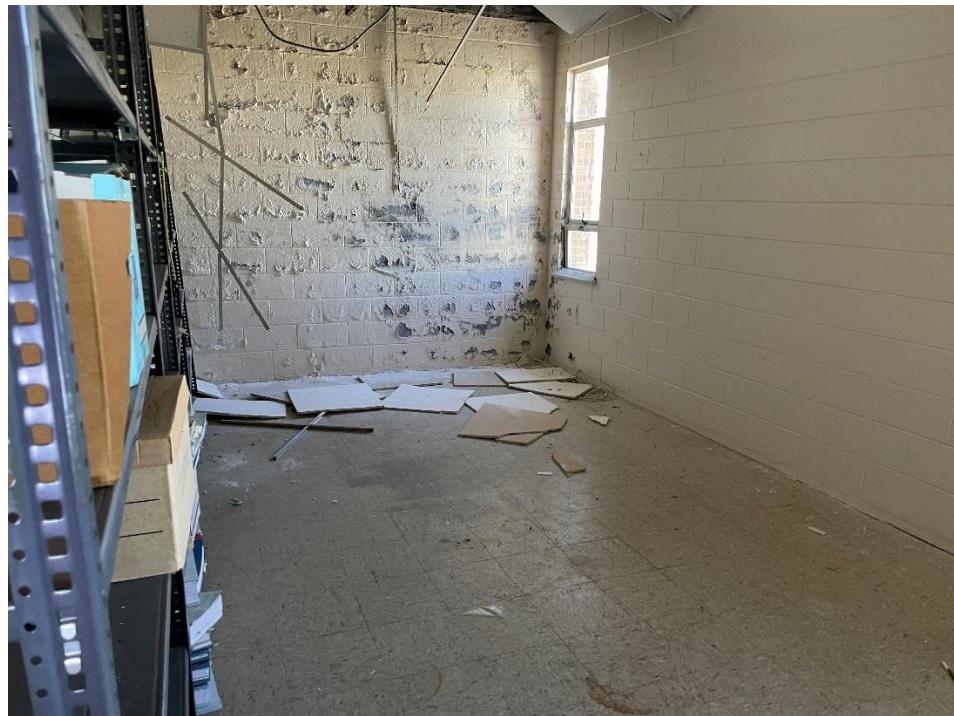
Photo 29 – View of room 203 with water damaged CMU walls.

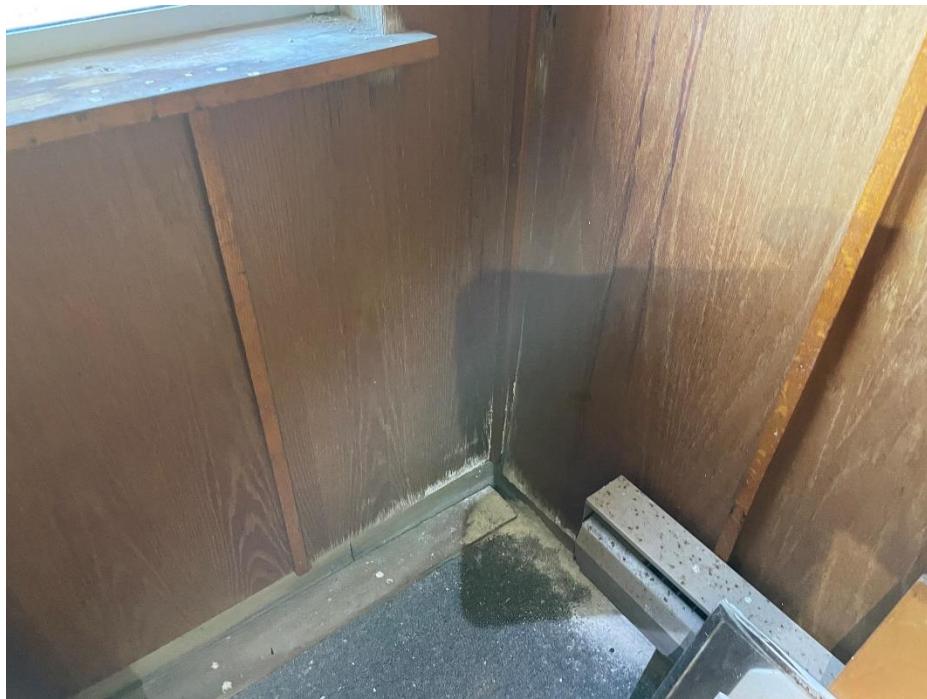
Photo 30 – View of room 207 with suspected mold on the wood paneling and carpet with evidence of CMU wall damage behind.

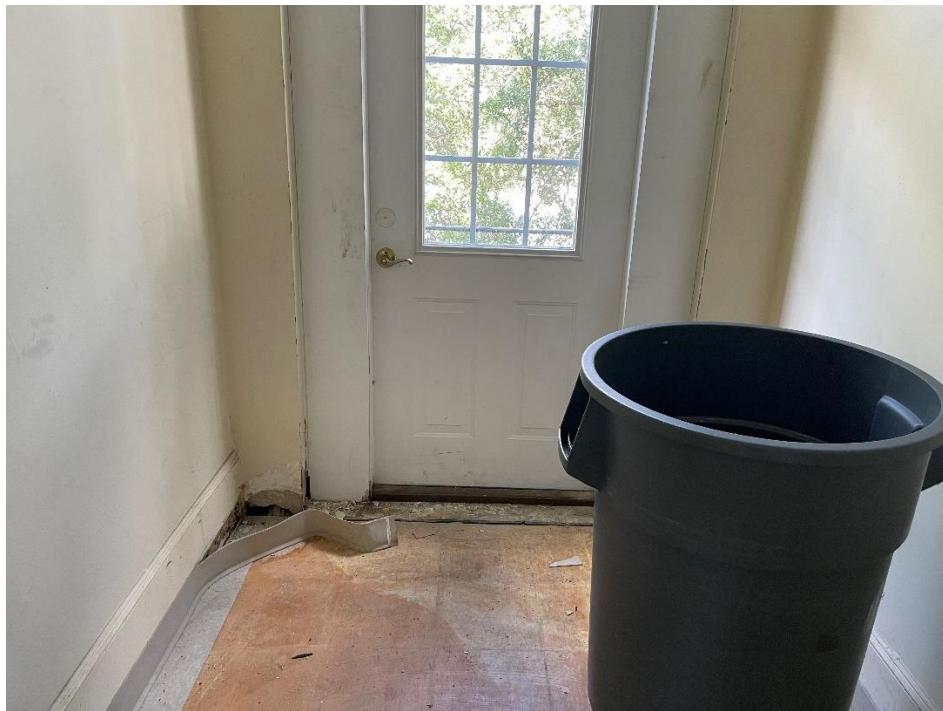
Photo 31 – View of the second floor back door with evidence of water damage around the base.

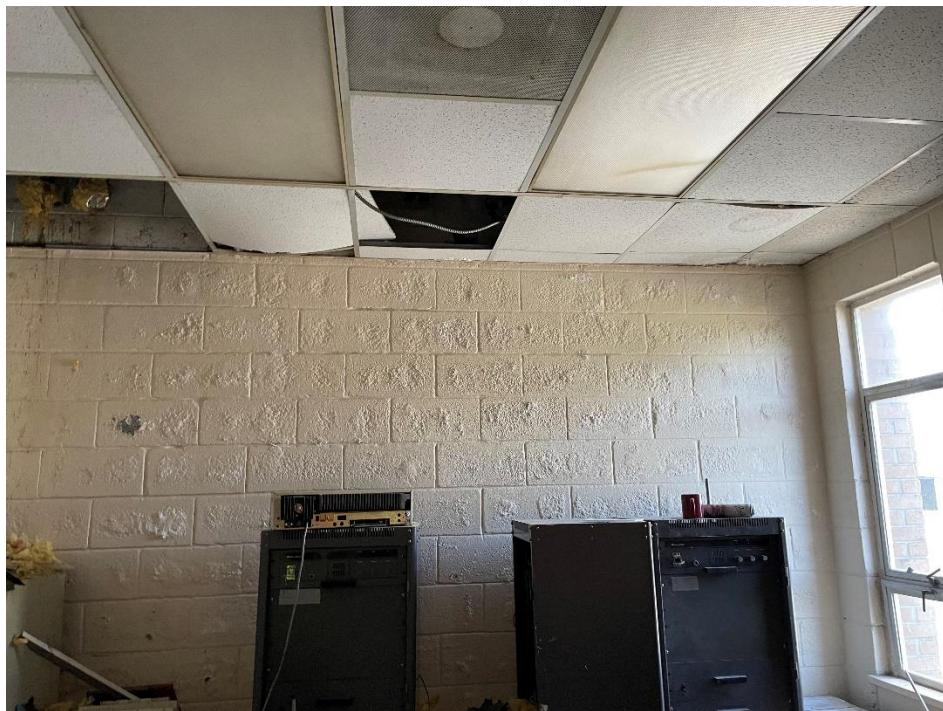
Photo 32 – View of the second floor back room to the right where sunlight (exterior penetrations) were observed along with animal activity.

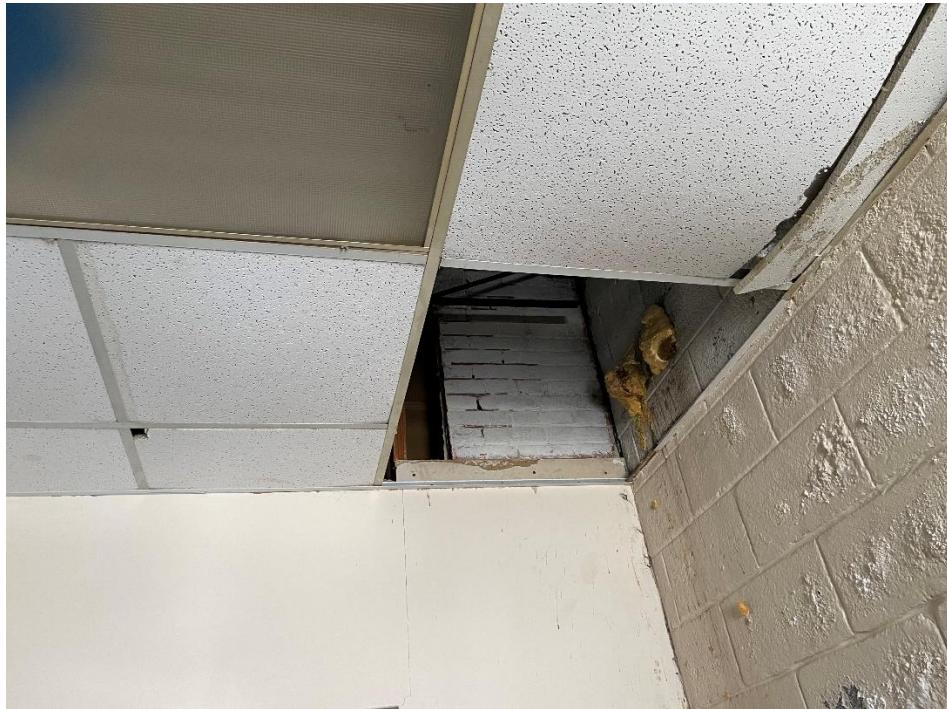
Photo 33 – View of the second floor back area joint of original building to east wing addition, area of suspected mold growth on the first floor.

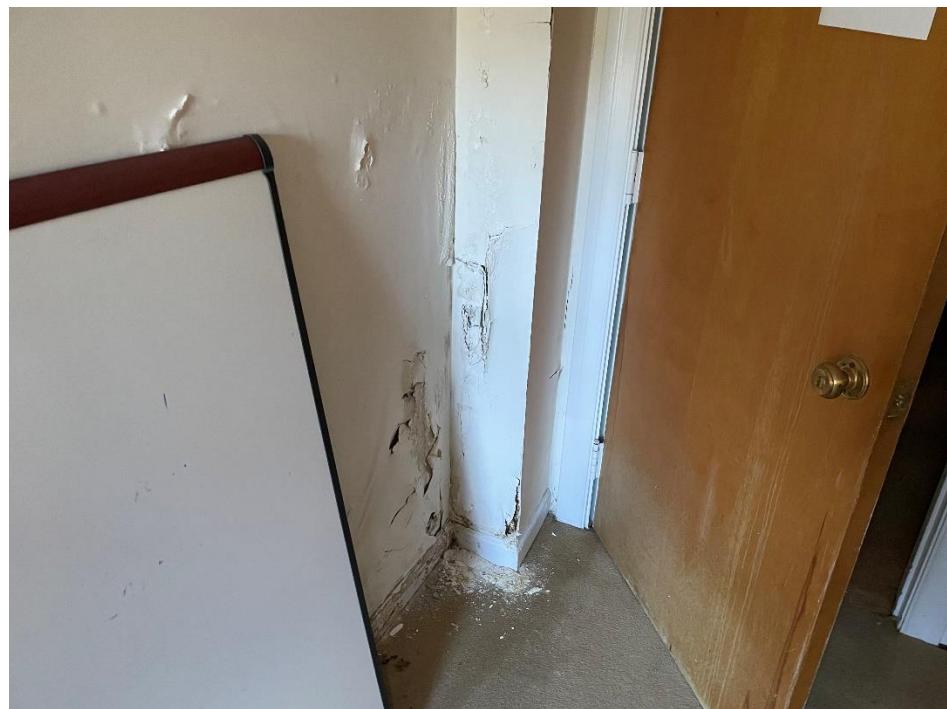
Photo 34 – View of the water damage at second floor conference room, where the east wing abuts the original structure.

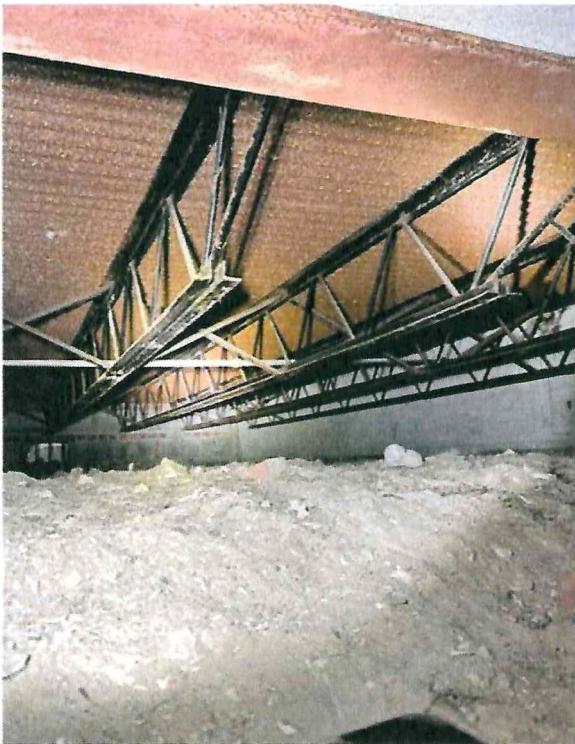
Joists and Metal Decking with Surface Corrosion

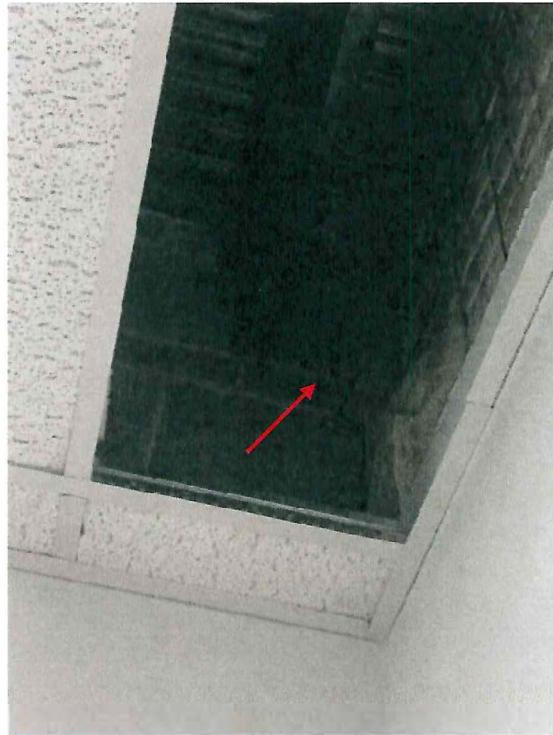
Crack Observed in CMU Wall Above Suspended Ceiling at Interface with Original Masonry Wall

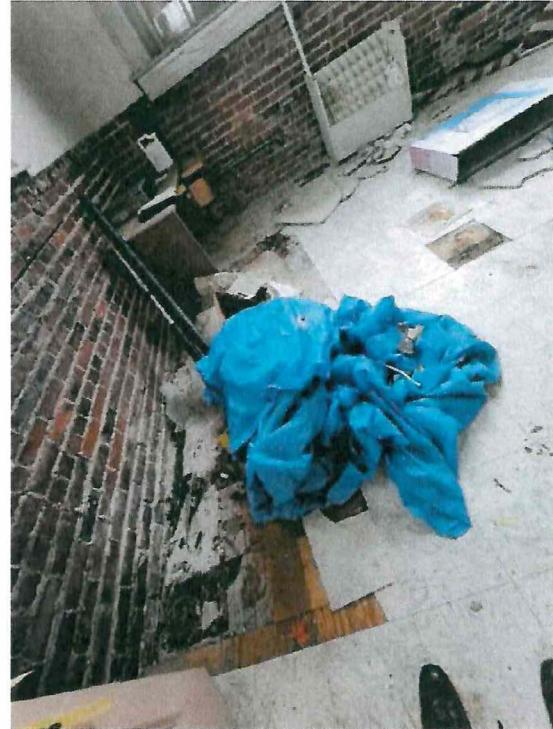
Southwest Corner of Original Building with Water Damage to Floor (Mechanical Room)

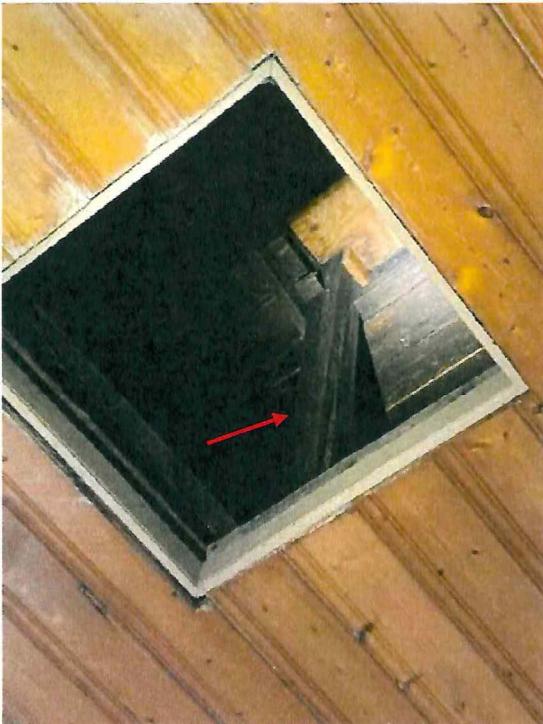
Timber Post Supporting Bell Tower (Active Water Leak Observed at all Four Posts at Roof Interface)

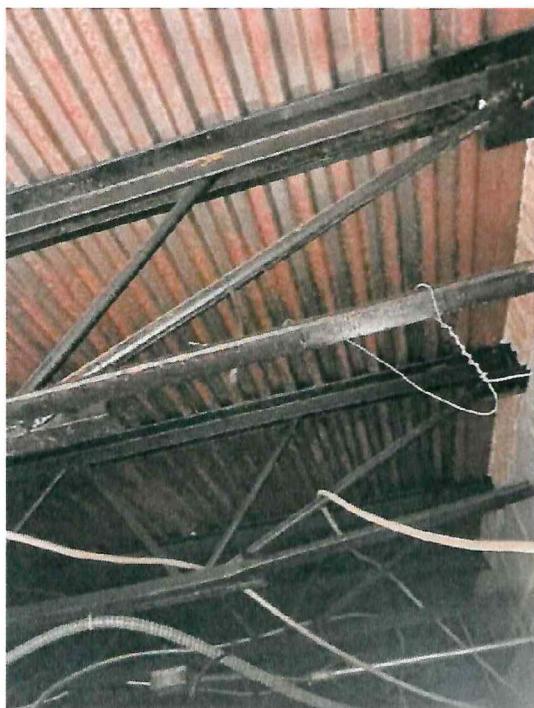
Metal Decking with Surface Corrosion

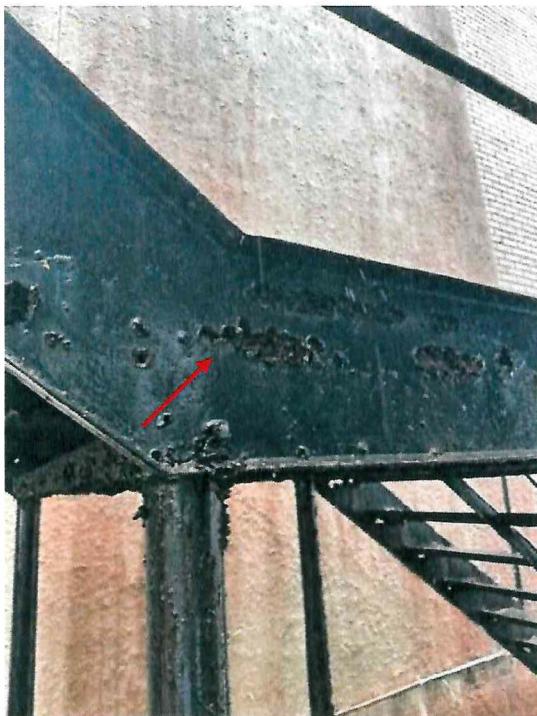
*Northern Stair Entrance with Severe Corrosion and Deterioration – **UNSAFE CONDITION***

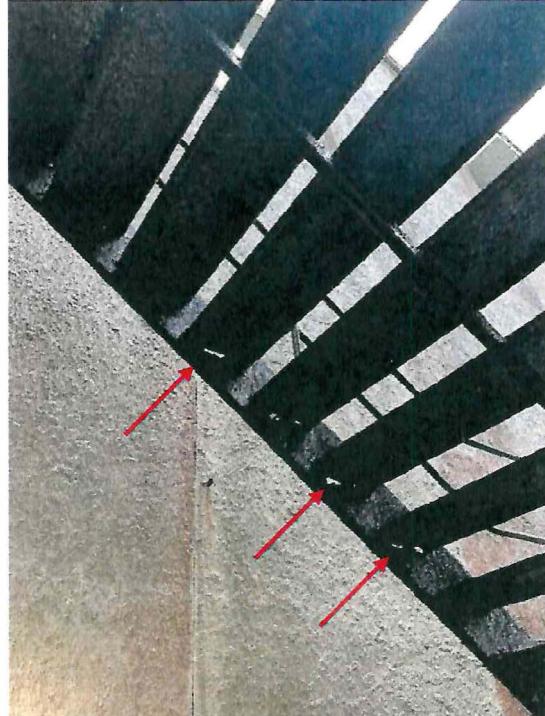
*Northern Stair Stringers with Severe Corrosion – **UNSAFE CONDITION***

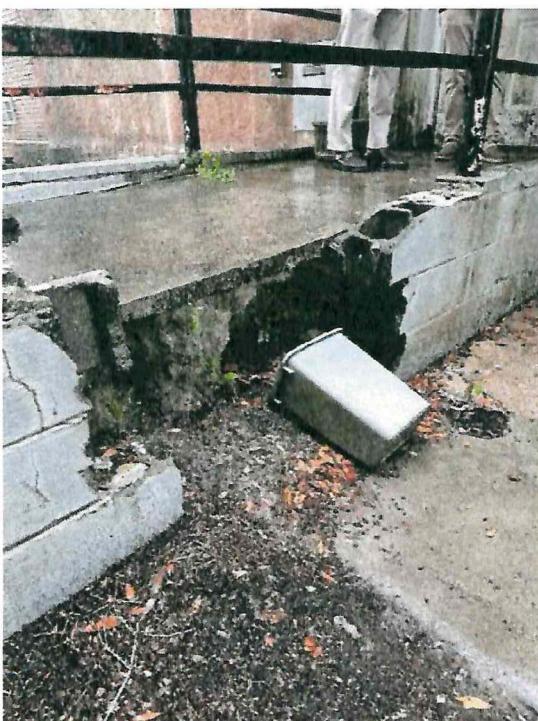
CMU Failure and Undermined Concrete Slab at West Side of North Exterior Ramp

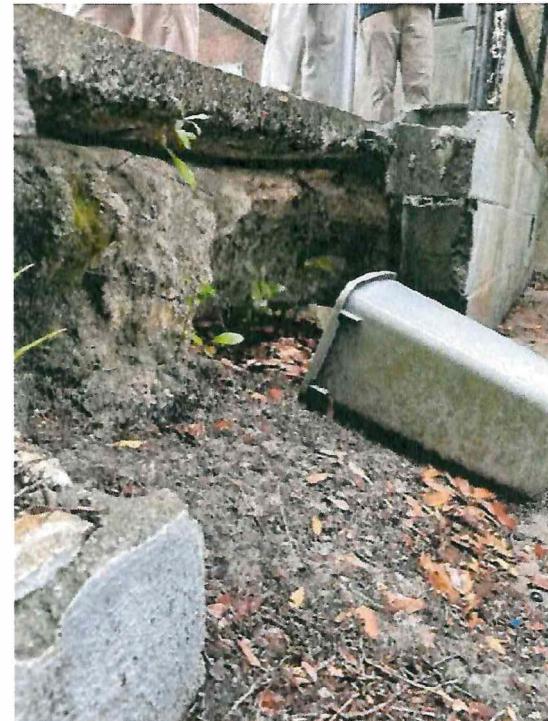
CMU Failure and Undermined Concrete Slab at West Side of North Exterior Ramp

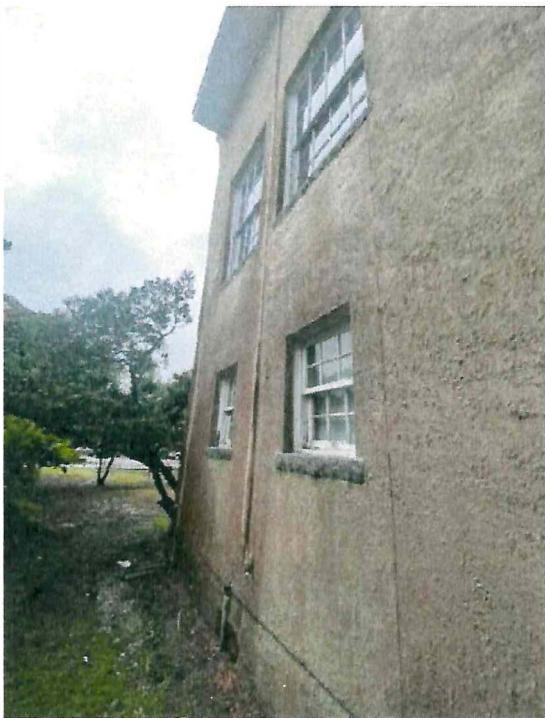
Eastern Wall Exhibiting Efflorescence

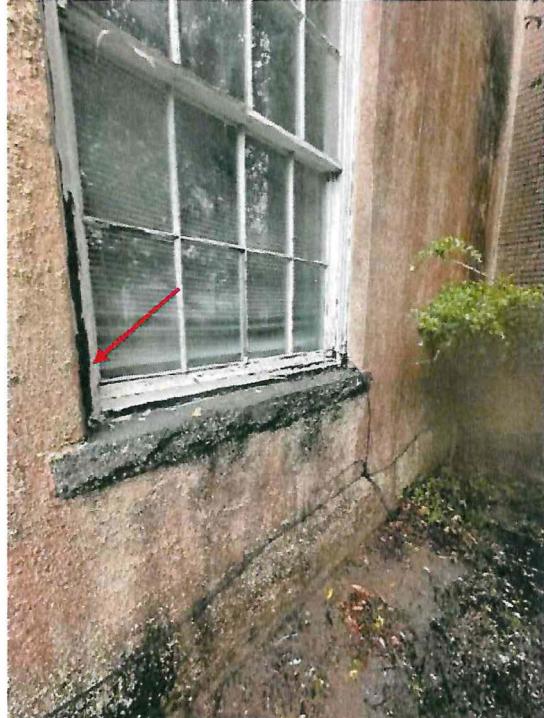
Typical Condition of Severely Deteriorated Wood Window Framing
