Southport Old City Hall Police Conversion

PROPERTY CONDITION ASSESSMENT REPORT

PROPERTY CONDITION ASSESSMENT
OF
SOUTHPORT OLD CITY HALL / UYA
201 E. MOORE STREET
SOUTHPORT, NC 28461

Re: Property Condition Assessment: City of Southport Municipal Building Assessments
201 East Moore Street
Southport, NC 28461

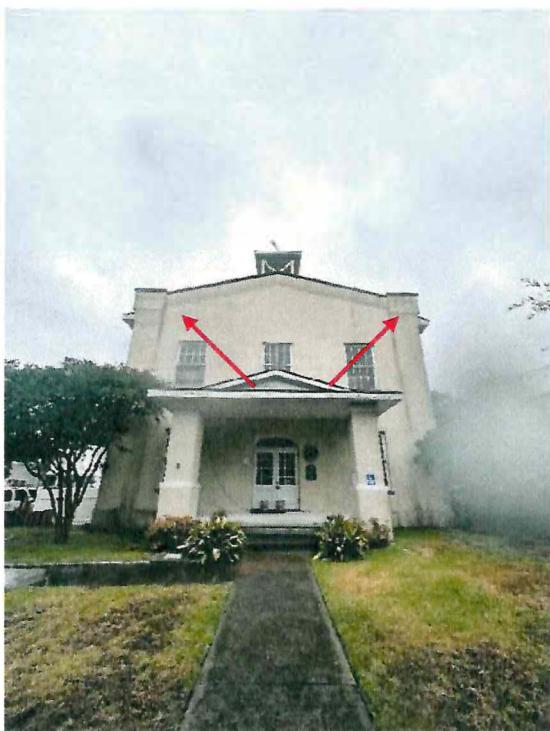
Southern Corbels and Walls of the Original Building Appear to be Experiencing Staining from High Concentrations of Moisture

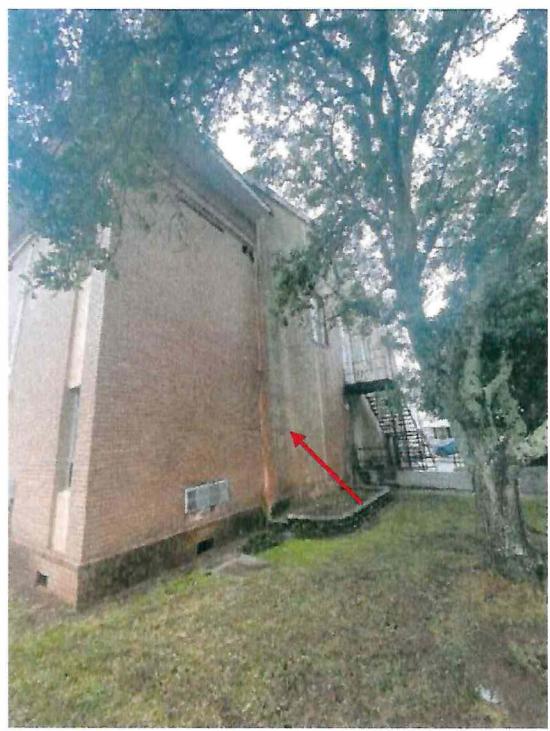
Joint Between the Northern Wall of the Original Building and the East Wing Appears to be Exhibiting Staining Along its Full Height

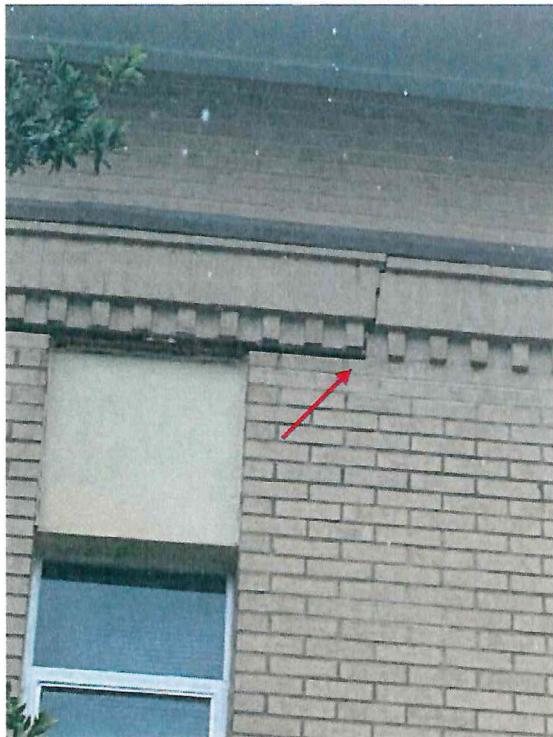
Advanced Lintel Corrosion and Joint Crack Above Window

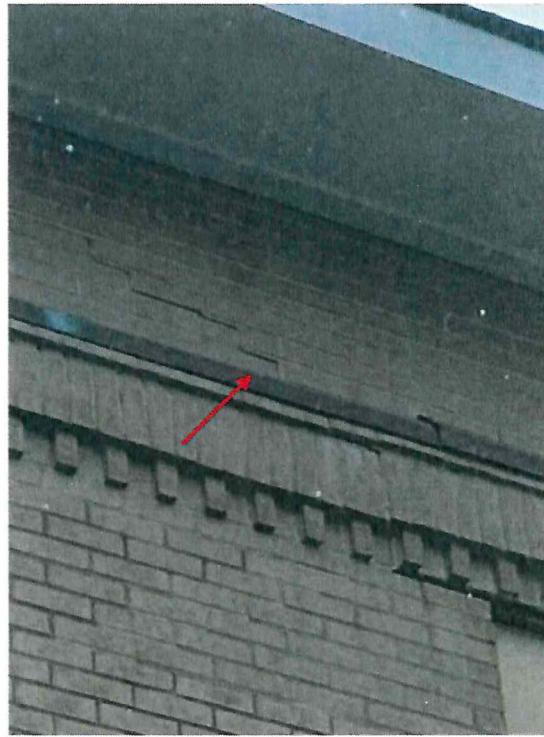
Stair Step Mortar Joint Crack
