Southport Old City Hall Police Conversion

PROPERTY CONDITION ASSESSMENT REPORT

PROPERTY CONDITION ASSESSMENT
OF
SOUTHPORT OLD CITY HALL / UYA
201 E. MOORE STREET
SOUTHPORT, NC 28461

Re: Property Condition Assessment: City of Southport Municipal Building Assessments
201 East Moore Street
Southport, NC 28461

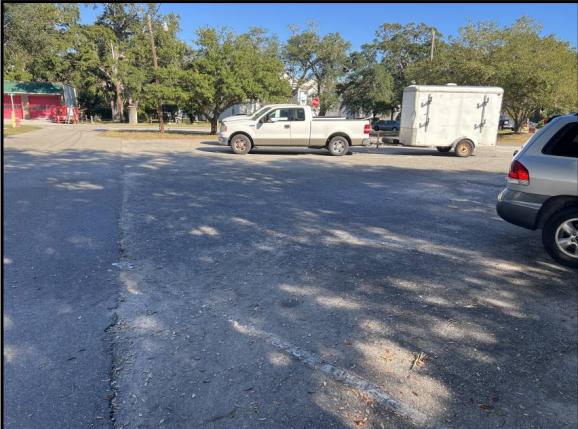
Current condition of asphalt paved parking area

It is recommended to address these issues through isolated repairs and replacements, which can be carried out as a regular maintenance activity as the need arises.

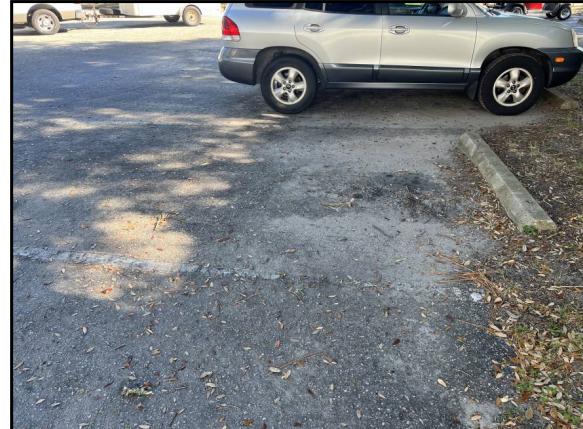
Deterioration of the asphalt paved parking area

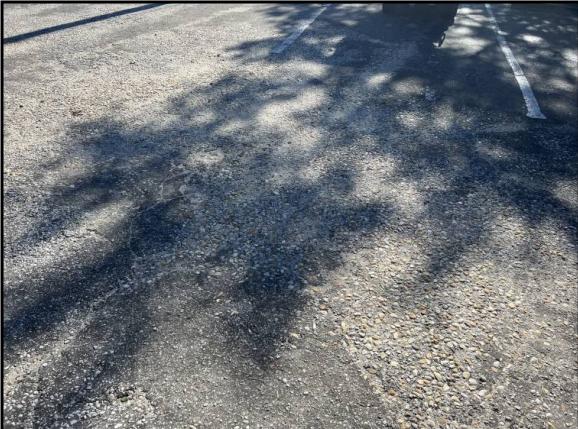
Deterioration of the asphalt paved parking area

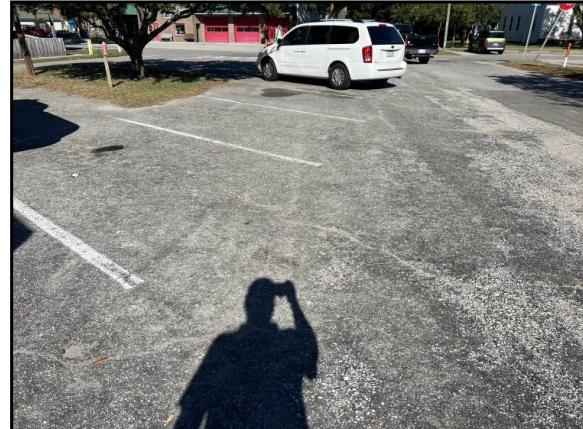
Faded parking stripping and deterioration of asphalt paved parking area

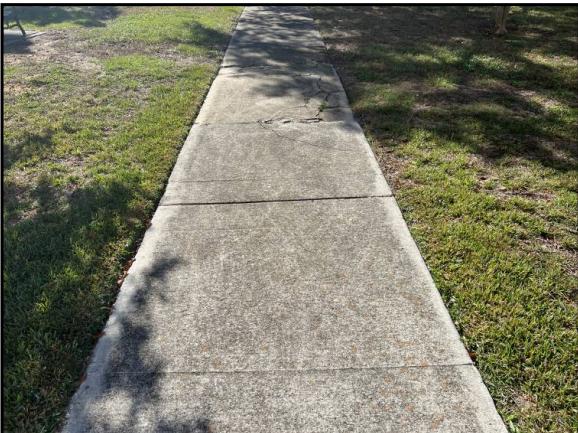
Recommendation: The pedestrian concrete walkways were noted to be generally in fair to poor condition, with isolated instances of cracking and deterioration evident. Similar issues, including cracking and deterioration, were observed along the concrete ADA ramp. Additionally, moderate rusting was noted in various locations along the metal post-supported stairway. It is advisable to address these identified deficiencies, and their correction should be taken into account during budget planning for the subject property.

Current condition of concrete walkway

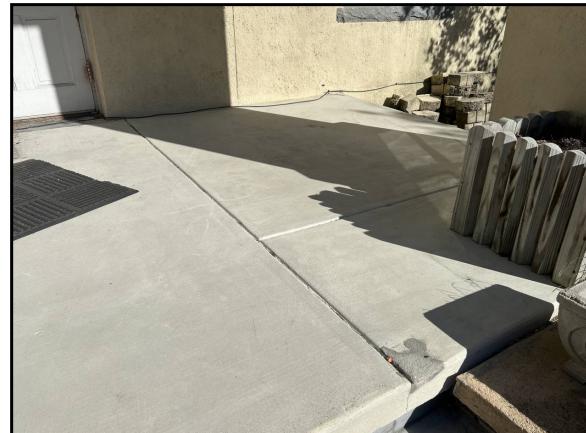
Current condition of the concrete porch at the front main entrance

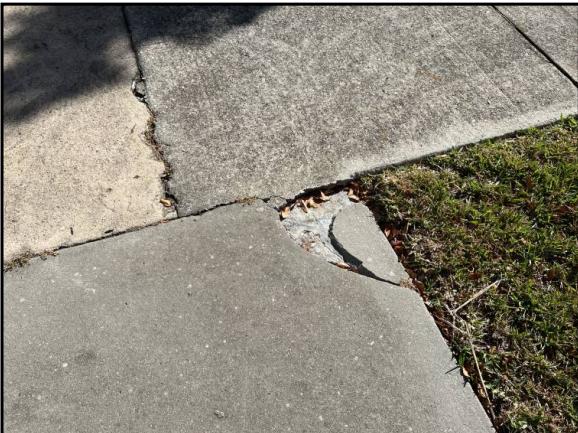
Cracked and deteriorated concrete walkway

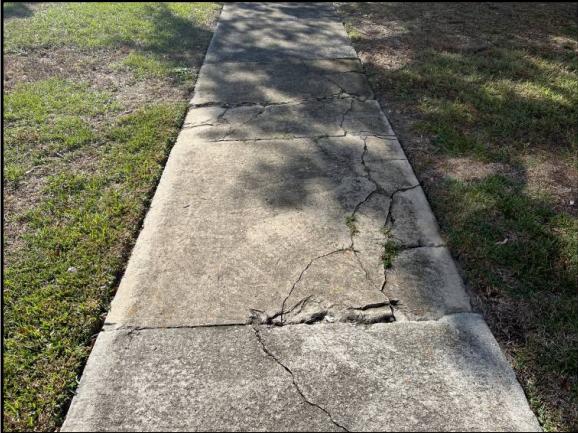
Cracked and deteriorated concrete walkway

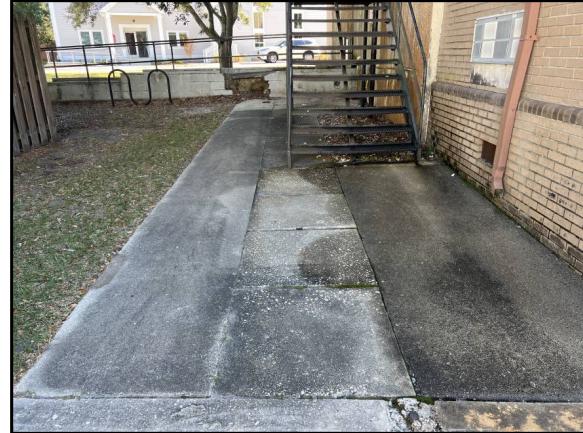
Current condition of concrete walkway at the rear of the building

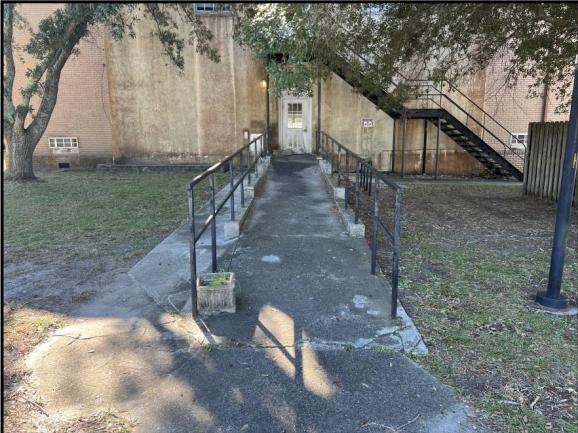
Concrete ADA ramp that provided access to the rear entrance

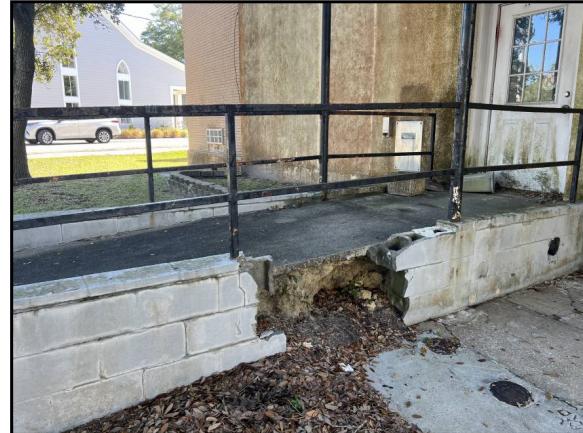
Damage and deterioration of foundation wall for the ADA concrete ramp

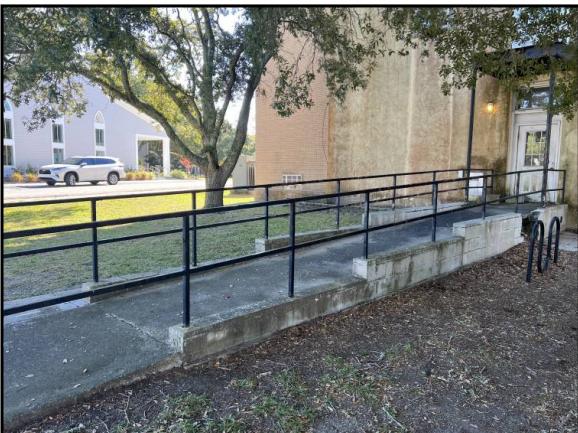
Current condition of metal railings along the concrete ADA ramp

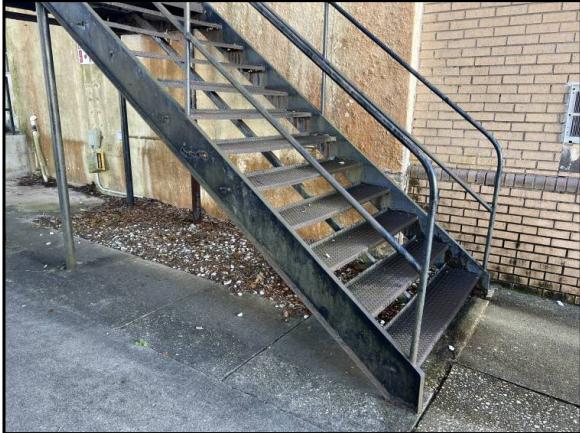
Observed rust at the metal pole supported stairs

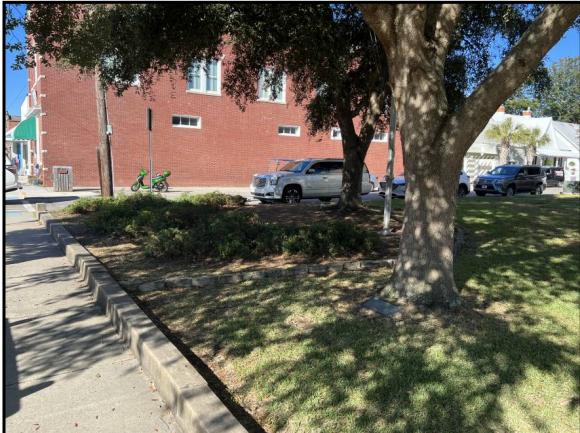
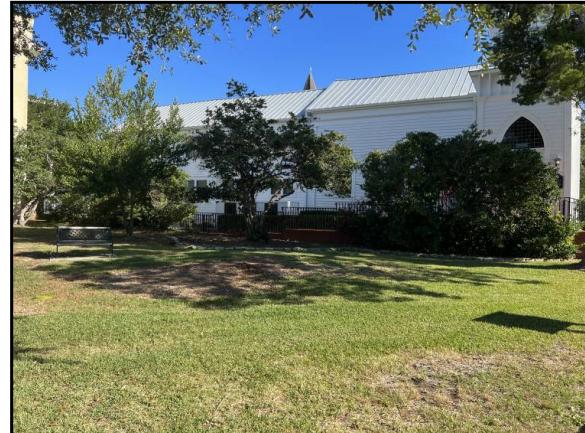
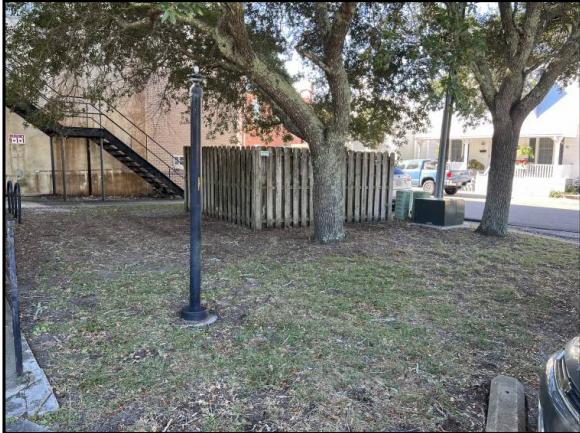
Current condition of landscaping

Addressing these landscaping concerns should be incorporated into the property's routine maintenance plan.

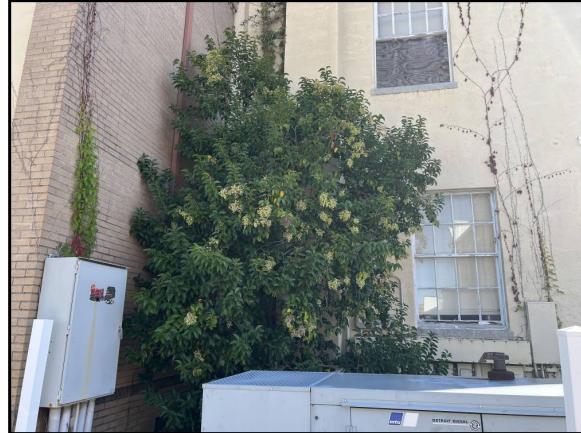
Shrubs and vines in contact with the building's exterior

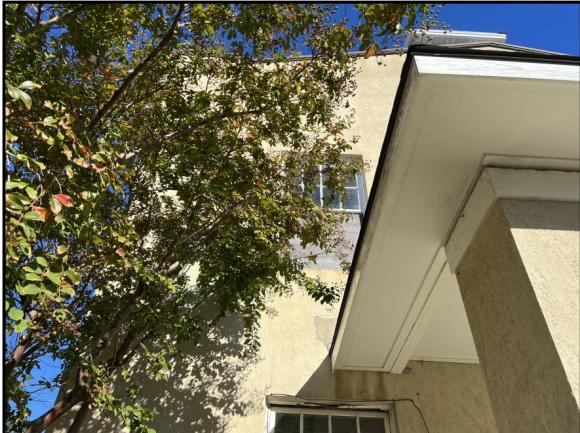
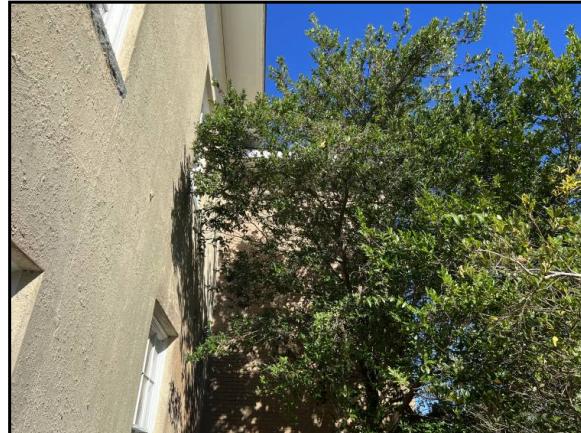
Tree limbs overhanging and in contact with the building's exterior

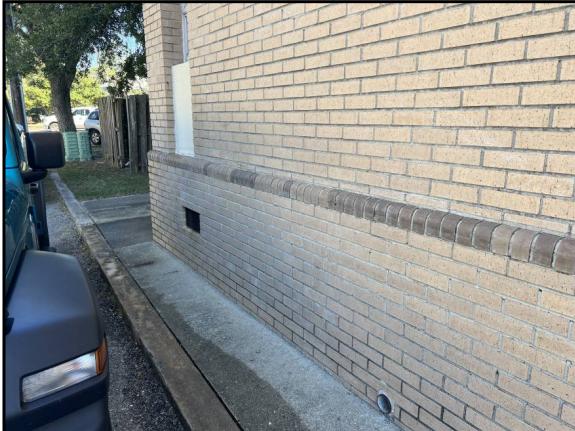
View of exterior indicating a crawl space type foundation

Recommendation: Isolated areas of the foundation systems are exposed, which allows for limited observation. Due to historic classification, substantial compliance with current essential service facility and code requirements is not likely feasible or cost-effective. Review and analyze the capacity of original systems and strengthen critical elements. Historical building code may be used to lessen structural requirements. A critical review of essential service facility occupancy is recommended.

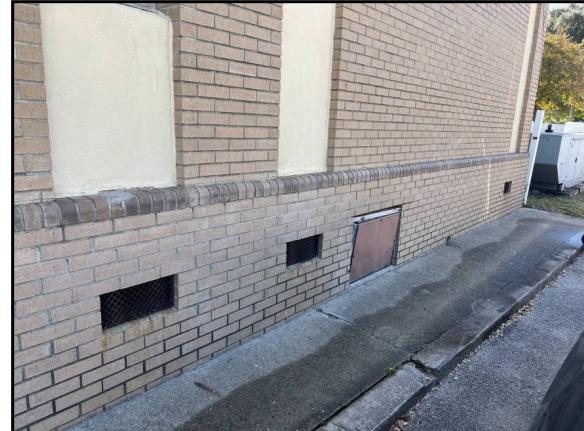
View of foundation vents and access door for the crawl space

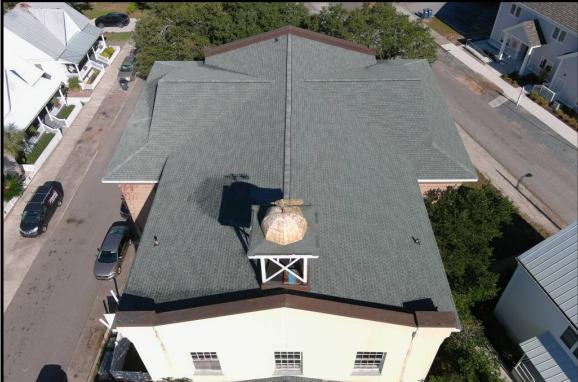
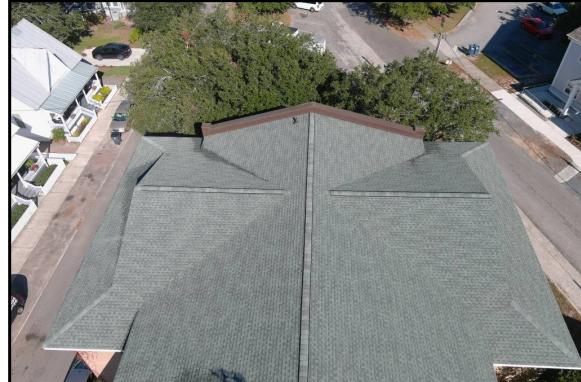
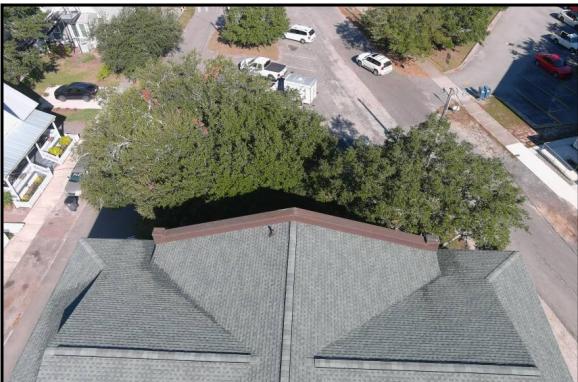
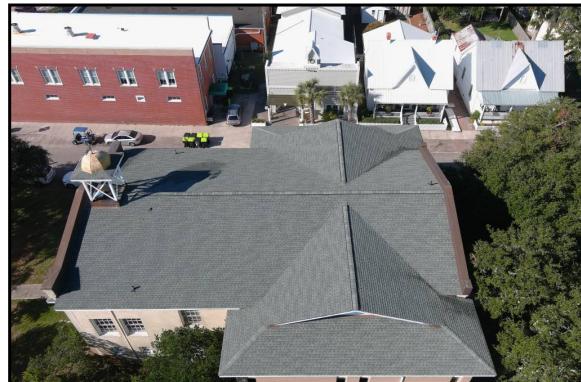
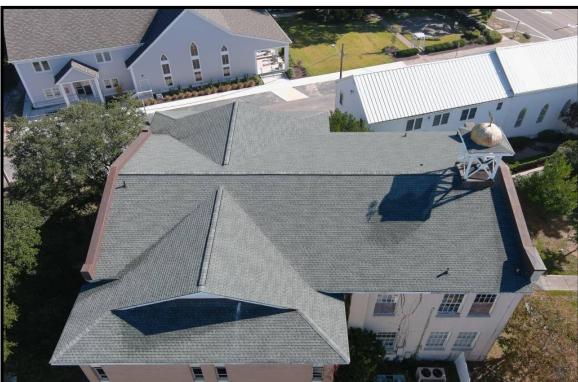
Aerial view of the current condition of the roof

Recommendation: According to the Property Contact, the roof finishes were replaced approximately 5 years ago. It is advisable to explore the possibility of installing gutters and downspouts for the current roof system. The inclusion of a well-designed gutter and downspout system offers various crucial advantages, such as effective water management, safeguarding the roof, preventing erosion, avoiding water staining, and preserving the foundation. As part of the property management's routine maintenance program, incorporating annual roof inspections, debris removal, and addressing minor repairs is recommended.

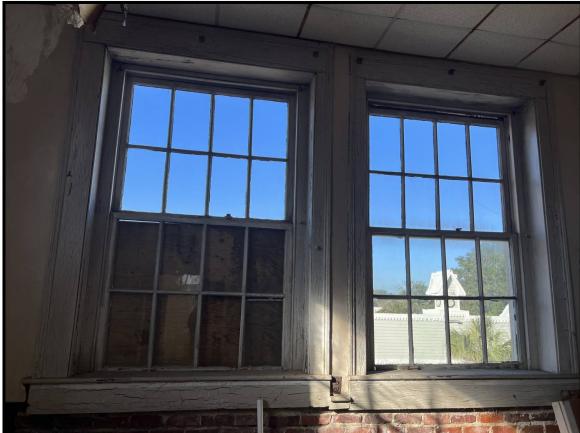
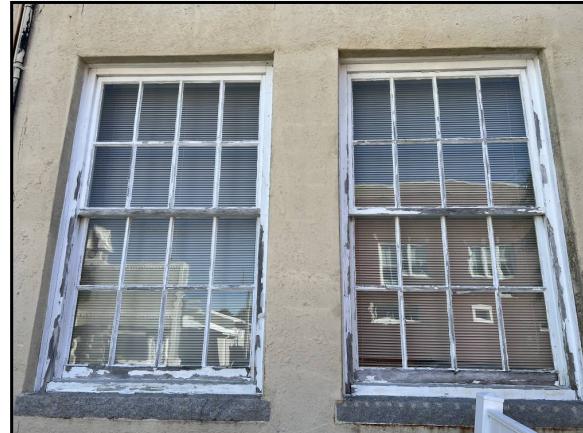
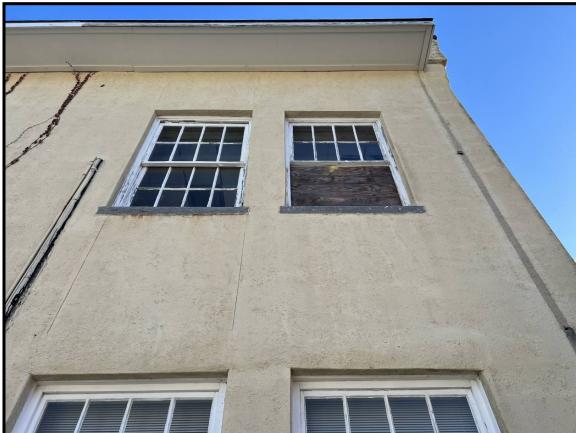
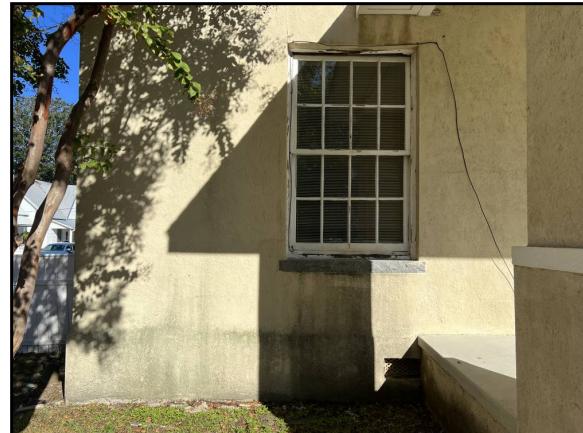
Current condition of the windows

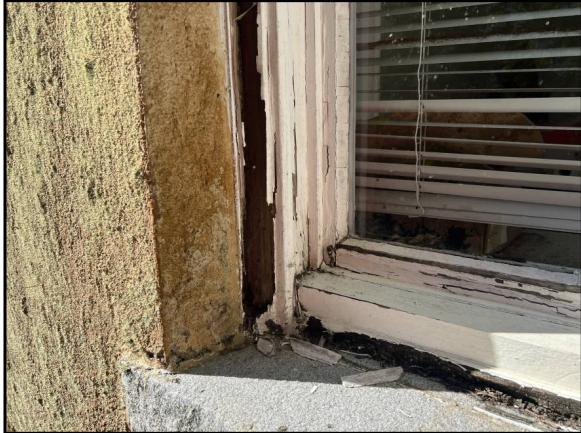
Description Windows: The wooden windows were assessed for their condition, functionality, and overall integrity. Visual inspections revealed the presence of wood rot, surface wear, and paint deterioration, consistent with natural exposure to the elements.

Current condition of the windows

Recommendation: Including window replacement in the property's budget and maintenance plan is recommended to address this aspect of the building envelope comprehensively. Timely replacement will not only enhance the property's overall condition but also contribute to long-term cost savings and sustainability.

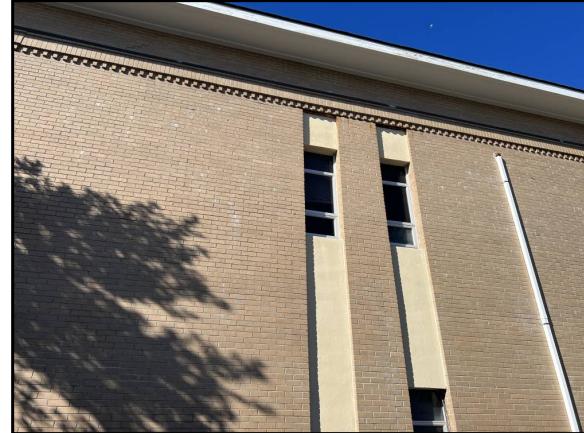
Current condition of the windows

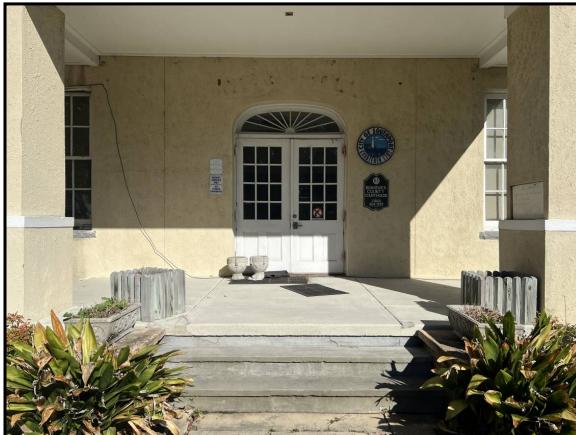
Doors: Similarly, the wooden doors were inspected for signs of wear, structural soundness, and functionality. Some doors exhibited minor surface cracks, which, while not compromising their stability, may warrant periodic maintenance. Hardware, such as handles and hinges, was checked for proper operation

Current condition of the front entrance door

No significant issues were immediately apparent with the doors, but ongoing monitoring and preventive measures, such as sealing and repainting, are recommended to preserve the wood and prevent potential deterioration.

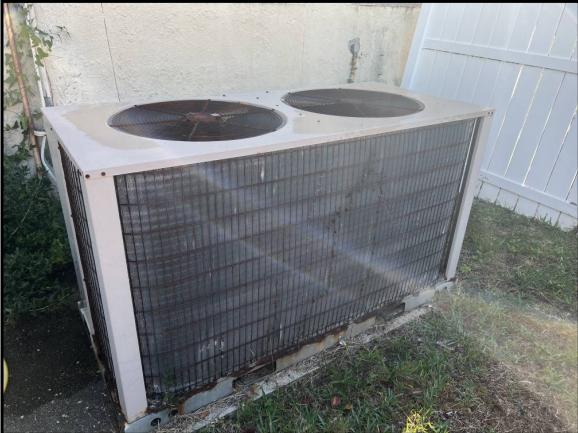
Luxaire 10-ton heat pump; manufactured in 1996

Recommendation: The noted condition, along with the varied ages of the package units, suggests a potential decrease in efficiency and reliability. Recommending the replacement of the mechanical systems aims to reduce the risk of unforeseen failures, enhance energy efficiency, and improve overall occupant comfort. An alternative consideration is adopting a phased approach to system replacement, giving priority to the most crucial units. This approach allows alignment with budget limitations and operational needs.

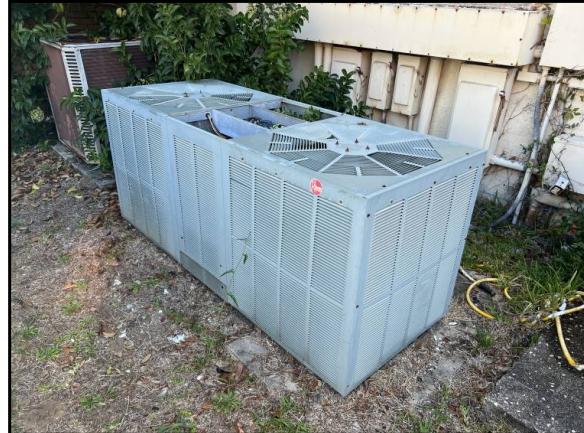
Rheem heat pump; unknown size and manufacturing date

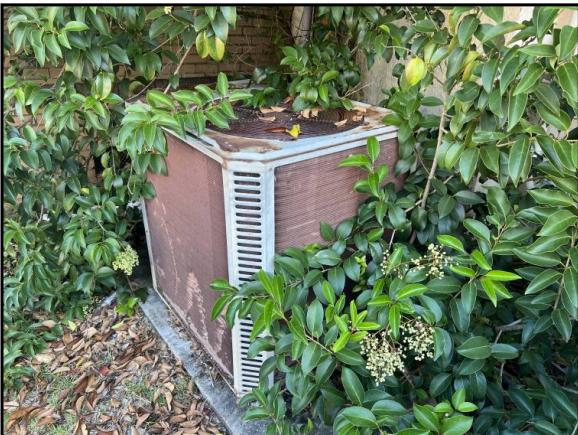
Heat pump; unknown manufacturer, size, and manufacturing date

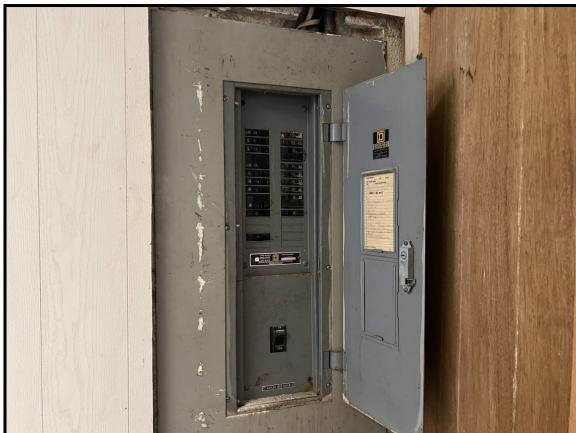
Typical condition of electrical panel box

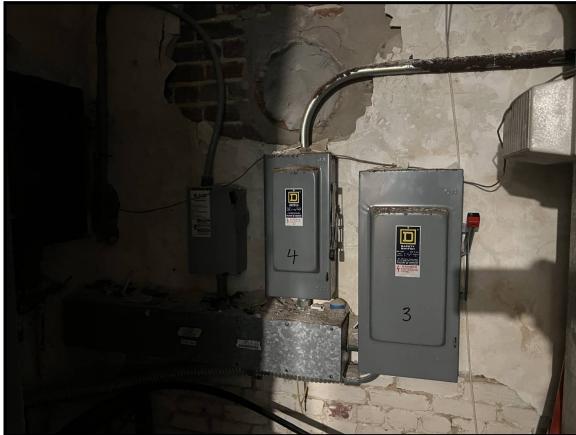
Electrical disconnects for some of the mechanical equipment

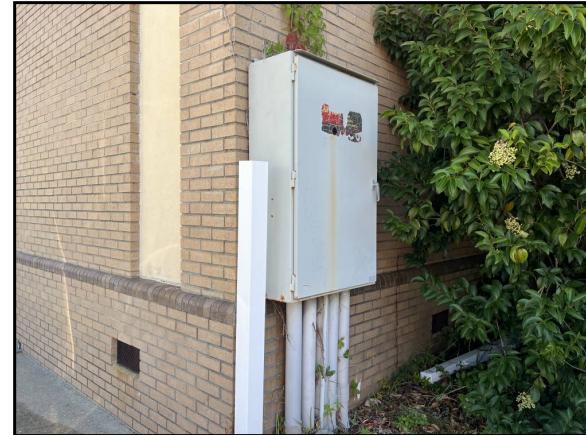
Electrical components for the natural gas generator

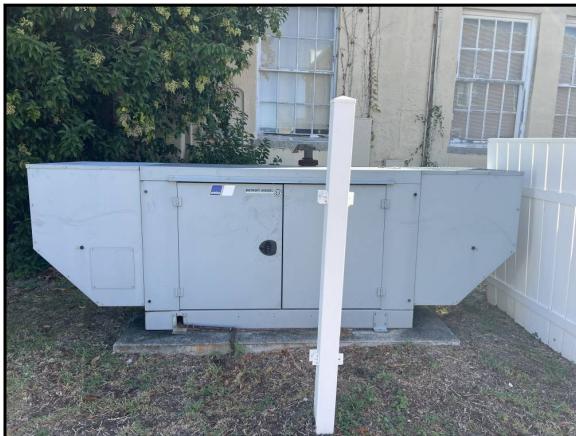
View of natural gas generator

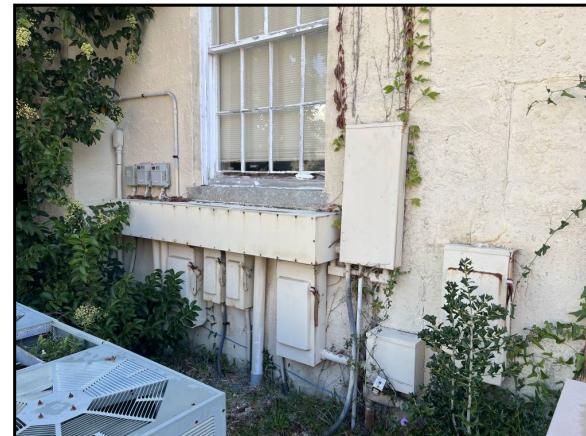
Electrical feeds and disconnects for the outside mechanical equipment

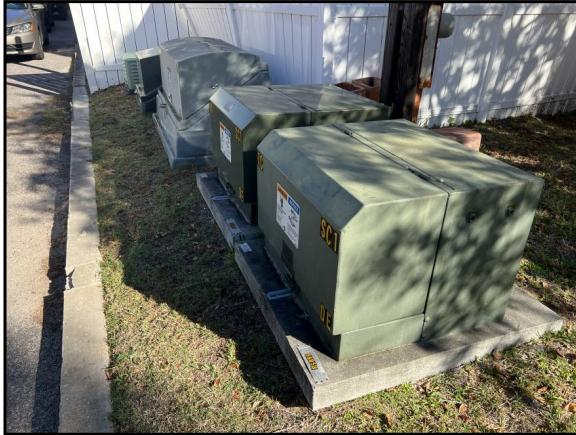
View of onsite electrical transformers

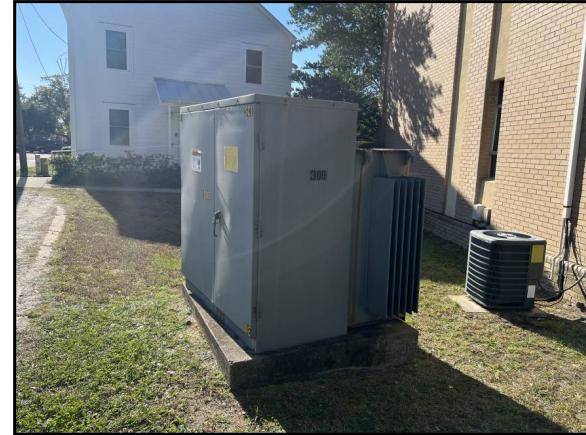
View of onsite electrical transformer

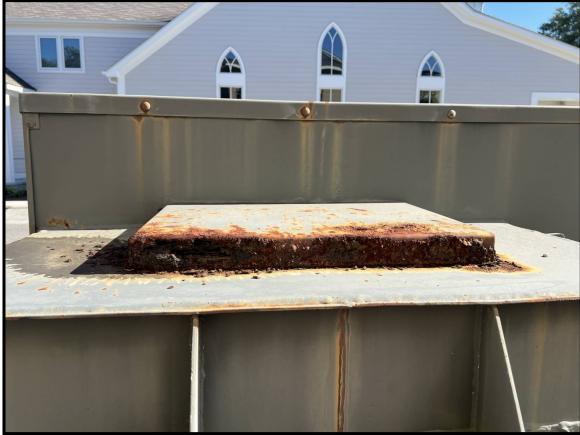
Observed rust atop the main electrical transformer

Recommendation: The electrical power service was deemed sufficient for the current demands of the building. However, a more in-depth evaluation of the electrical system may be necessary to assess its suitability for the intended future use of the facility. It is crucial to address the observed rust on one of the pad-mounted transformers, and the local utility provider should be contacted for necessary maintenance. Routine upkeep, including periodic infrared surveys, is anticipated throughout the evaluation period.

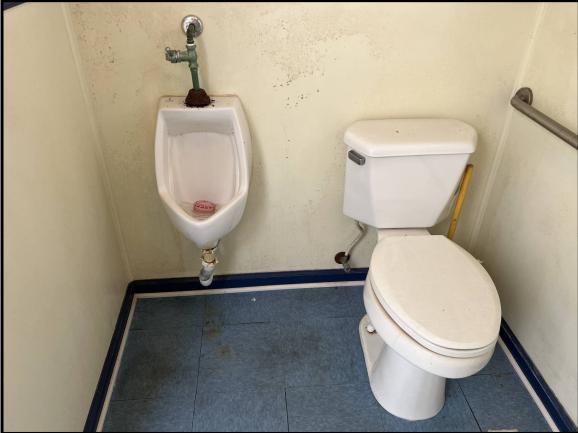
Typical plumbing components and fixtures for the bathrooms

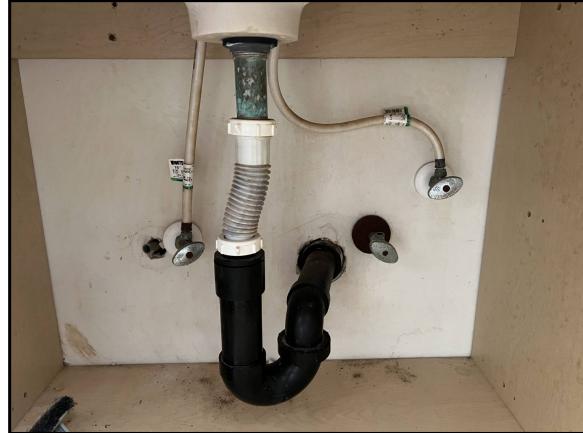
Typical condition of the plumbing components

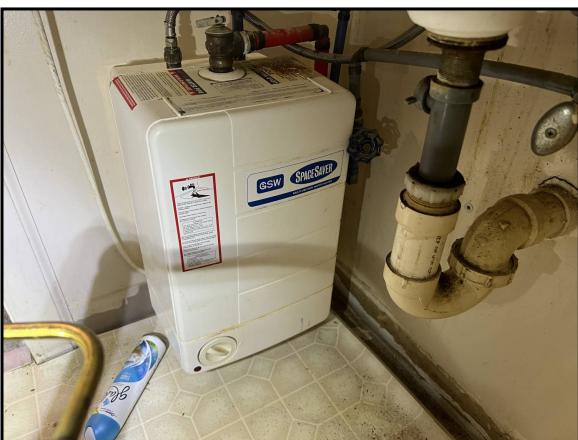
View of a on-demand electrical water heater located in one of the bathrooms

Recommendation: The observed water heaters appeared to be in poor overall condition. Based on age and EUL, replacement is anticipated and costs are included in the Short-Term Costs Table.

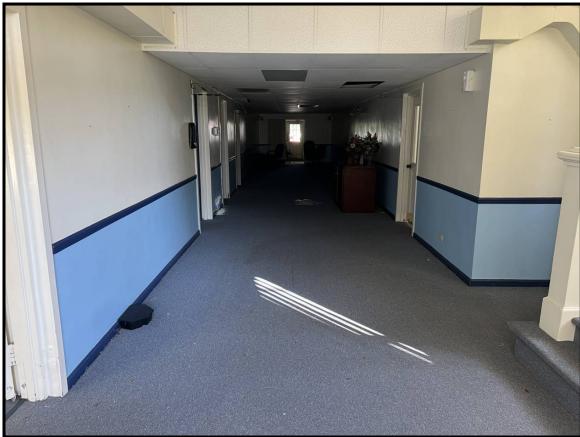
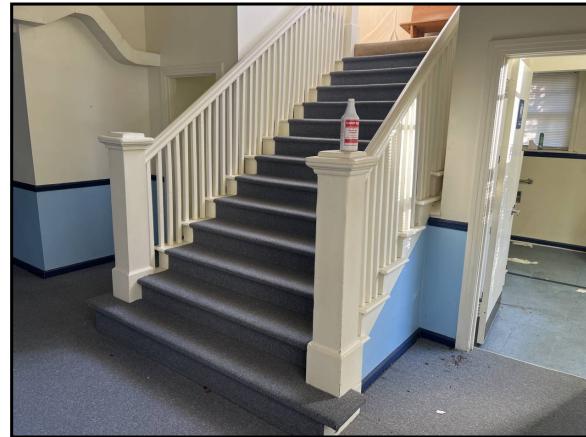
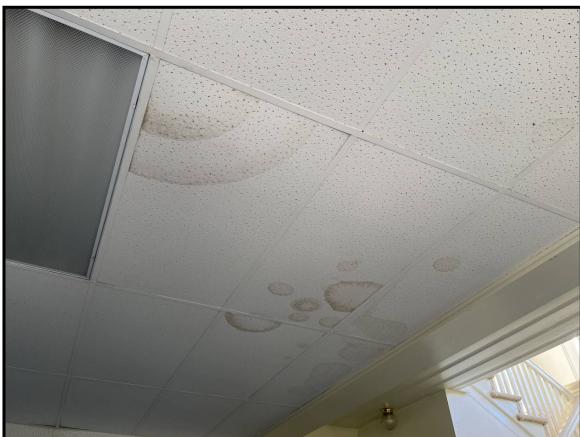
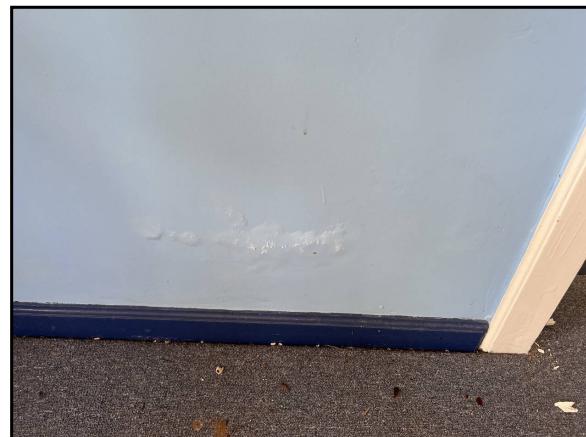
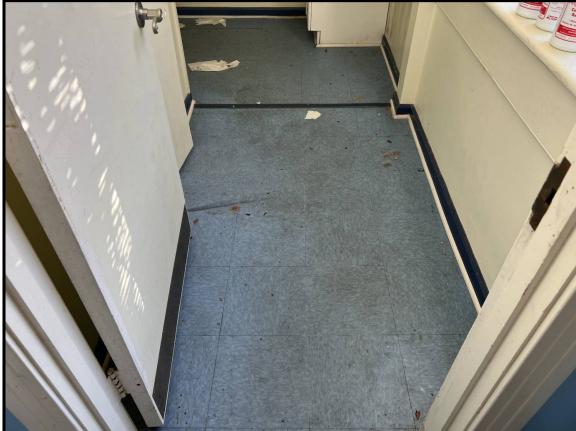
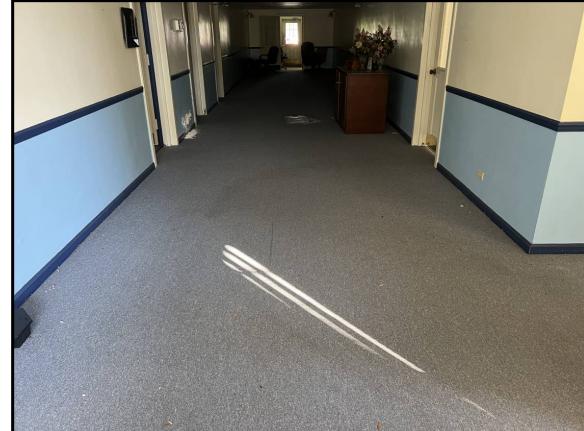
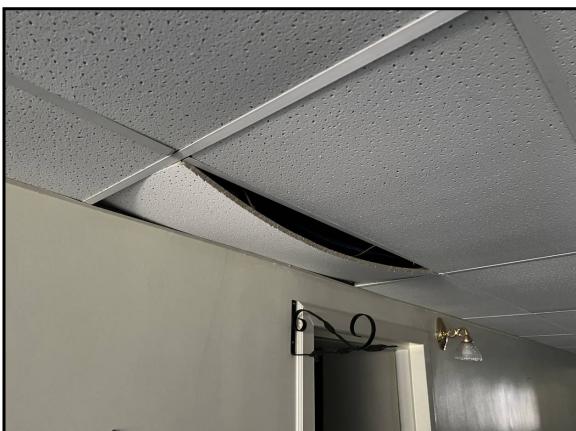
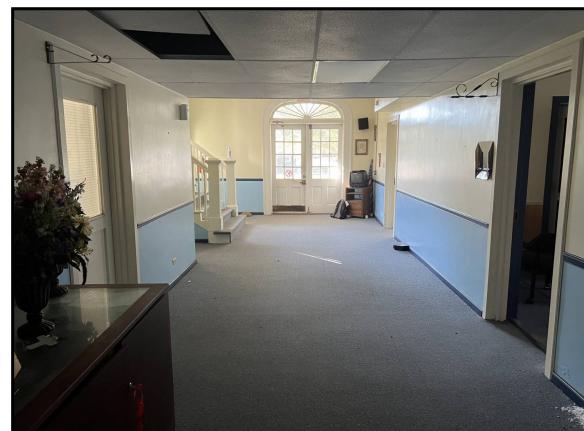
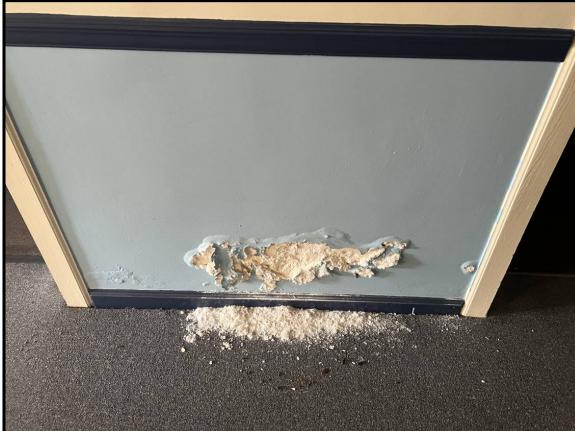
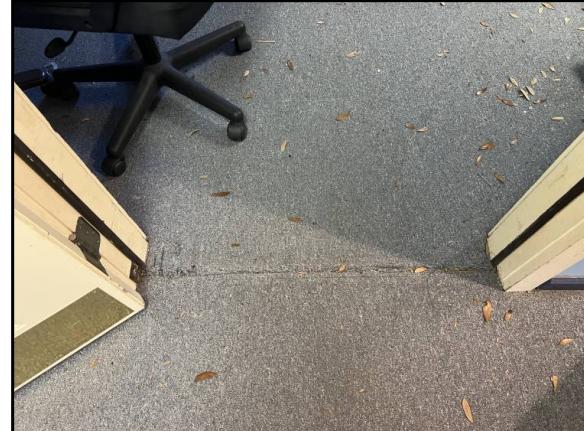
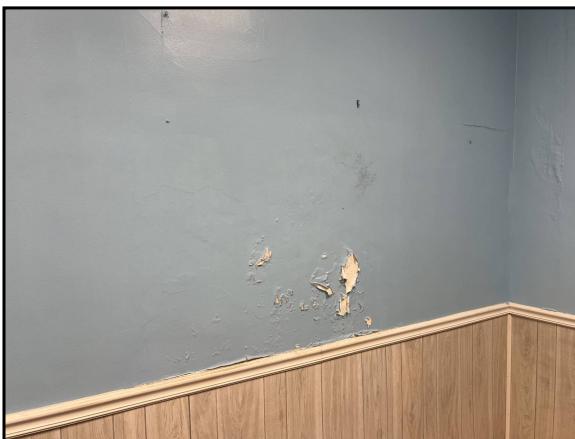
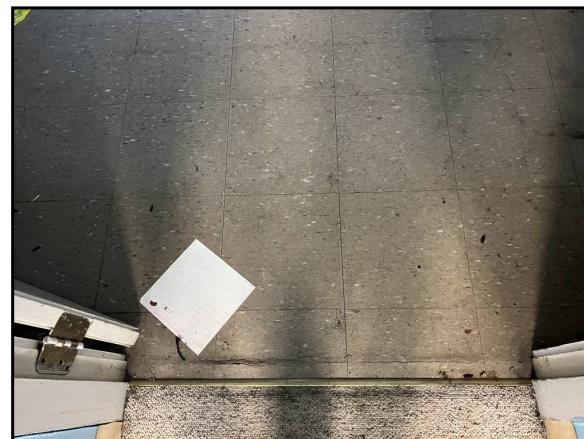
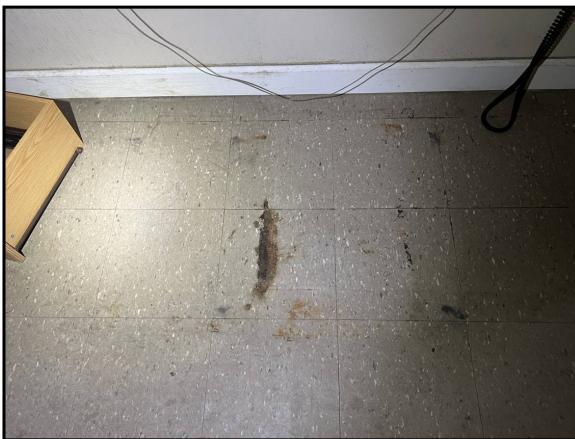
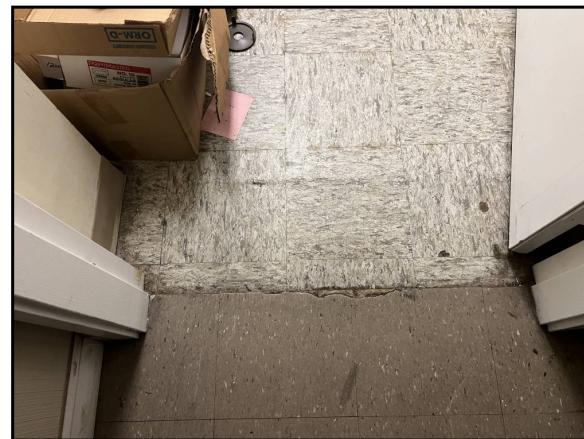
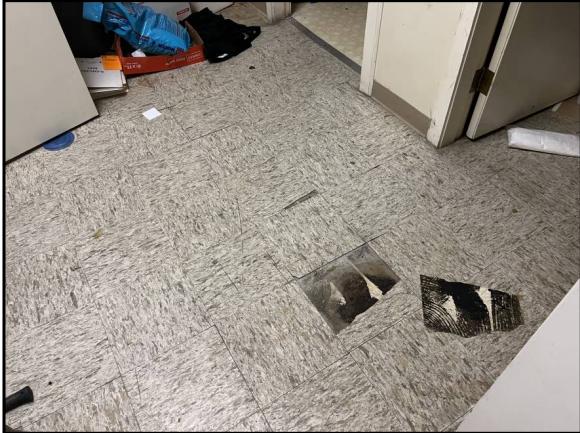
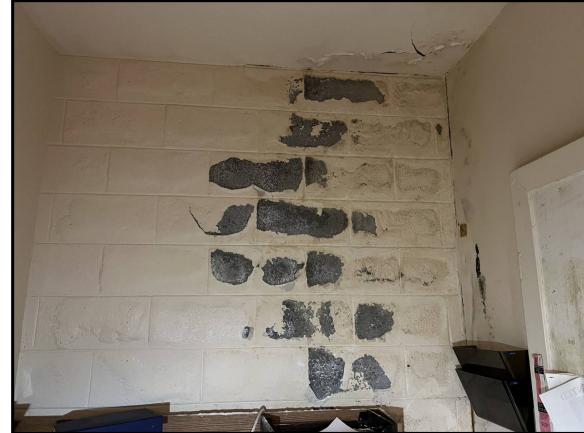
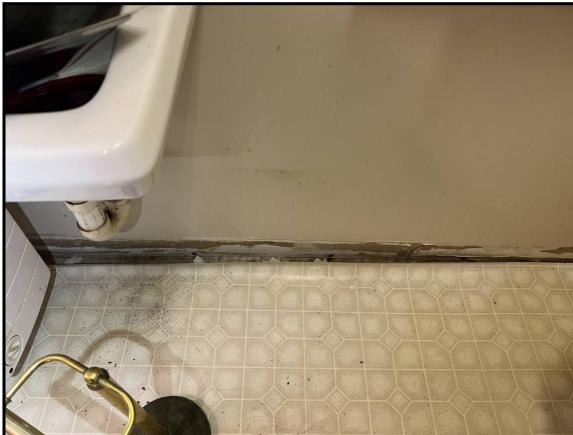
Recommendation: Upon observation, the interior finishes were assessed to be in fair to poor condition, with discernible evidence of past water intrusion. Anticipated actions include maintenance, repairs, and potential replacements of the interior elements. These measures should be aligned with the projected future use of the building.

View of current condition of interior finishes

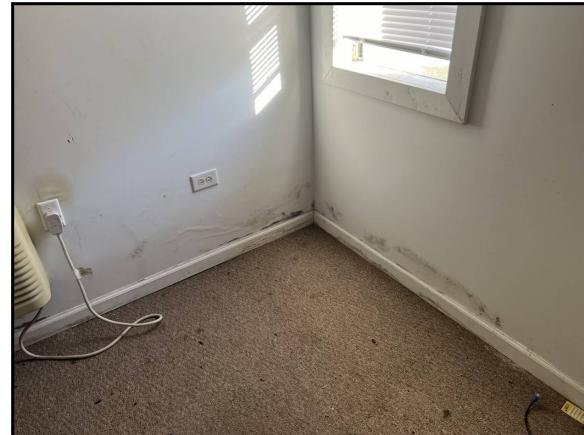
View of current condition of interior finishes

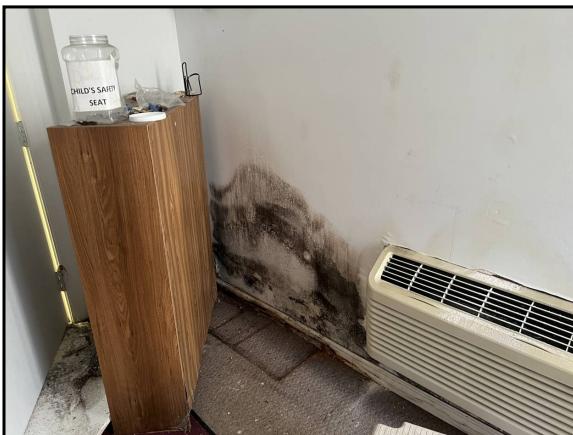
View of current condition of interior finishes

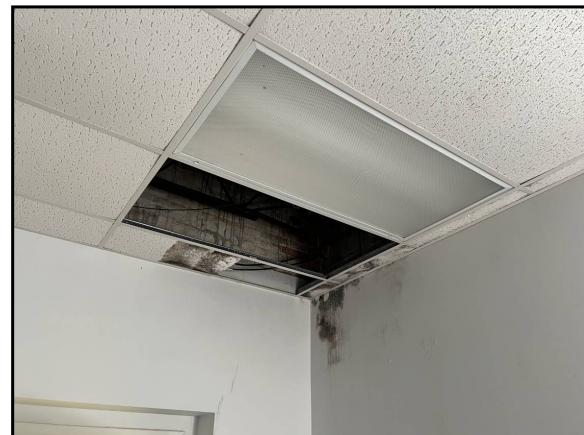
View of current condition of interior finishes

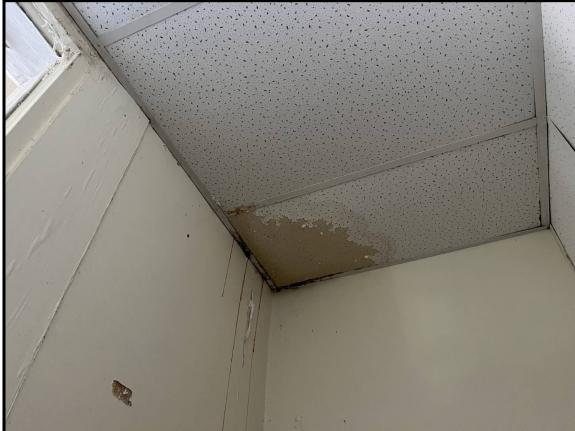
View of current condition of interior finishes

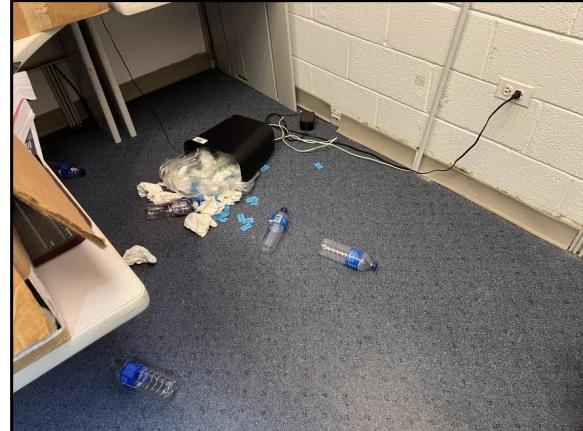
View of current condition of interior finishes

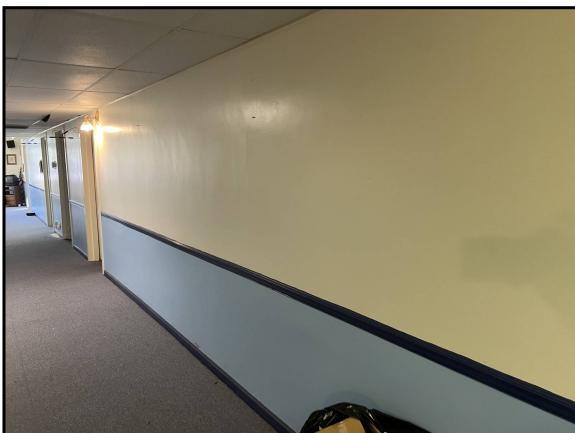
View of current condition of interior finishes

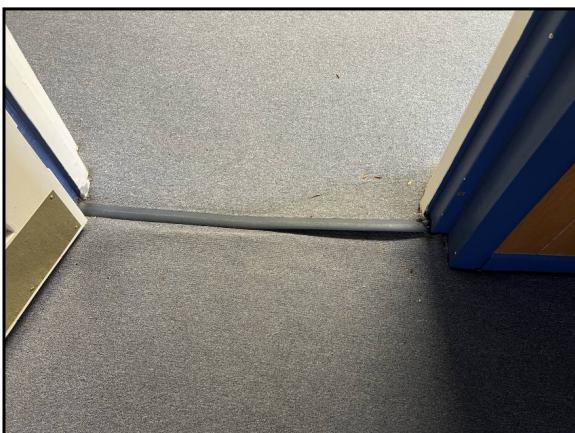
View of current condition of interior finishes

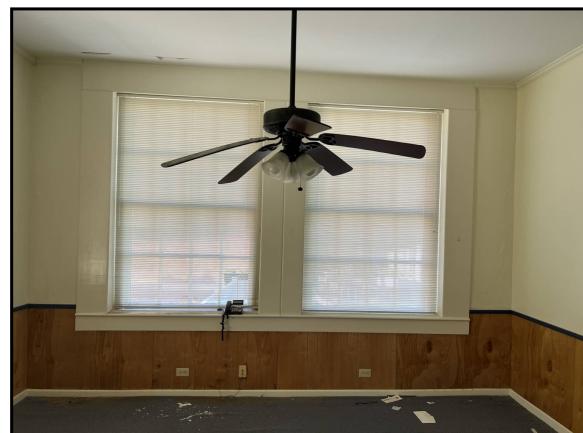
View of current condition of interior finishes

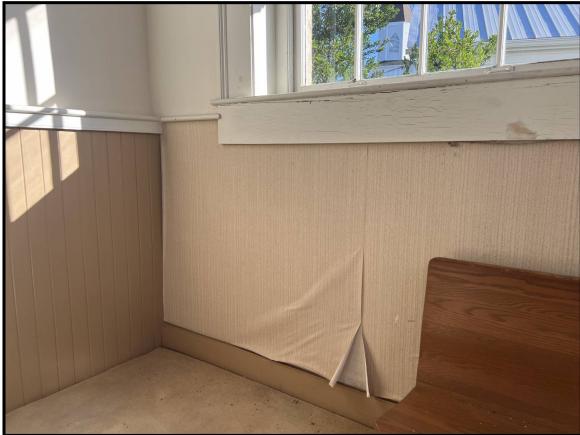
View of current condition of interior finishes

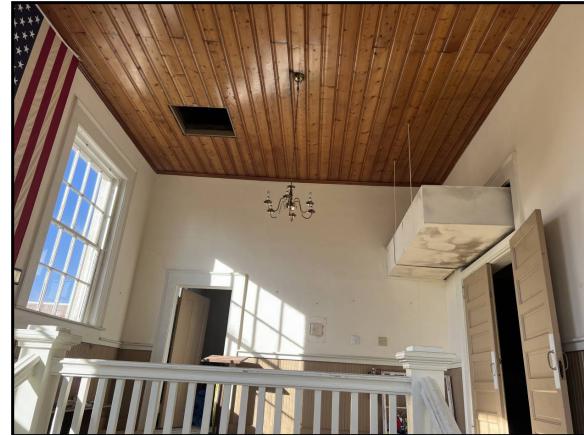
View of current condition of interior finishes

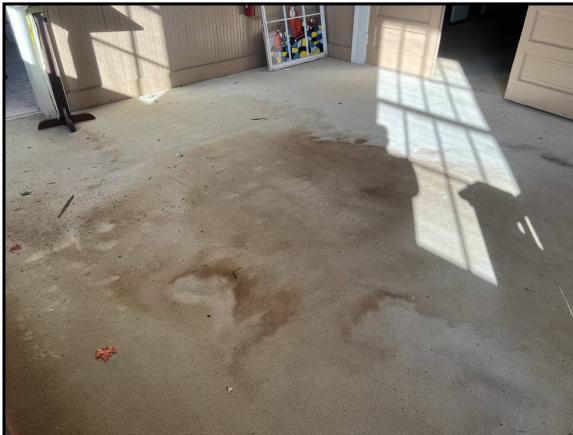
View of current condition of interior finishes

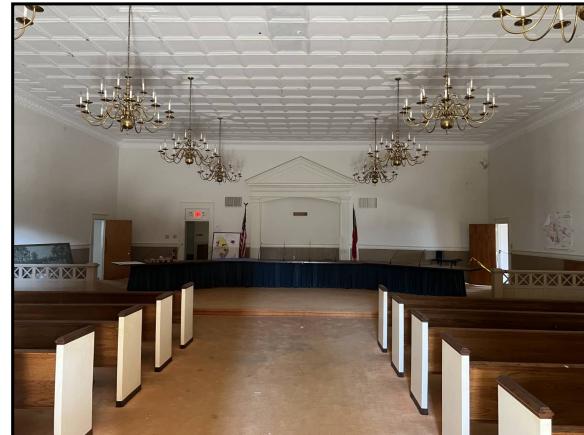
View of current condition of interior finishes

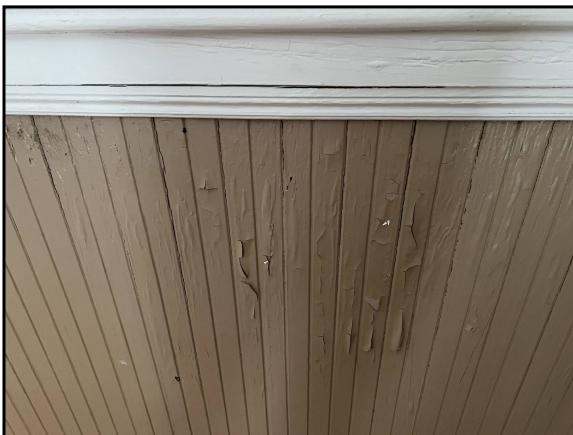
View of current condition of interior finishes

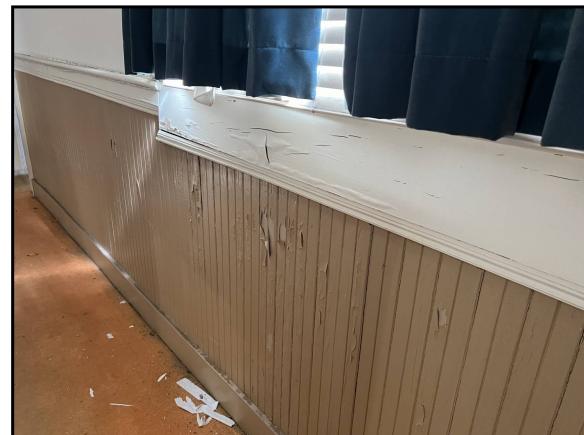
View of current condition of interior finishes

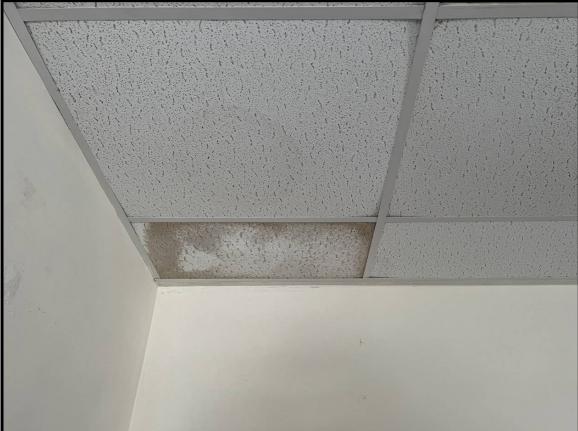
View of current condition of interior finishes

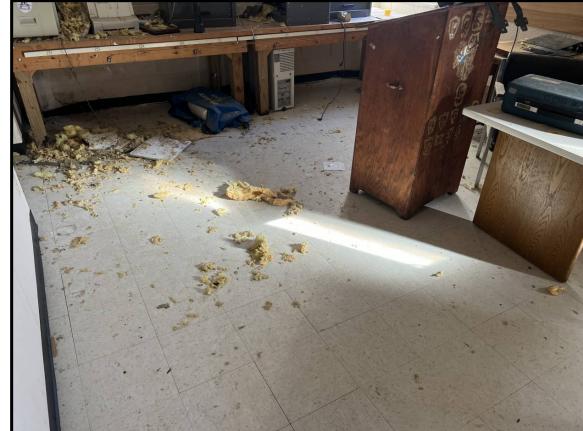
View of current condition of interior finishes

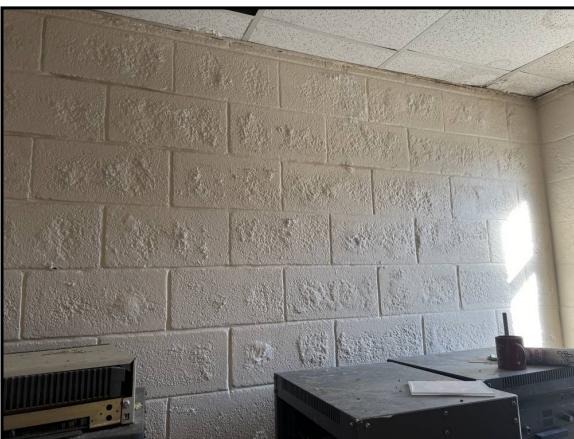
View of current condition of interior finishes

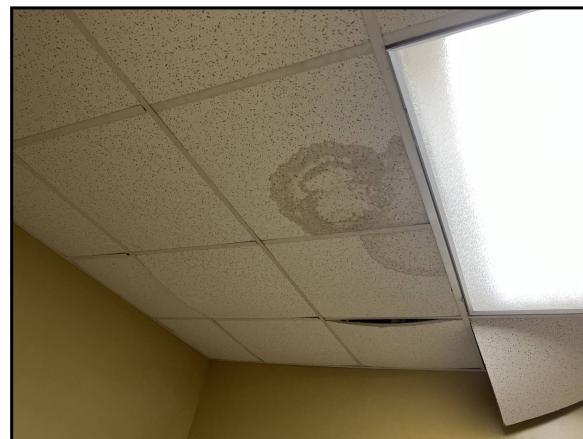
View of current condition of interior finishes

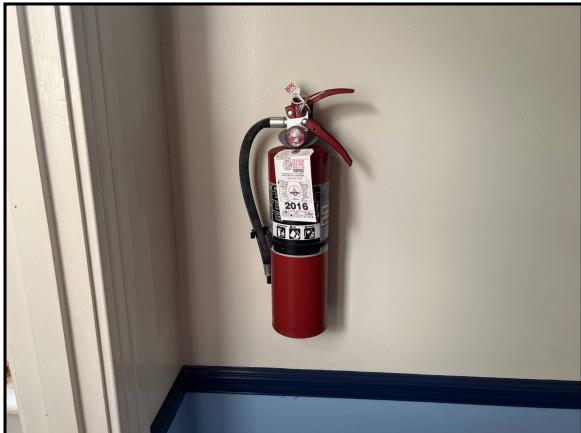
Typical condition of fire extinguishers located throughout the interior of the building

Recommendation: It is highly probable that the life safety and fire protection systems will require updating and alignment with current codes to meet the anticipated use of the building in the future.
