Southport Old City Hall Police Conversion

PROPERTY CONDITION ASSESSMENT REPORT

PROPERTY CONDITION ASSESSMENT
OF
SOUTHPORT OLD CITY HALL / UYA
201 E. MOORE STREET
SOUTHPORT, NC 28461

Re: Property Condition Assessment: City of Southport Municipal Building Assessments
201 East Moore Street
Southport, NC 28461

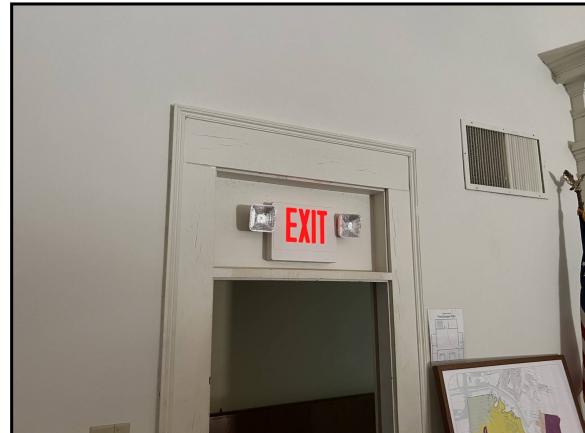
Typical condition of illuminated exit signs located throughout the interior of the building

Recommendation: It is highly probable that the life safety and fire protection systems will require updating and alignment with current codes to meet the anticipated use of the building in the future.

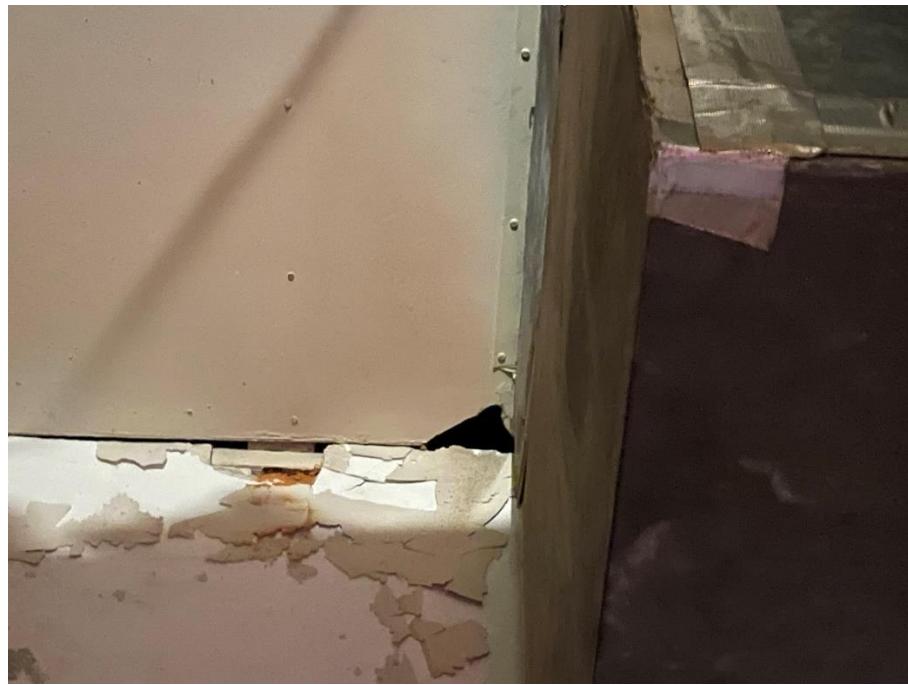
Photo 8 – View of suspect ACM cement board ceiling in the mechanical room.

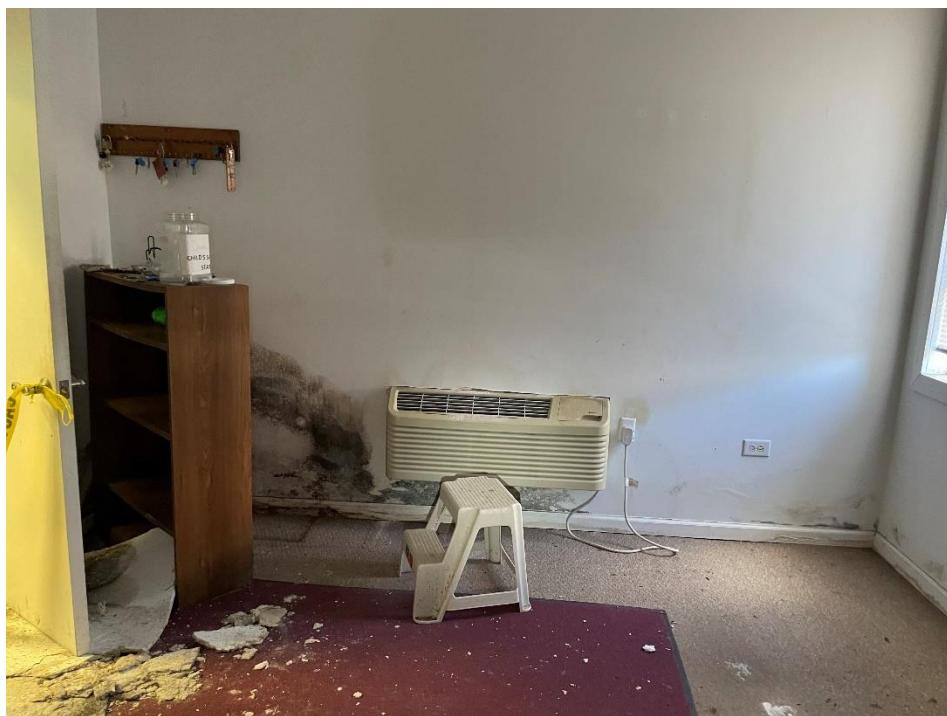
Photo 12 – View of the suspected mold and water intrusion in Room 12.

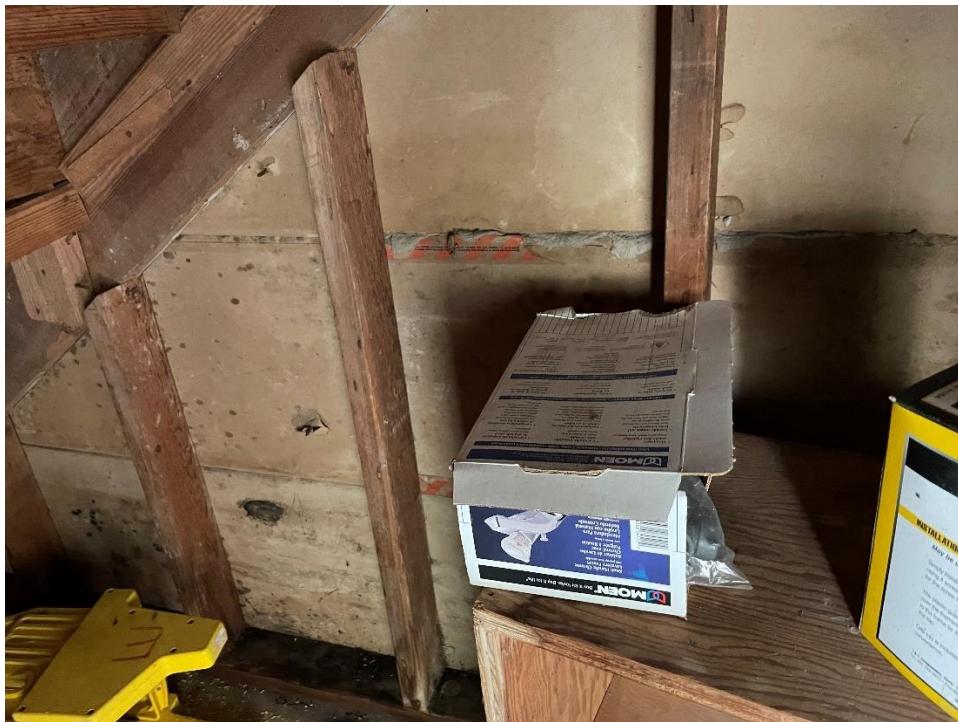
Photo 16 – View of the understairs closet by the bathroom with suspected mold growth on the gypsum lath.

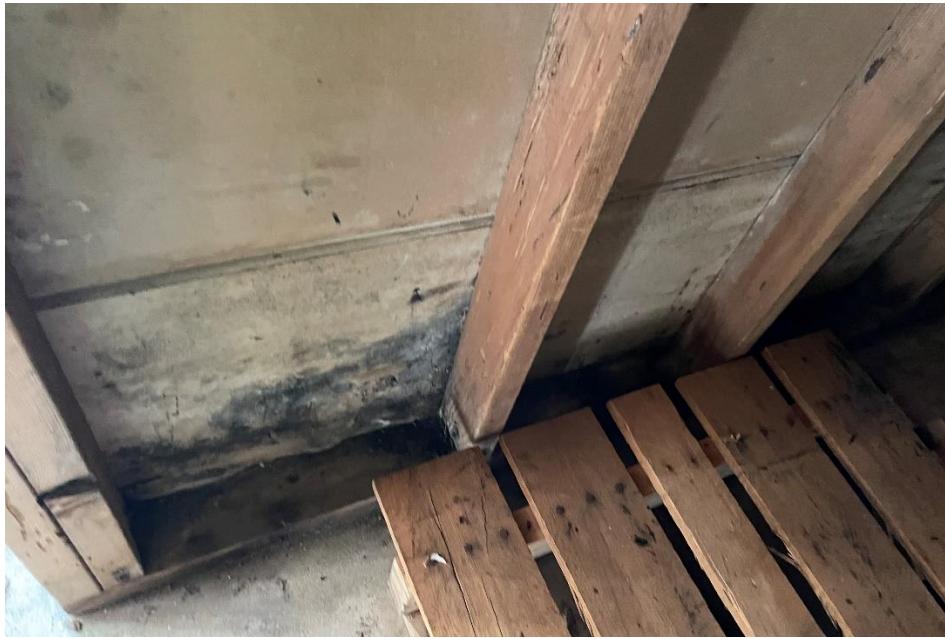
Photo 17 – View of the understairs closet by the bathroom with suspected mold growth on the gypsum lath.

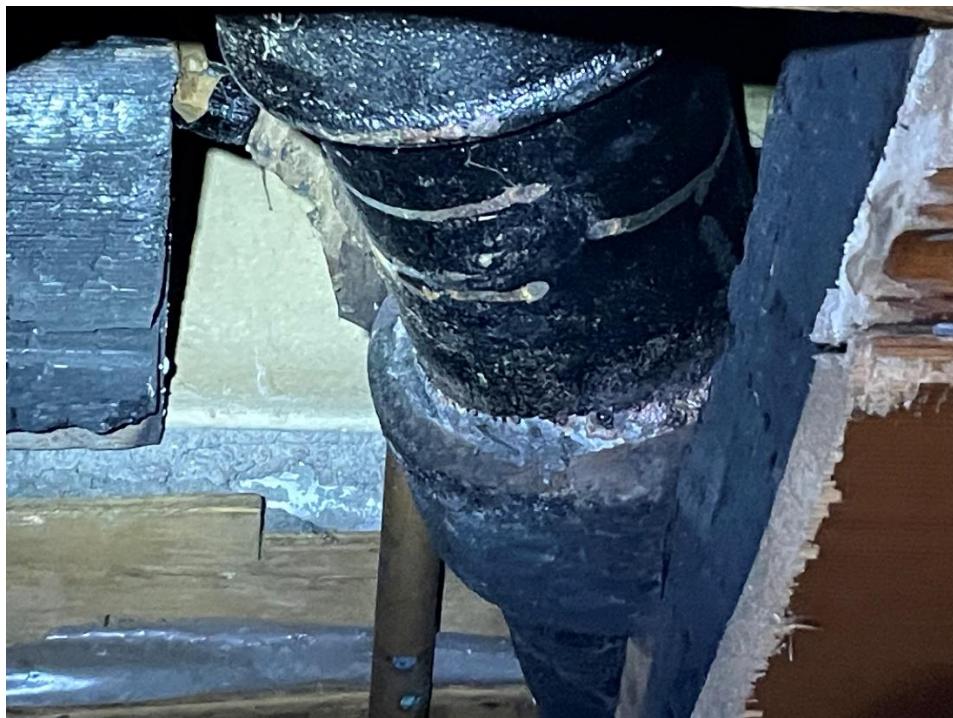
Photo 18 – View of the suspect ACM pipe insulation (black wrap) within the interstitial space between the first and second floor, above the wooden ceiling.

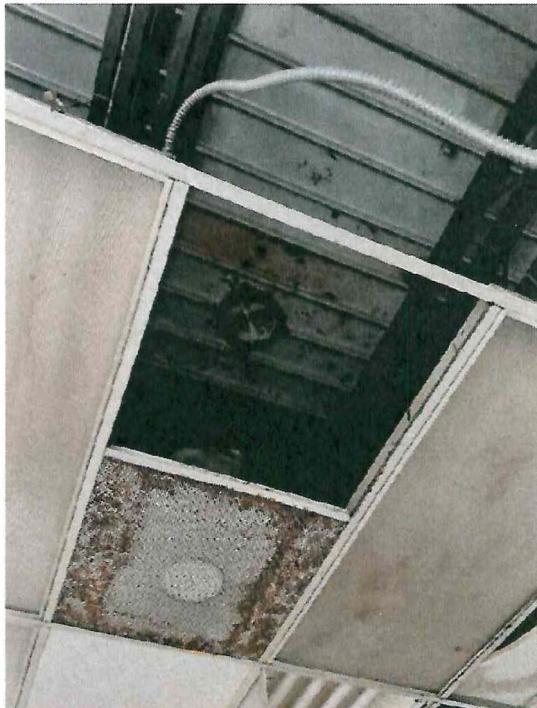
Filled Penetration in Metal Deck Above Second Floor
